The conservation works to the roof and rainwater goods of Kilcarbery house

Building Dossier for works done during March and April 2014

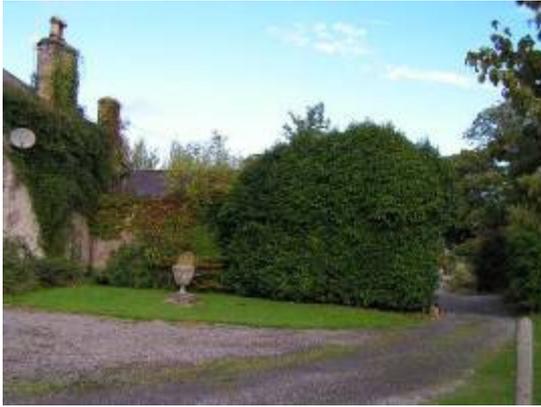
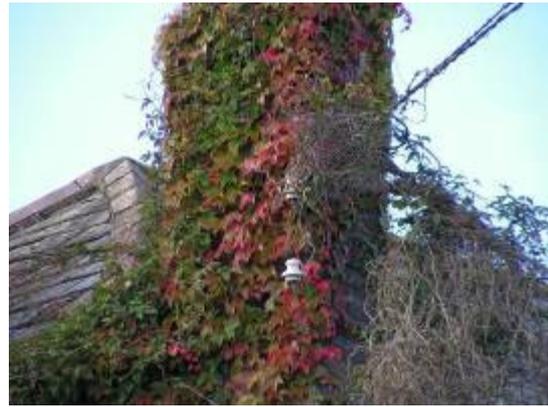
The east side of the house, the outbuilding to the east of the house and the rear chimney above the east side of the house had been extensively colonised by creepers and ivy, making condition assessment difficult. (Autumn 2010)

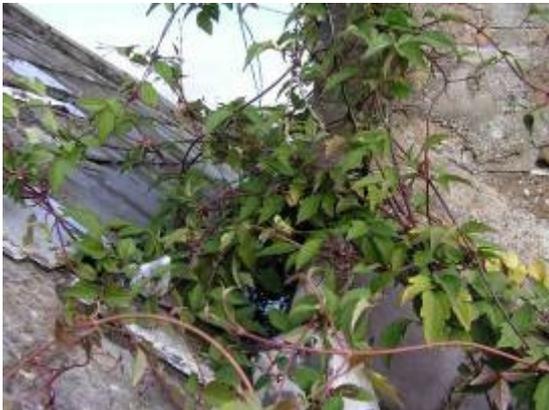
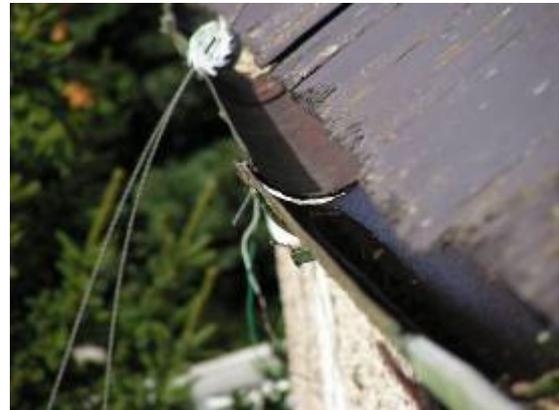
The photo on the left shows the eastern hipped roof at the base of the chimney stack before the works. Creepers had blocked the valley and caused visible ponding of water behind the chimney. Right photo: One of the broken joints in the cast iron gutter and a slipped slate above the front of the house. (Autumn 2010)

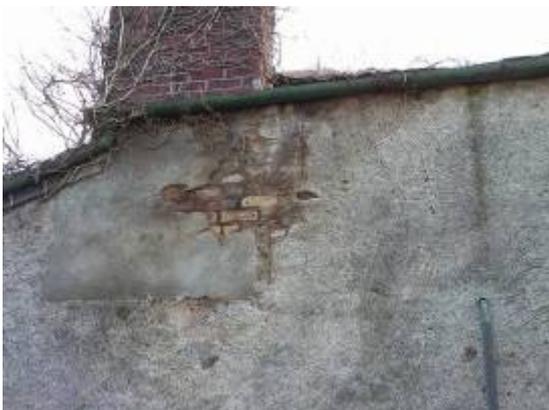
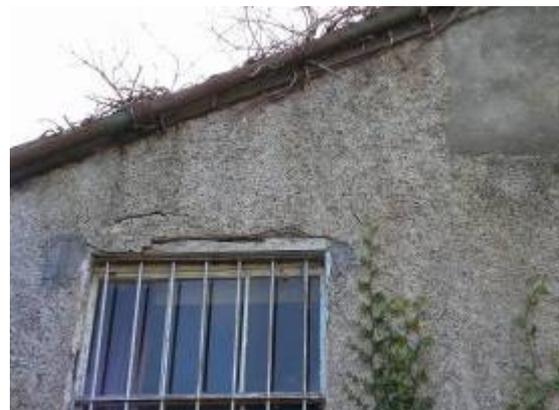
Two views of the west façade, Autumn 2010. The walls under the small chimney had been saturated by leaking, blocked gutters, which probably has not been helped by the cement render applied over. On the right the sloping gutter along the catslide roof is broken and blocked by mature and woody creepers – all since removed. The wall and window underneath have been saturated and partly decayed as a result.

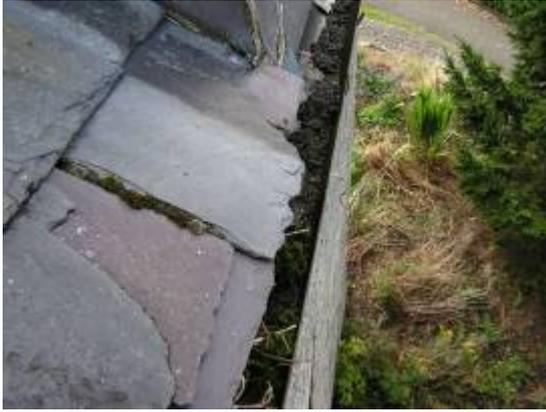
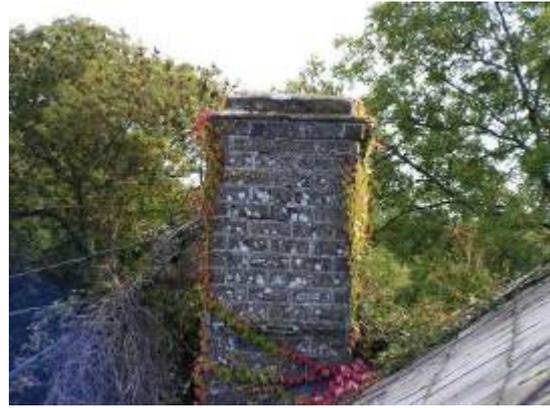
The gutter under the western hipped roof was completely blocked with clay and mosses. The small, back chimney on the east side of the catslide roof was colonised by creepers

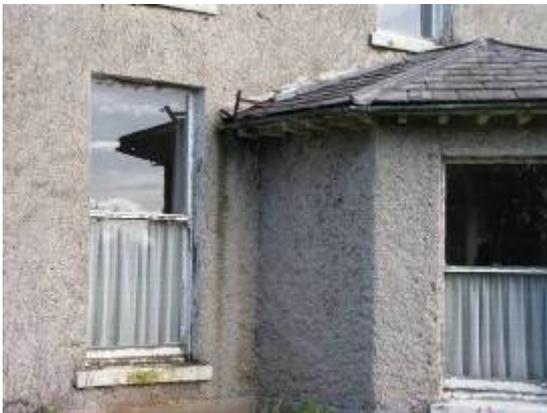
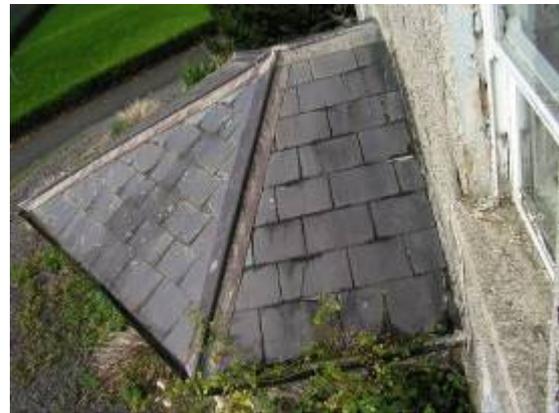
Two views of the porch roof, Autumn 2010. Note the lime mortar fillet at the junction of the wall. Note the blocked gutter. Note the stain in the wall render, the decayed window reveal on one side and the rotten window where the gutter overflows and has saturated the wall.

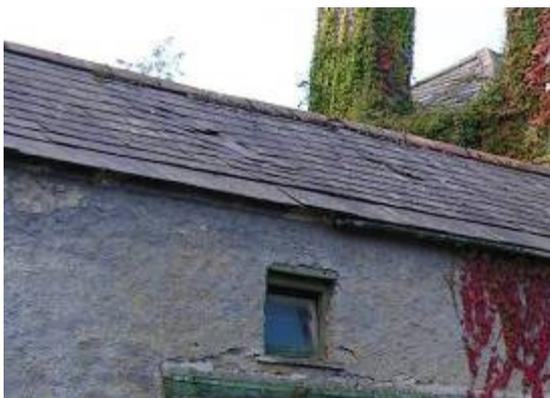
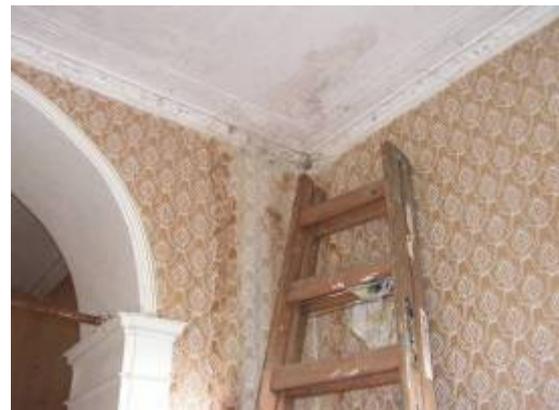
Left side photo: The northern slope of the roof of the outbuilding to the east of the house is on the left. Right side photo: The stain on the ceiling of the entrance porch

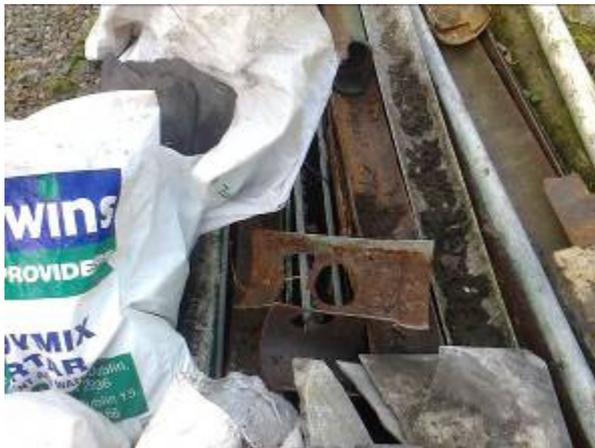
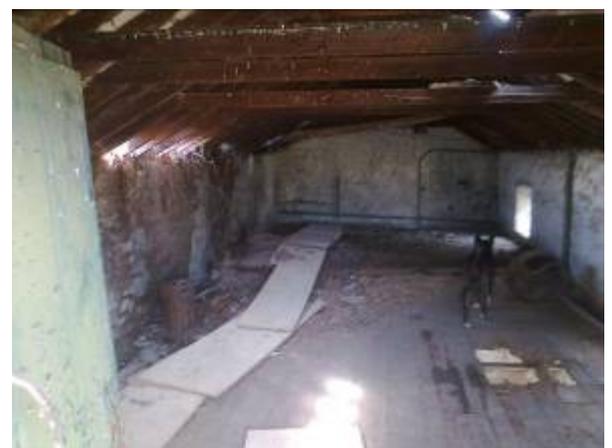
Left: The severe corrosion in the old rainwater gutters and outlets. Right: The tree trunk after cutting and the hole in the roof slate in the shed attached to the east side of the house. The old plywood sheet floor is also visible. Parts of this floor were not safe to walk on, April 2014.

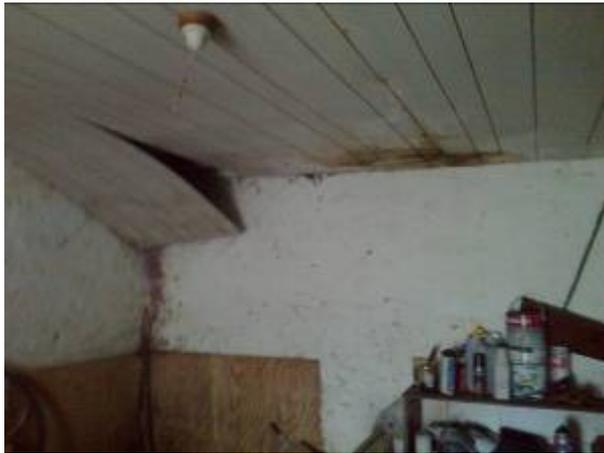
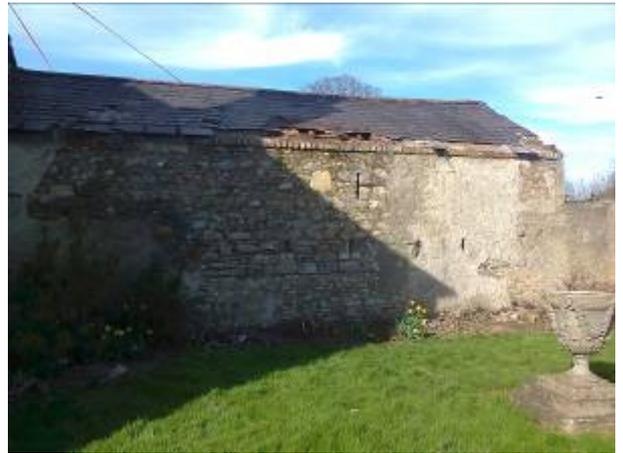
Left: the collapsing beauty board ceiling in the utility room. Right: The hole in the roof of the in the shed attached to the east side of the house, after cutting and removing the tree, April 2014

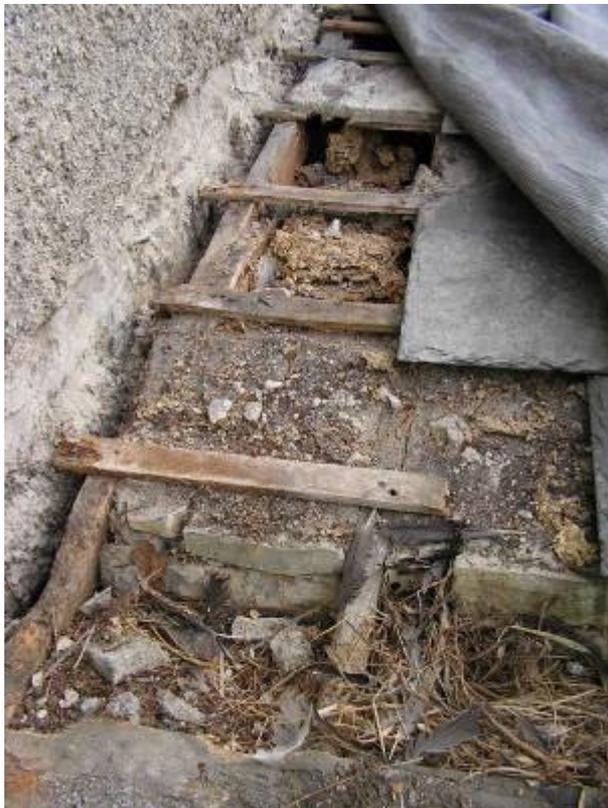
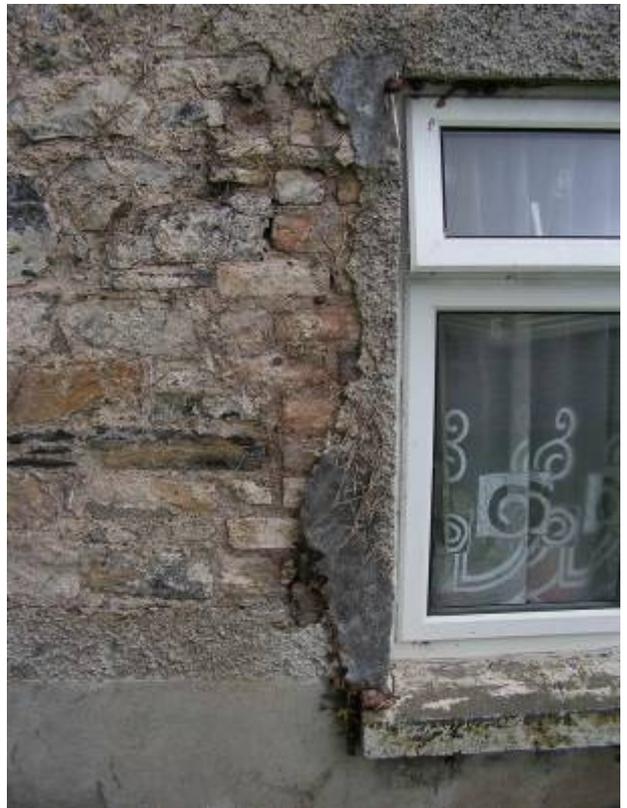
Left: The west pitch of the roof above the entrance porch. Right: The kitchen window - severe loss of render resulting from years of rainwater washing down the façade from the failed gutter above, May 2014

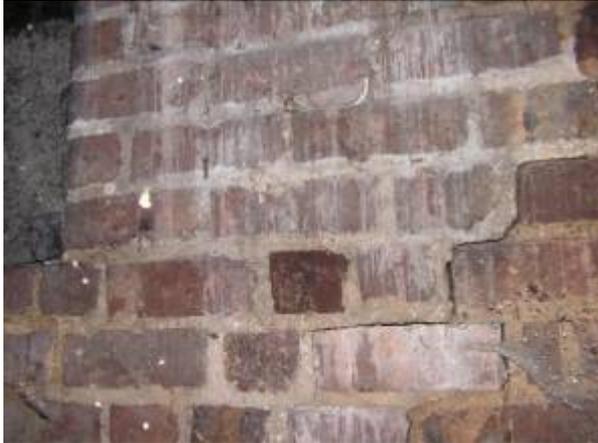
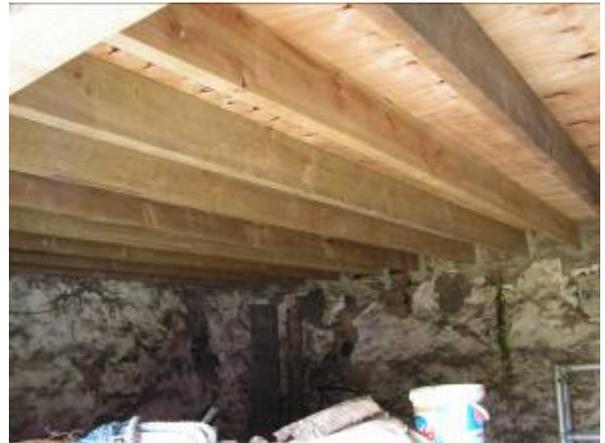
Left: The crack in the rere chimney, west side of roof, viewed from a hole in the ceiling of the rere west bedroom. Right: The new floor in the shed attached to the east side of the house, May 2014.

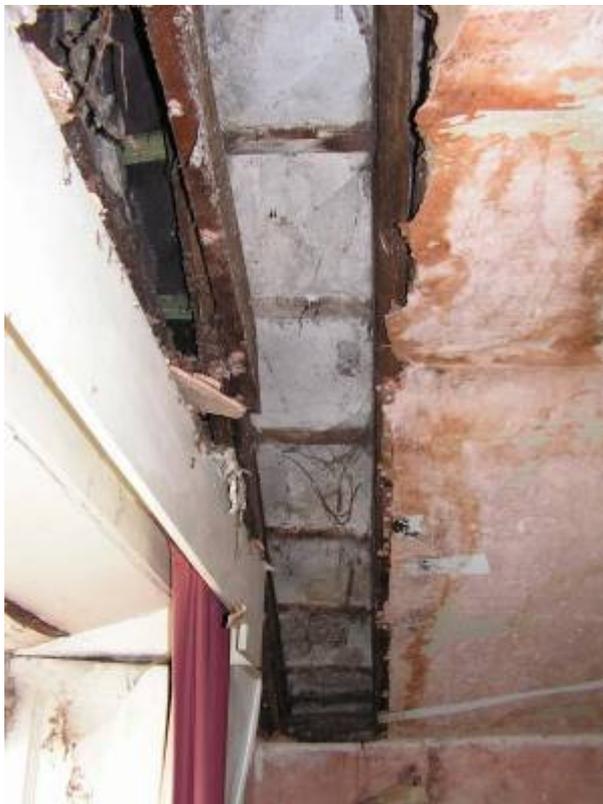
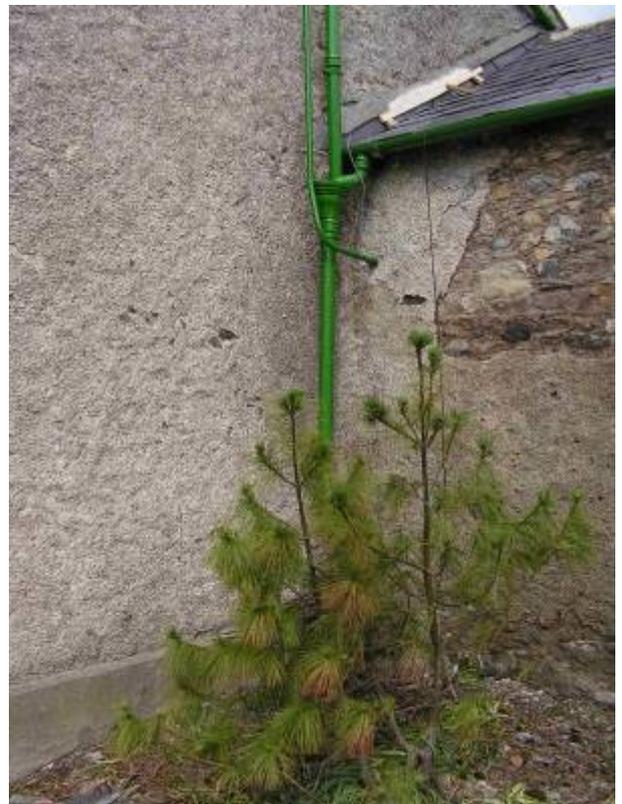
Left: The opening up works to the sloped ceiling of the rere west bedroom. Severe structural damage resulting from decay was evident in the rafters and slating battens. Note the stains on the adjacent gypsum plasterboard ceiling. Right: New cast iron rain water down pipe and hopper at the junction of the house and the shed attached to its east side, May 2014.

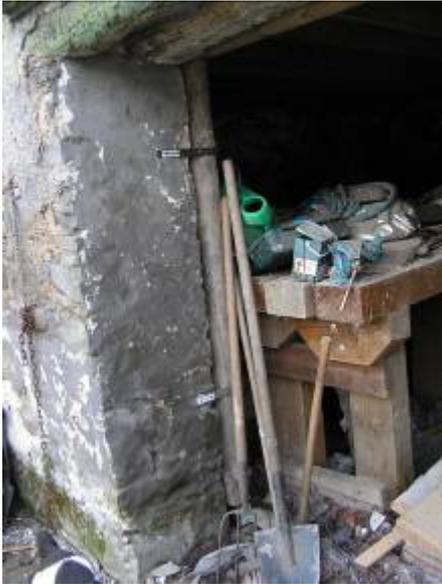
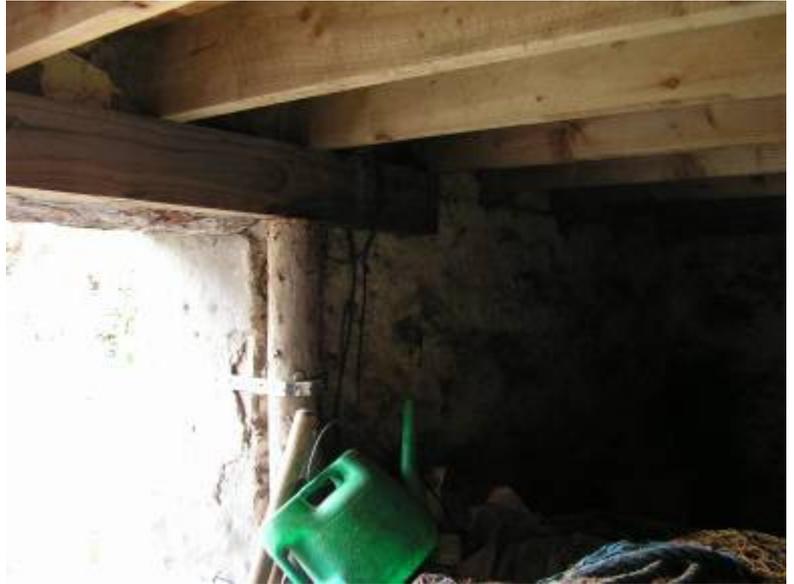
Left: The post and beam supporting the new floor joists above the entrance to the shed attached to the east side of the house. Right: The same detail viewed from within the shed, May 2014

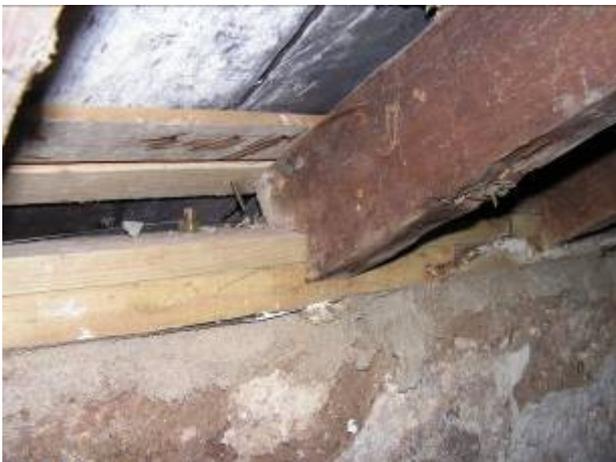
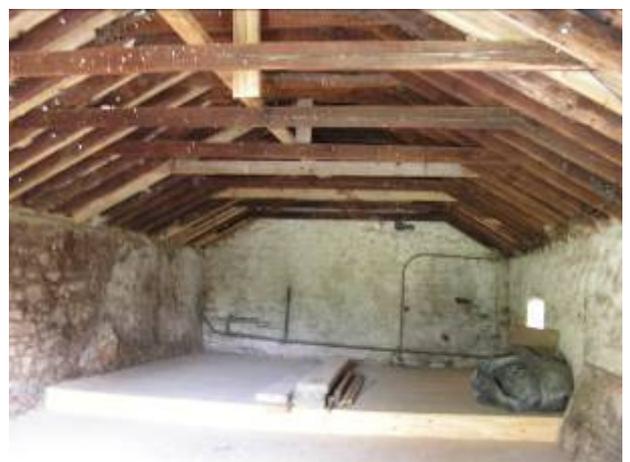
Left: New wall plate and tilting fillet at the base of the roof. Right: The repaired shed.

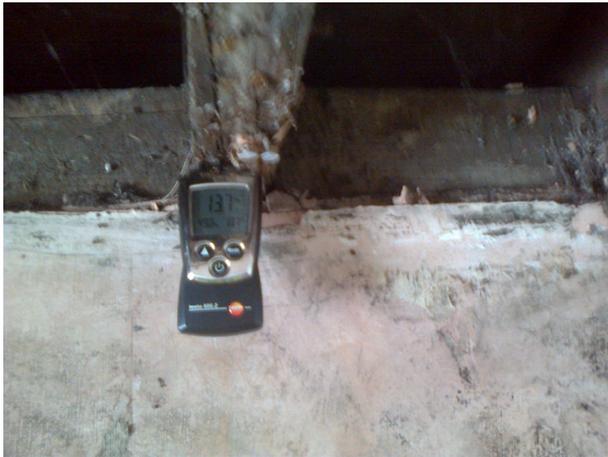
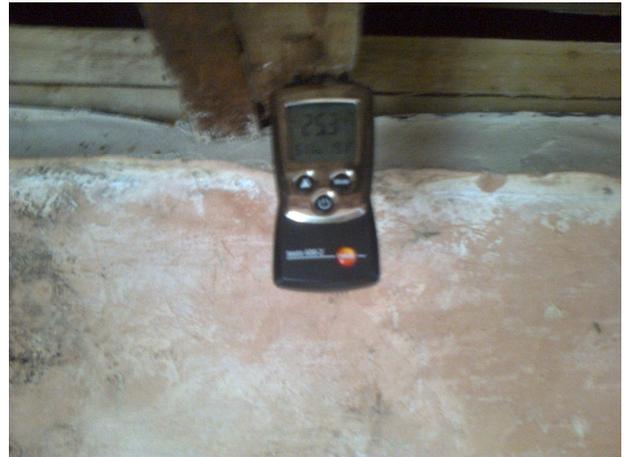
Moisture content readings of the bearing ends of roof rafters at the lower end of the rere bedroom and catslide roof, taken in November 2014, six months after completion of the works. The tests showed a reduction in moisture content in the timbers and that the timbers are slowly drying out.
