Conservation of the ruins at Killininny, Oldcourt, Tallaght, Dublin 24

Building Dossier for works done during March and July - September 2016

Date of this report, 31st January 2017

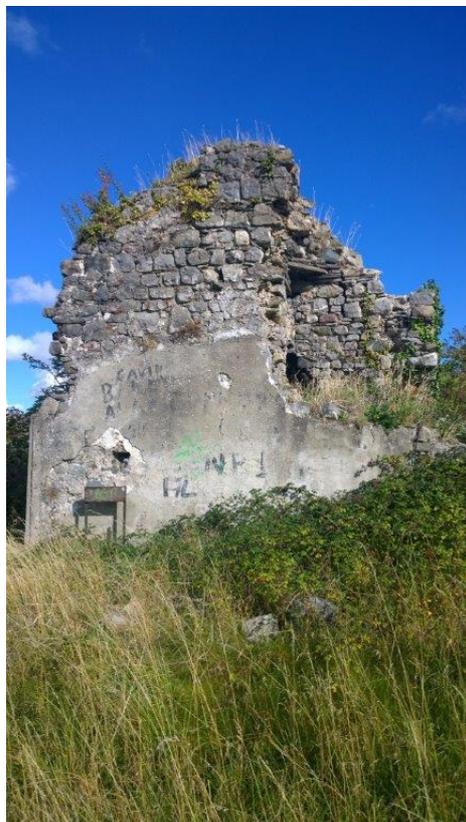
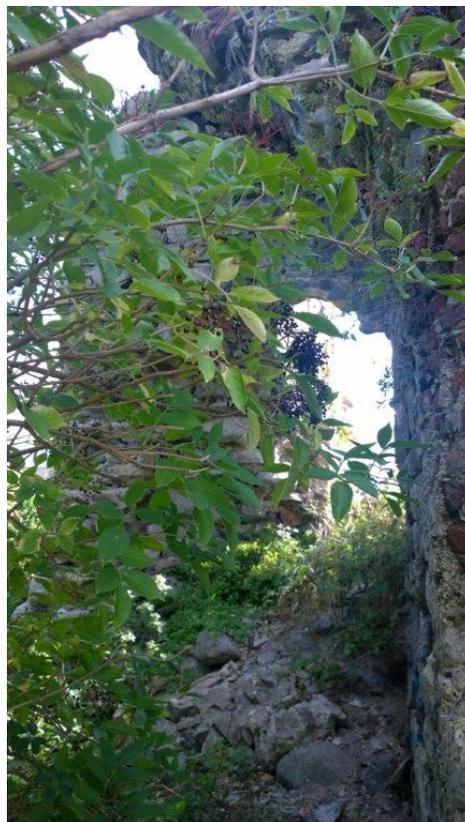
Left: The remains of the tower, from the south-west, October 2015. Right: The remains of the tower and vault, from the north, October 2015

11. Repairs to the remains of the tower and the fragment of masonry vault: Jason Bolton's report highlighted the importance of the fragment of the vault springing and its fragments of mortar. This fragment appeared to be supported in tension by the mortar between the joints and by friction and was unsatisfactory. Therefore, the engineer designed a simple sheet of stainless steel which was pre-curved in a workshop to match the profile of the vault reinforcement and to support it from underneath. Although this is a modern intervention it is discrete and functional, and was designed in consideration of Article 10 of the Venice Charter.

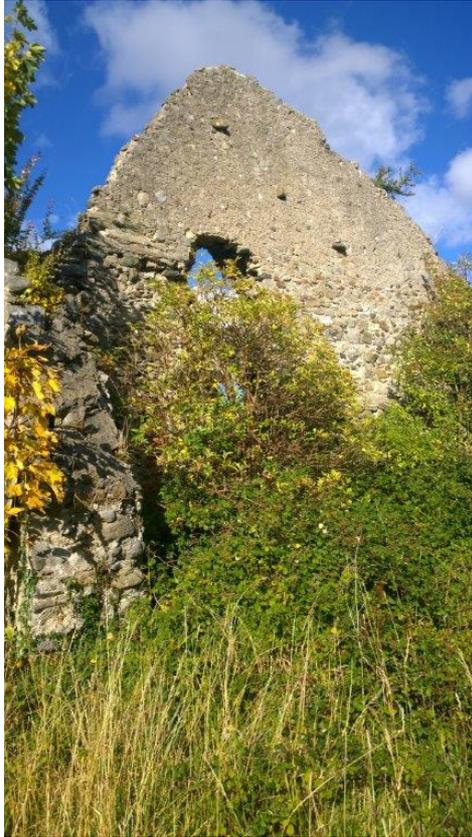
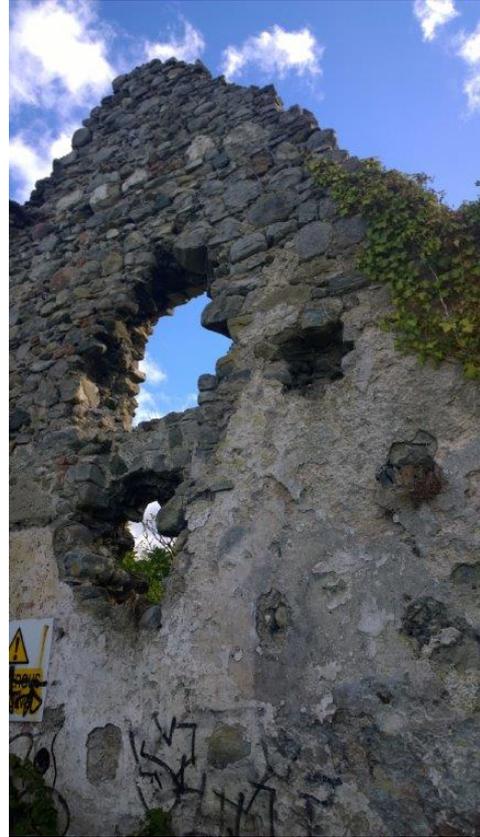
Left: The internal face of the north-facing gable wall, from the south-west, October 2015. Note the sand and cement repair of the wall on the left. Right: The external face of the north-facing gable wall, from the south-west, October 2015. Note the lacunae and fragments of plaster

7. The lacunae or holes in the north-facing gable wall: Originally it was agreed that the edges of these holes would be lined with salvaged stone to prevent loose masonry from falling out of the wall cores. However during the works it was decided to completely fill these holes. We could not ascertain if the holes were former window openings that had gradually enlarged or were holes that had formed gradually in the wall.

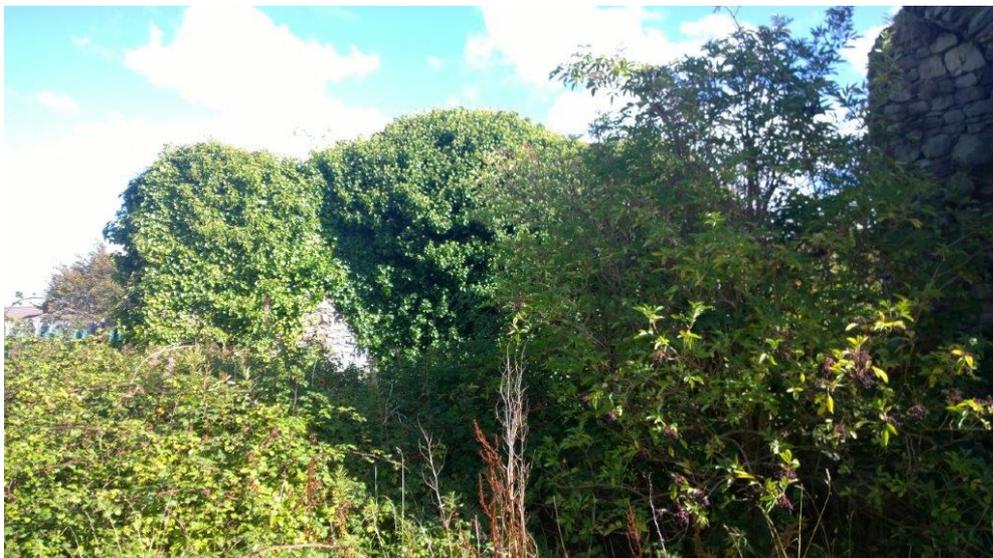
The heavily overgrown eastern wall of the ruin, viewed from within, from the west-north-west. Note the fragment of vault of the tower visible in the top right corner of the photograph. October 2015

2. Removal of the remaining ivy, trees, shrubs and weeds: The drier, looser ivy and creeper growth which had died back was carefully pulled from the walls which allowed for a more thorough examination and careful assessment of the building. The remaining fresh ivy was carefully cut, defrilled and treated with herbicide. Great care was taken to avoid disturbance of the ground during all the conservation works. All works were restricted to the superstructure, in other words those parts of the building above ground level. No excavation and disturbance of the ground was permitted by the conservation officer.

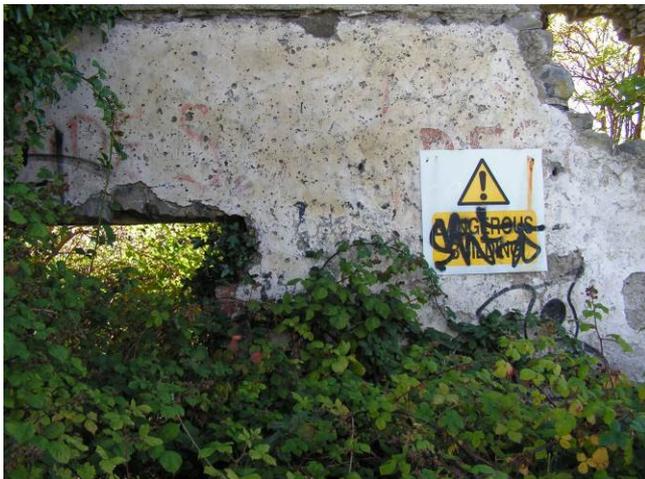
Left: The doorway in the external face of the north-facing gable wall, October 2015. Right: The brick lining to the internal face of the tower, viewed from the north, October 2016.

9. The oak lintols above the door opening in the north-facing gable wall: The masonry above this doorway was supported by five individual oak beams or lintols. The timber had decayed. It was decided to (i) block up the opening and to remove the two innermost lintols, and (ii) to support the masonry above by building up to it with a 215mm thick concrete block wall (concrete blocks laid on the flat, jointed with a sand and cement mortar, resting on a 100mm thick poured mass concrete strip foundation, and rendered with a sand and cement finish). The new wall is thinner than the surrounding masonry, recessed on both sides and clearly identifiable as modern. It is reversible and can be removed at a later date – the edges of the new wall are not chemically or mechanically jointed to the reveals of the door opening with any mortar, they merely support the masonry above the rotten and removed central oak beams. The intervention is recognisably modern is entirely reversible. The age of the remaining oak was not established by any means such as dendrochronology or carbon dating; this could be done as part of any future investigation or conservation works.

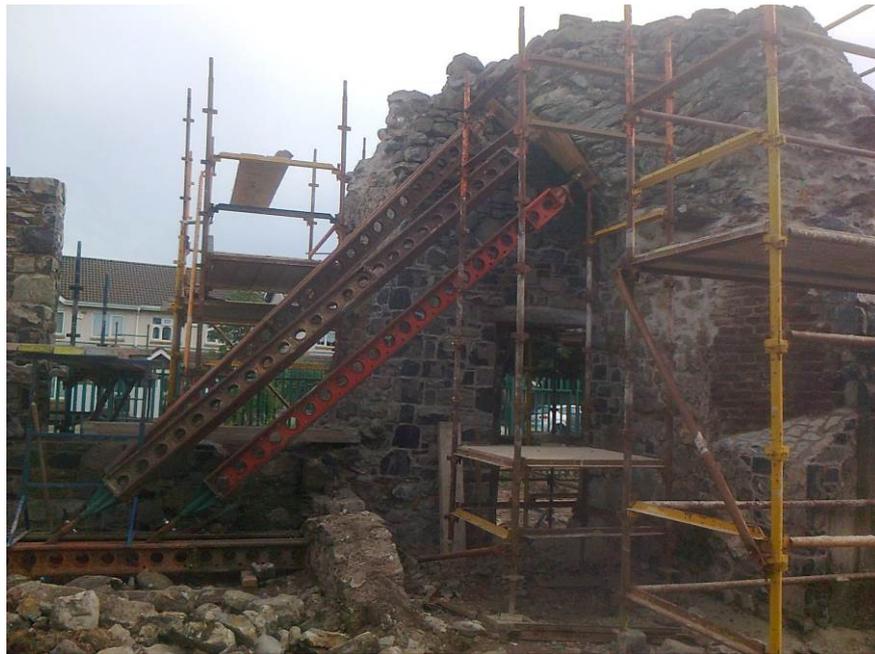
Temporary propping of the stone vault until the repair was in situ.

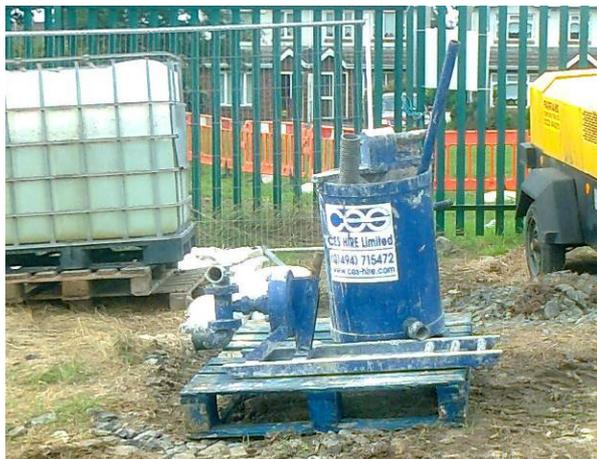
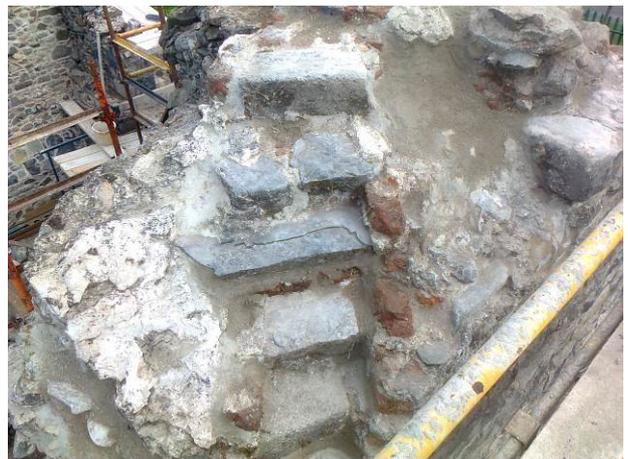
Left: The hand-operated grouting pump and paddle. Right: The steps on top of the stump of the tower, August 2016

10. Grouting of wall cores: Unlike the thinner eighteenth and nineteenth the century walls, the construction of the remains of the tower was much thicker, about 1.5 – 1.8 metres thick and also massive. During the eighteenth century a lining or facing of brick and small stones had been applied to the north, internal face of the former tower. This had fallen away, exposing the wall core. Because of the massive structural failure of the tower above and the damage to the remaining stump, a decision was taken to grout the wall cores and cavities in this part of the monument. A liquid grout, the consistency of yogurt was mixed from a 1:2 mix of NHL 5.0 hydrated hydraulic lime powder, sharp, gritty wall-graded, clean sand and water, and was hand pumped with a proprietary mixer by three operatives: one to drill small holes and insert the nozzle end of the black flexible hope pipe into the pre-drilled holes, another to operate the hand pump periodically and the rotating paddle which prevented settlement and separation of the liquid grout in the drum, and the third person to clean off any spillages of grout onto the wall surfaces and to block any leaks with daubs of quickly applied mortar. In this way, starting at the bottom and gradually working up

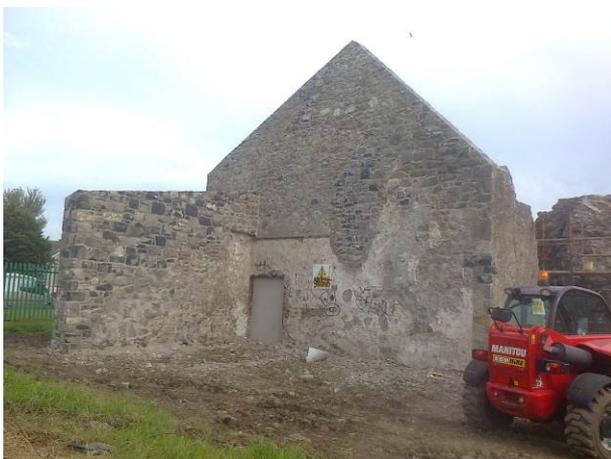
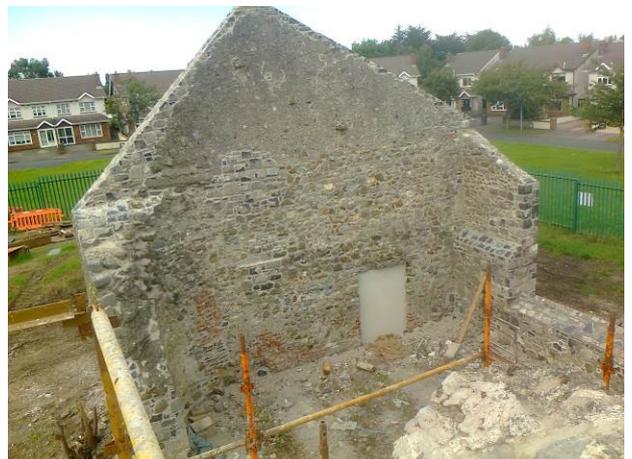
Left: The filled lacunae of the outer face of the north-facing gable, August 2016. Right: The inner face of the north-facing gable, August 2016

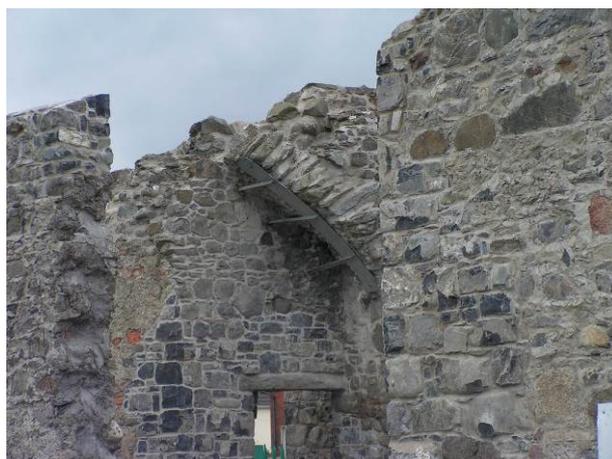
Left: the steel plate under the stone vault, October 2016.
