Thermal upgrading and energy-use improvement works to Kiltalown house, Kiltalown, Tallaght, Dublin 24.

Building Dossier for works done during October and November 2013

Date of this report, February 2015

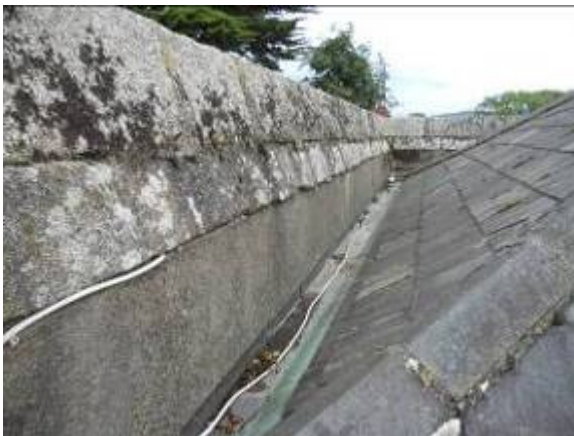
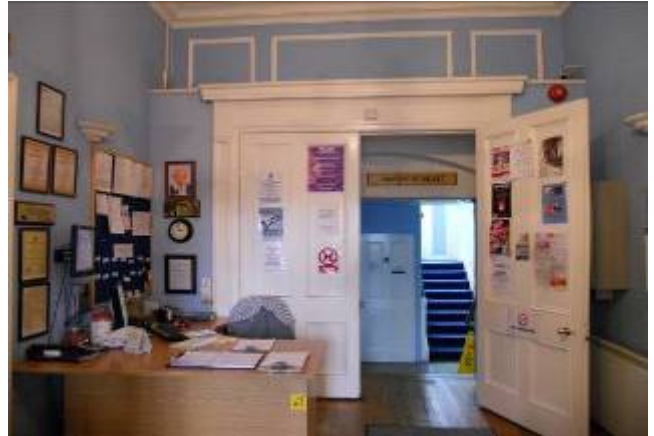
Left side: The north-eastern hip of the roof of the late Georgian block and parapet wall, viewed from the north, September 2013.

Right side: The entrance hall, September 2013

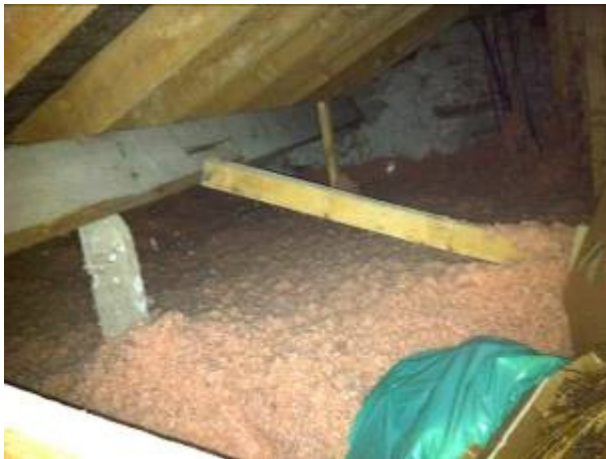
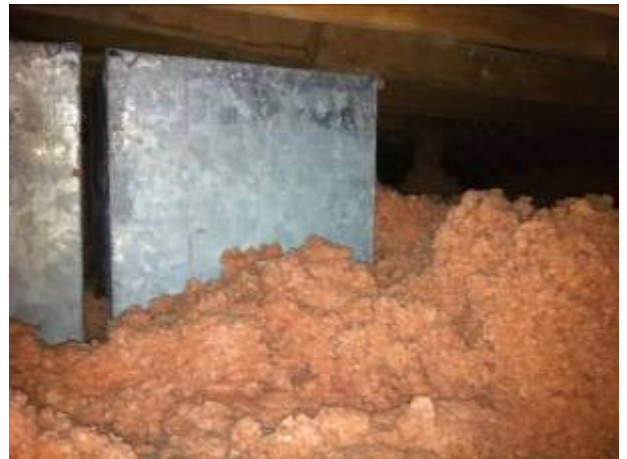
Left side: Two views of the attic above the older, rear part of the house. Right side: The blown insulation and steel cold water storage tank are visible. September 2013

- (1) The existing blown insulation was evenly spread with a garden rake or a similar implement,
- (2) All the cavities between the roof space and the coved ceilings below were insulated with a 50mm thick hemp board, cut to size and slid down between the rafters leaving a clear a minimum 50mm clear ventilation space above the insulation board and below the roof felt.

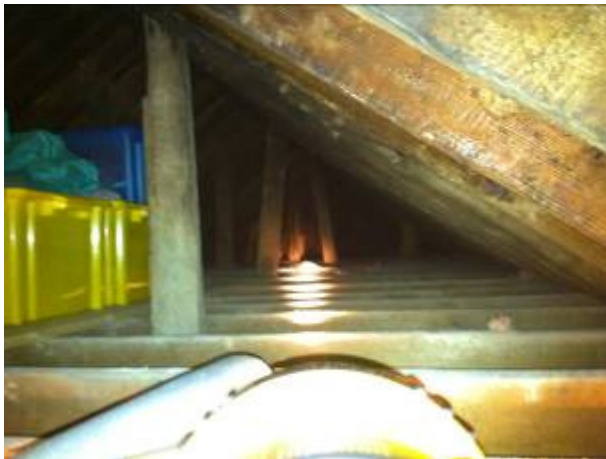
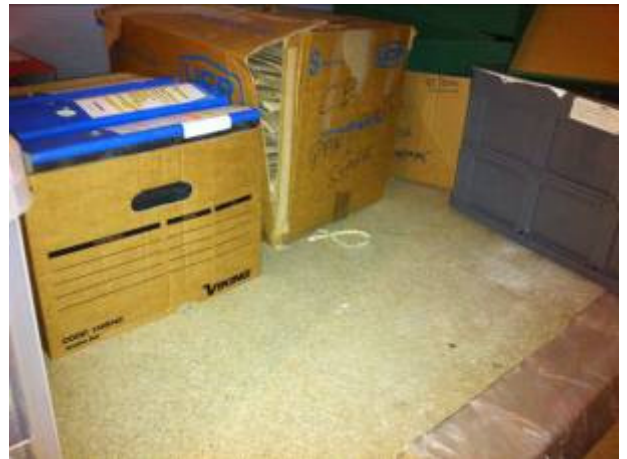
Left side: The main attic above the front, late-Georgian block. Right side: the small un-insulated attic in the extreme south-western corner of the older rear part of the house. September 2013

It was recommended that a new sheep's wool quilt be laid between the joists of the small un-insulated attic at the extreme south-western end of the house. However this was over-ruled by the building occupants who would prefer to continue using this space as a file storage area. The proposed insulation of the area would have meant that this area could no longer be used for file storage. Also, no vents were installed in the slate roof covering above this area.

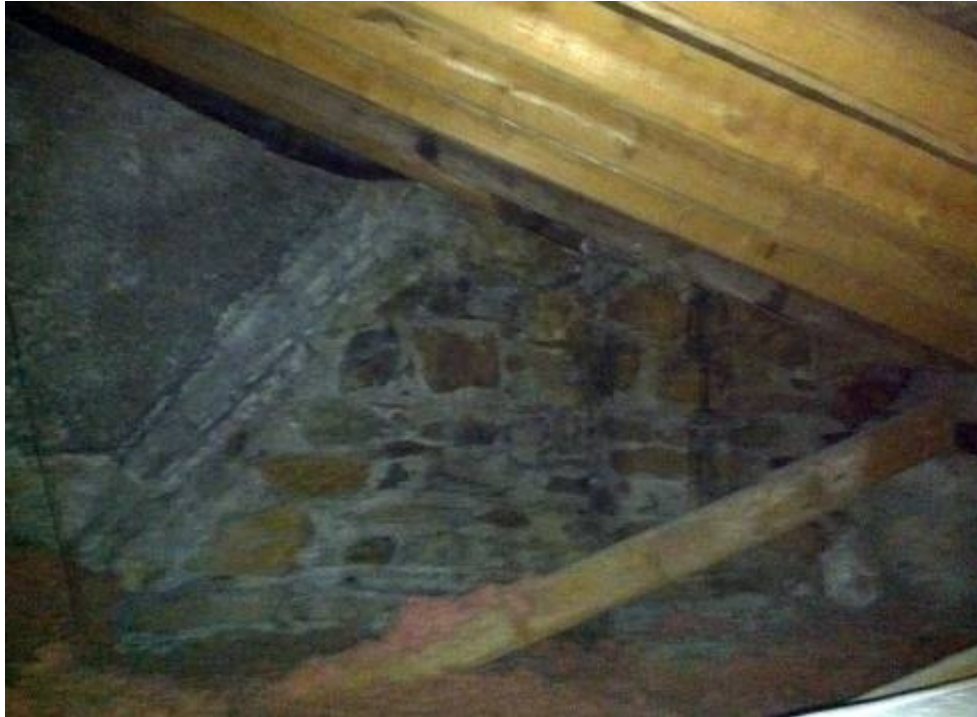
A view of the south-western end of the main attic above the rere of the house. Note the original south western gable of the early farmhouse, the oldest part of the house. The smaller attic at the extreme south-western end is on the other side of this wall and was built at a later date. Photograph taken September 2013.

As mentioned previously, we have recommended that the U-value of the external walls could be reduced as a longer term strategy. This could be done by installing a new vapour permeable calcium silicate lining board to the internal wall surfaces of the significant facades (the three facades of the late Georgian block) and an external insulation of lime render combined with hemp or other proprietary insulation to the less important facades of the old farmhouse and former stable buildings. These works were not carried out for reason mentioned previously in this report. We have also recommended the construction of a French drain around part of the building perimeter where the external ground levels are higher, or are level with the internal floor levels, to limit and prevent rising damp in these walls. These interventions would reduce the U-value of the external walls to 0.7 and would improve the Building Energy Rating to B2.

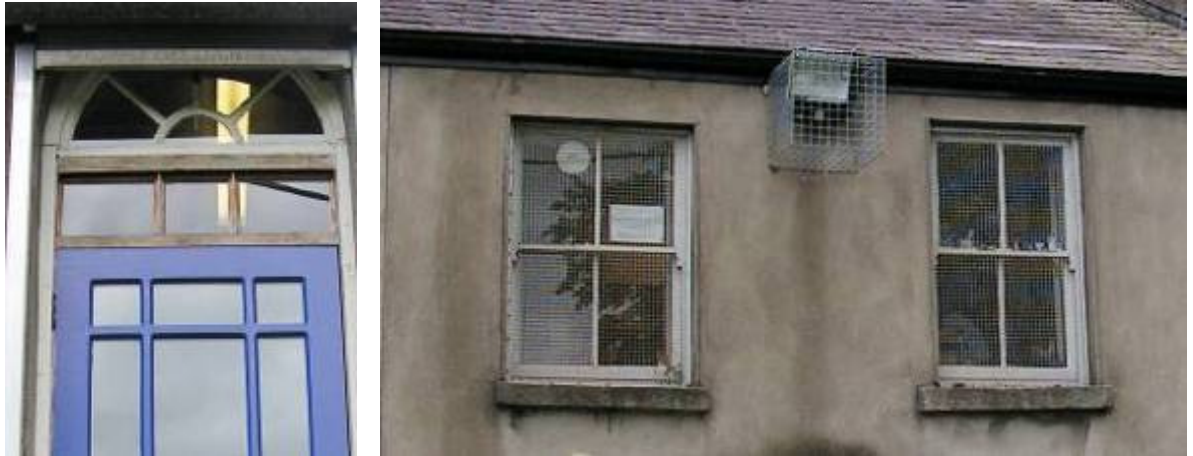
Left side: The emergency fire escape from the stairwell Right side: Existing modern sash windows at the back of the house. September 2013.

(4) That the four doors at the emergency exits be fitted with a proprietary brush-seal system built into their frame or door leaves to reduce draughts or uncontrolled ventilation. This includes the twin doors at the main entrance to the house, the door to the garden from the landing on the western stairwell, the door from the kitchenette to the courtyard, the door from the auditorium to the courtyard and the two doors at first floor level which access the emergency escape stairs at the north-east end of the house - in total seven door sets. As mentioned previously some of these doors were not draught sealed because of their unusual construction or because it was considered that the works was beyond the scope and expertise of the contractor. An expert joiner with experience in the repair of historic doors will be needed for this work, at some time in the future. The last two doors are modern and have severe rot along their lower edges and admit a lot of draughts. These could be replaced by modern draught-sealed, insulated doors. The very old door which opens from the auditorium to the courtyard should be retained because of its age, but it will require repairs and draught sealing by a skilled joiner with experience of repairing and thermally upgrading old joinery.

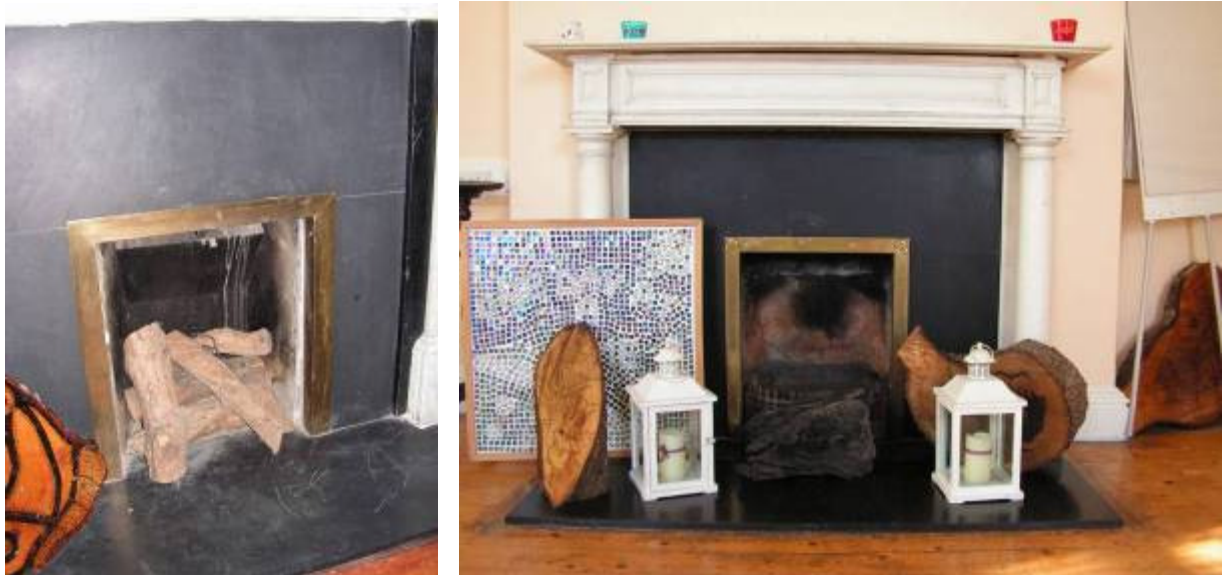
The two fireplaces in the large reception rooms on either side of the main entrance to Kiltalown house with the proprietary damper system installed. The small mild steel handle is just visible at the top of each fireplace opening.

- (1) With one exception, none of the fireplaces and chimneys in the house are used for combustion of solid fuels. Therefore a proprietary damper system supplied and installed by "Chimney Draught Stop Ltd." was fitted to the two chimney flues which are currently open and ventilated in the front, late-Georgian block. One inflatable balloon was also installed in the fireplace of the first floor training room, to draught proof the fireplace and chimney flue there.

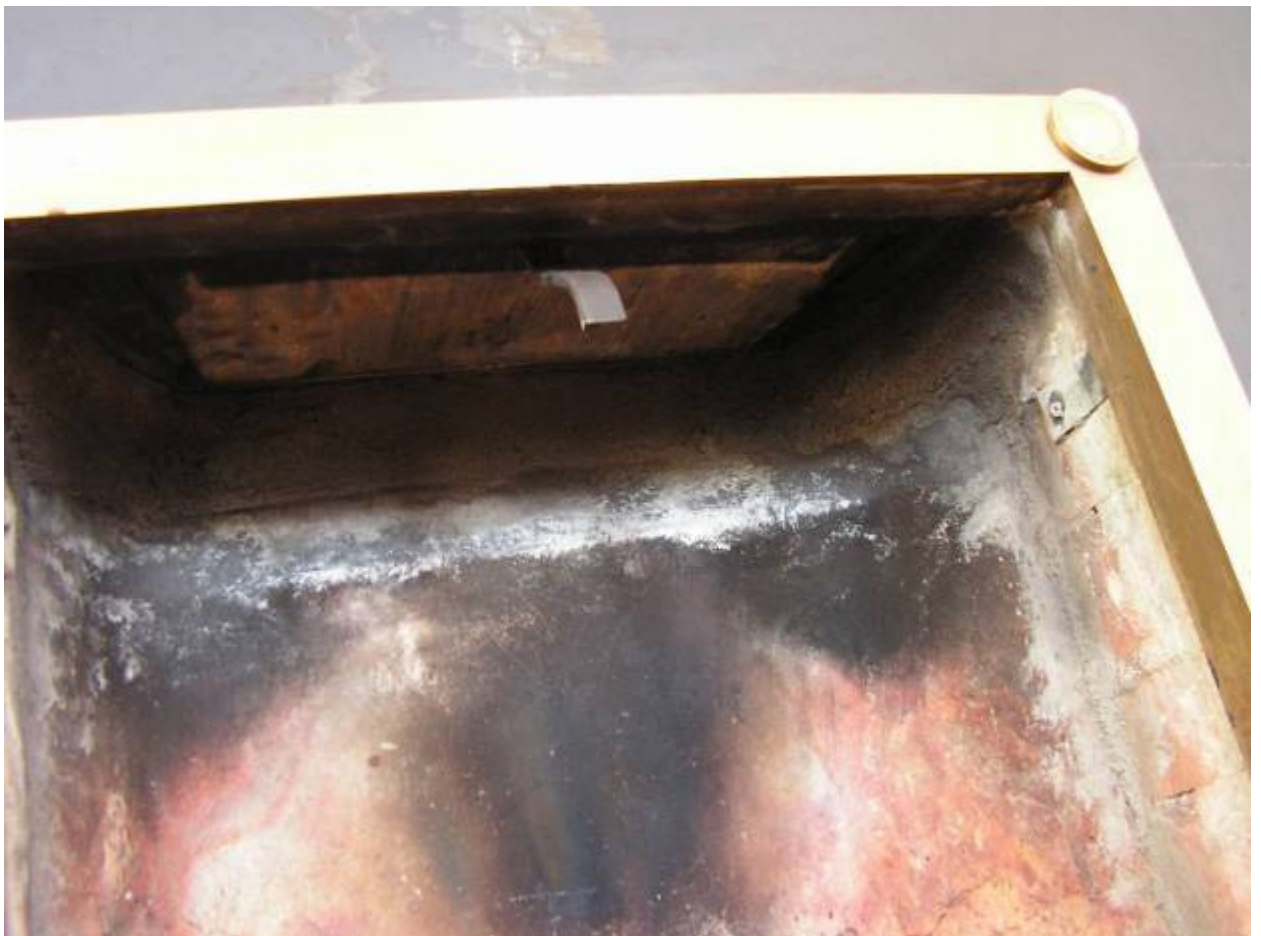
A close-up view of the manually operated proprietary damper supplied and installed by "Chimney Draught Stop Ltd."

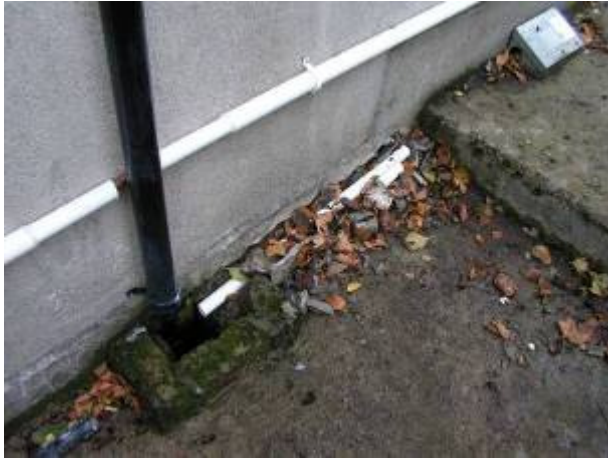
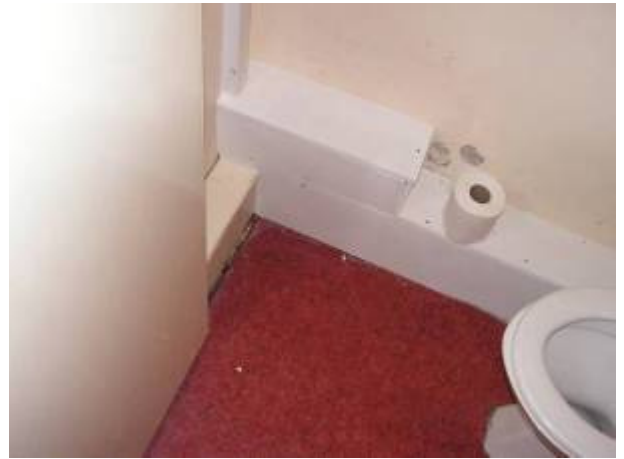
Left side: The gas mains extension behind the house. Right side: The repaired and boxed in waste water pipe in the toilets

In addition to these works, the waste pipe from the mens' toilet was found to be defective and leaking. This was fixed and boxed in by the contractor. Finally, we have advised the building users to close the existing shutters on the sash windows at night and when the building is vacant.

(3) A new 25kW boiler was installed in the utility room to operate the remainder of the new radiators in the south-western end of the house. This is supplied with gas from an extension to the existing mains supply pipe which had sufficient capacity. Also a single hot press was installed to replace the two previous hot presses. The capacity of the gas mains supply had been checked with the gas supplier. The location of the new boiler and gas mains extension are shown on the architectural drawing which is attached as an appendix to this report.

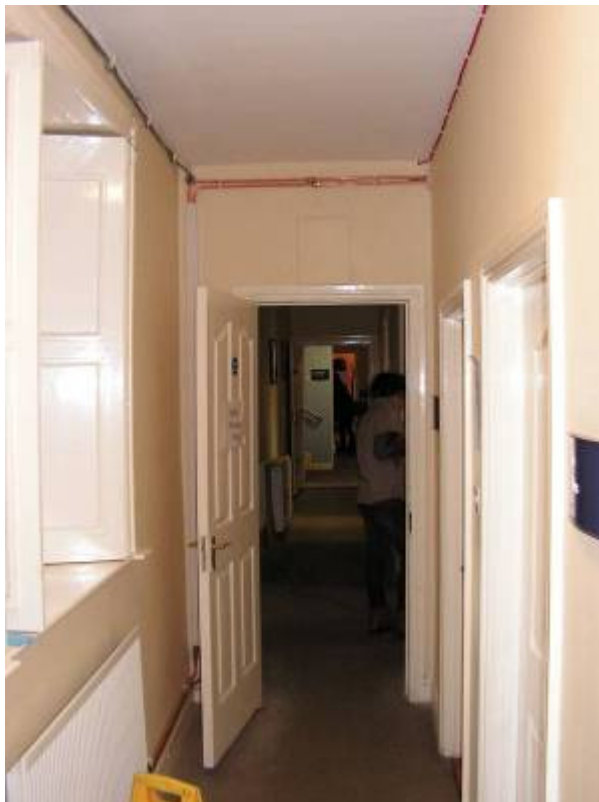
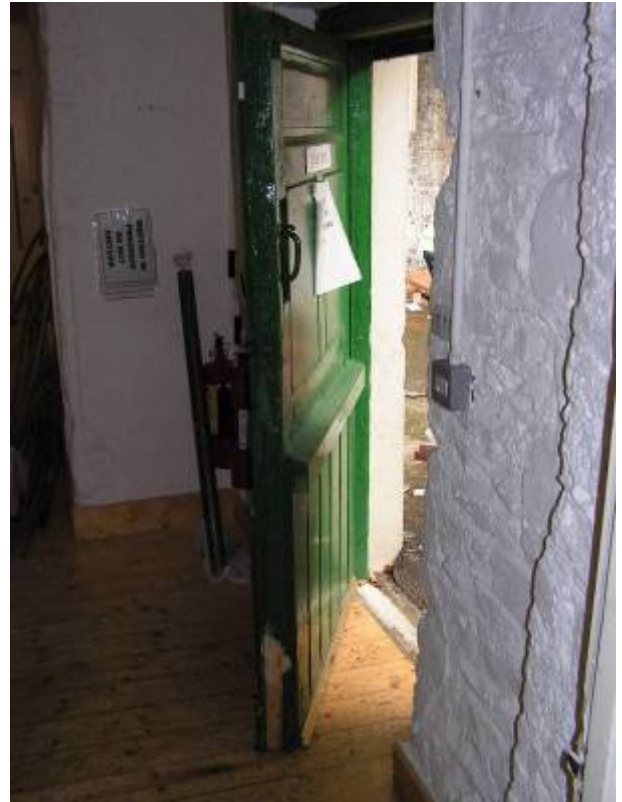
Left side: The new central heating pipes at the east end of the house. Right side: The very old door from the kitchenette and living room to the courtyard.

The routing of new flow and return pipes to and from new radiators can be fraught in old houses. In this case, the pre-existing duct in the corner of the western stairwell was enlarged slightly to accommodate the pipes instead of making a new duct and the overall run of pipe work was reduced from that originally specified.
