Conservation works to the roof of the Roman Arch, Dodder Valley Road Lower, Rathfarnham.

Building Dossier for works done during October and November 2014

Date of this report, February 2015

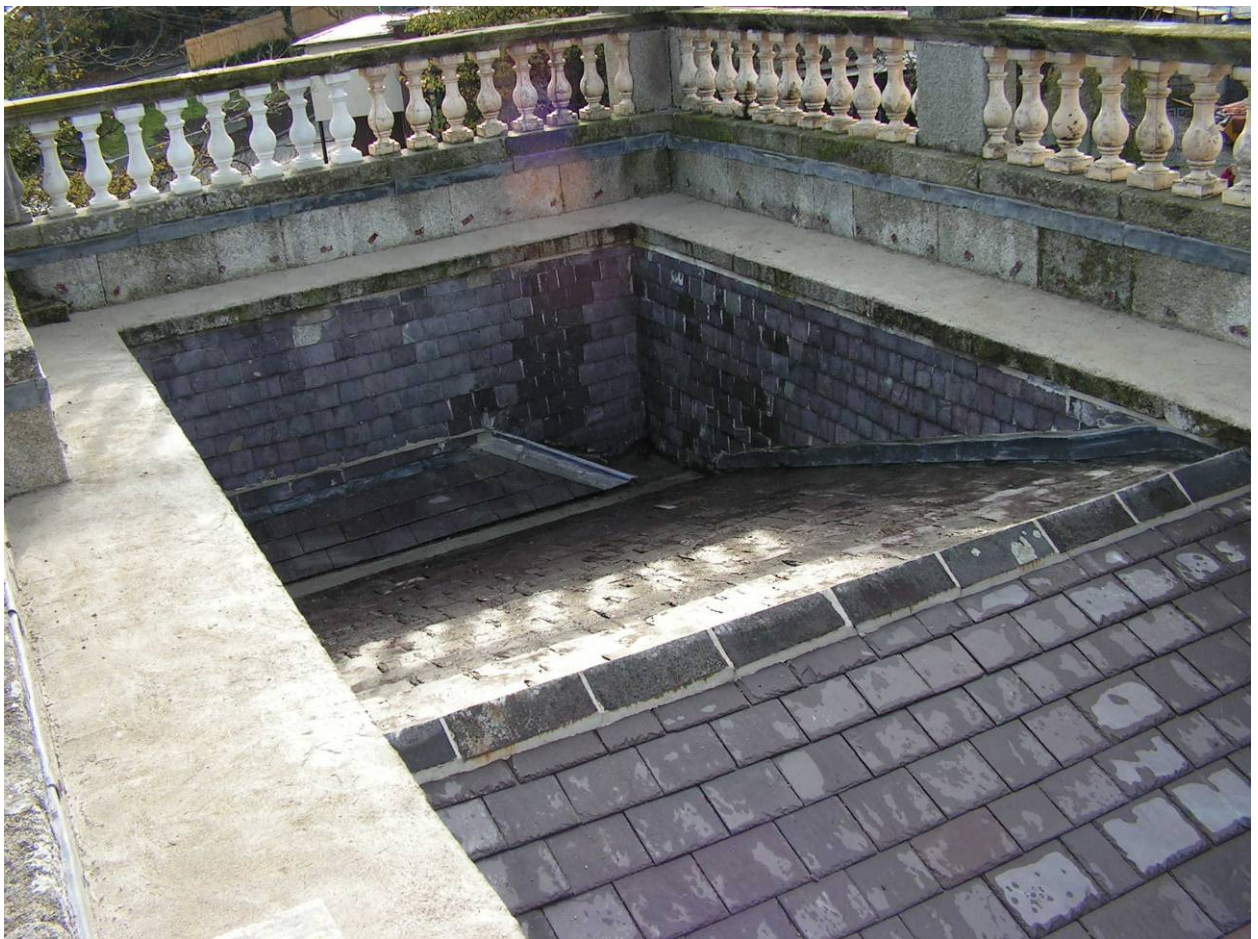
A view of the roof of the building after the works were complete, November 2014.

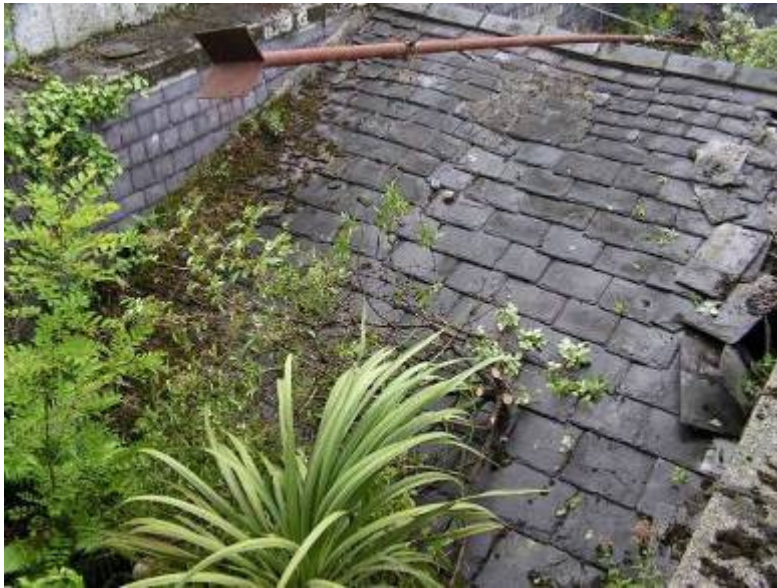
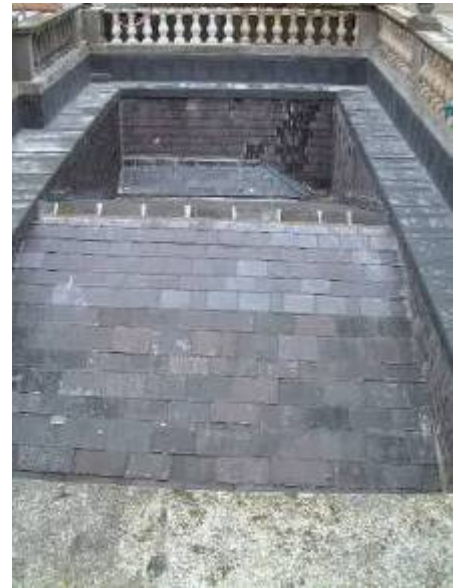
Left side: Part of the roof as photographed in February 2009, before the 2010 conservation works. Right side: The roof, viewed from the north-west in July 2010, after completion of the 2010 conservation works. Lead was dressed into the mortar joints of the blocking course, down the face of the blocking course and over the upper surface of the parapet wall to prevent water from wetting the masonry below

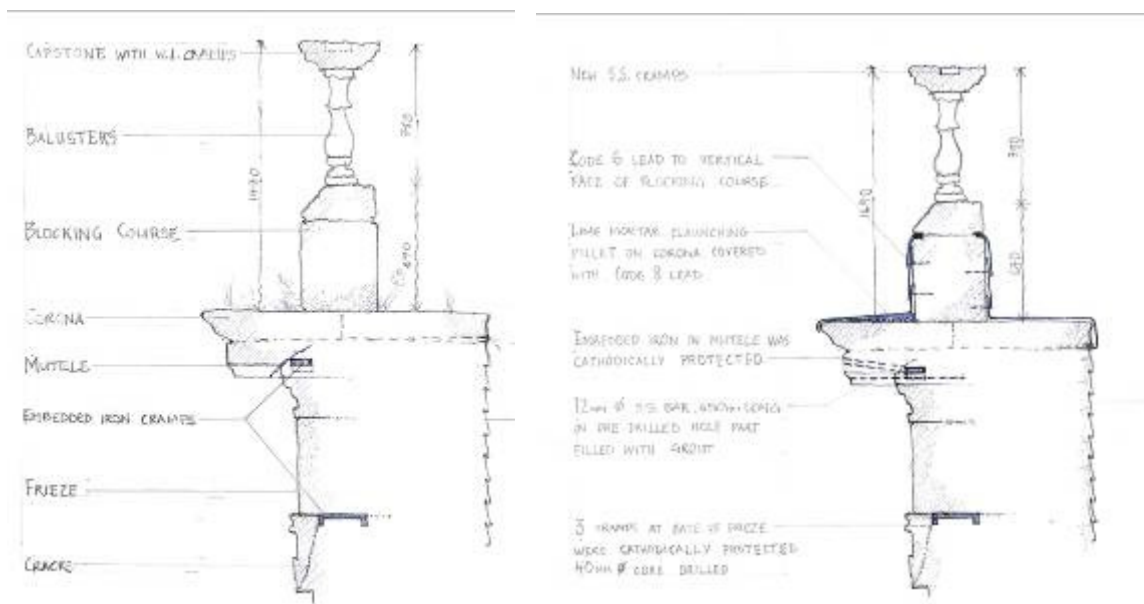
Left side: The south-western cornice as found in February 2009, before any works were carried out. There were cracks in the facing stone caused by rusting iron armatures and considerable organic colonisation of the upper horizontal surfaces of the cornice and parapet wall. Right side: The south-western cornice as repaired in 2010

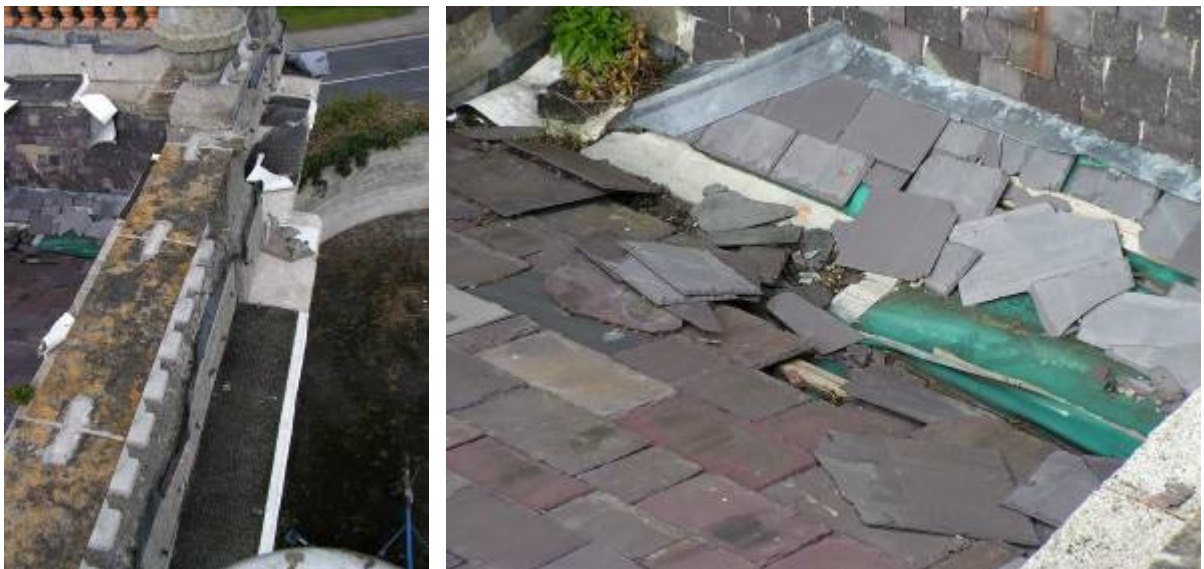
1. The upper surface of the parapet walls, inside the blocking course are exposed to rainwater ingress after the protective lead covering was stripped by thieves. They were originally built flat, with no discernable fall to direct rainwater to the roof. During the 2010 works water ingress to the 6m long wrought iron bar below the parapet, in the north-eastern entablature was identified as a contributory cause of corrosion.
2. Subsequently the recently installed protective lead was completely stripped from the northern gutter in 2011 by thieves.
3. The slates on the northern pitch of the roof beside the gutter were damaged during the removal and stripping of lead from the adjacent gutter board.
4. A small strip of lead was removed from a hipped roof in the southern gutter.

Left side: The north-eastern corner photographed in April 2013: The lead has been stripped from the outer cornice by vandals, leaving the lining loosely adhered. However the upper surface of the cornice was also dressed with a launching fillet of lime mortar during the 2010 works which still protects the stone underneath and directs rainwater to the edge of the cornice where it falls away harmlessly. Right side: The northern gutter: The lead lining of the gutter has been completely stripped and the adjacent slates disturbed and broken

5. All debris, broken slates and soil was cleaned out of the valley. (The valley was partly obstructed by wind-blown debris, soil and leaves and by broken slates, cut sections of underlay left during the vandalism)
6. The entire existing plywood base of the valley (3.5m long, 0.3m wide) was removed. New lead lining (Code 4) was installed on breathing paper & felt (to allow for thermal movement of the lead and to prevent chemical corrosion of the lead by chemicals in the plywood). (The lead was completely stripped and removed from this valley during the vandalism and theft)
7. Thirty slates were replaced on the roof on either side of the gutter with new natural slate, Welsh Blue Bangor, sourced from the Penrhyn quarries. (Approximately 20 slates were broken during the stripping and removal of the lead from the valley by vandals)

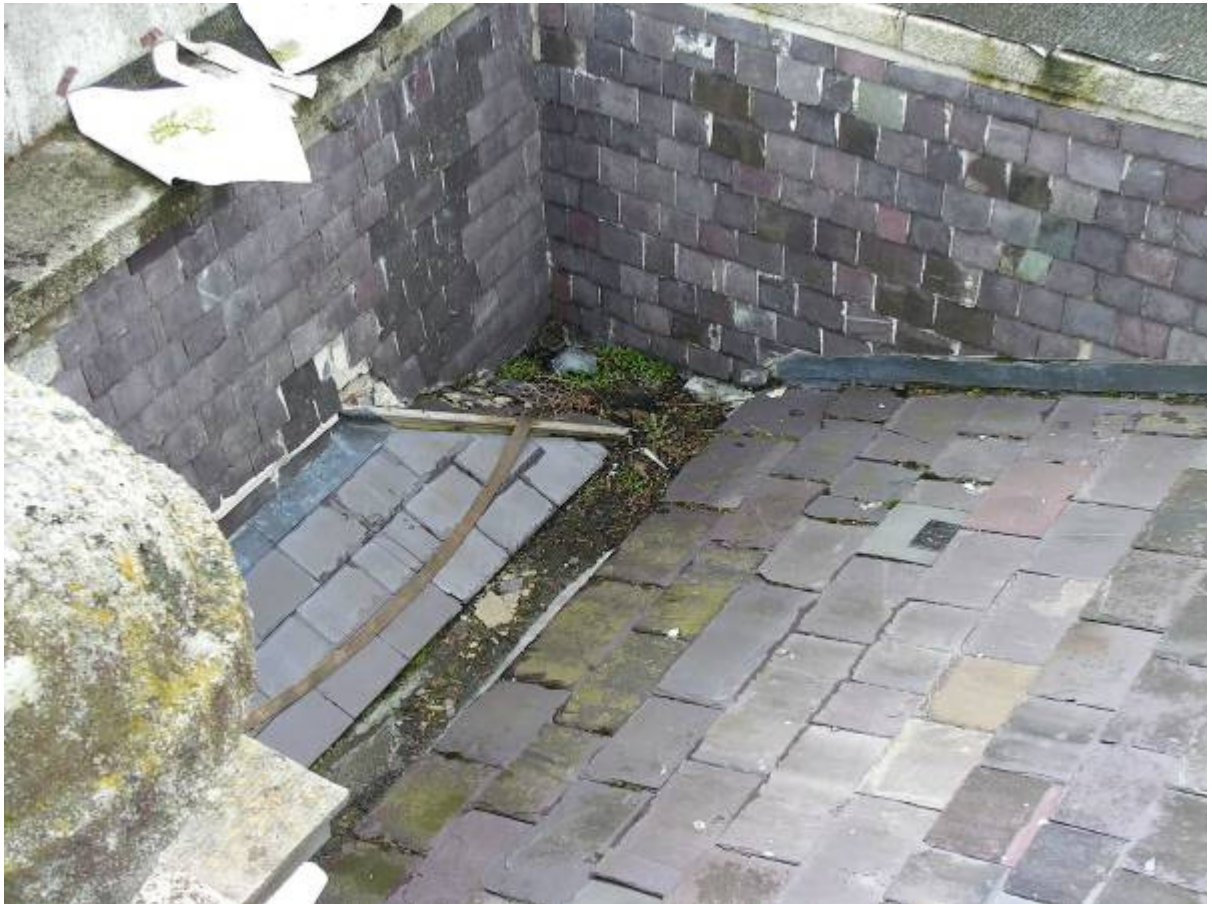
Southern gutter in April 2013: The lead has been stripped from the hip of the roof but fortunately, the thieves were interrupted by An Garda Síochána and the lead was not removed from the parapet wall roof junction or from this gutter.

1. All debris, broken slates, and soil was cleaned out of the existing lead lined valley. (The valley is partly obstructed by wind-blown debris, soil and leaves and by broken slates, cut sections of underlay left by the vandalism).
2. A new lead dressing was secured onto the exposed hip of the small roof, approximately 600mm long. (The lead was stolen from this hip)
3. The loose cowl was re-fixed to the top of the rainwater outlet. (The cowl was probably dislodged by the thief during the removal and theft of the adjacent lead from the hipped roof)
4. Two missing vertical slates were replaced, just above the small roof.

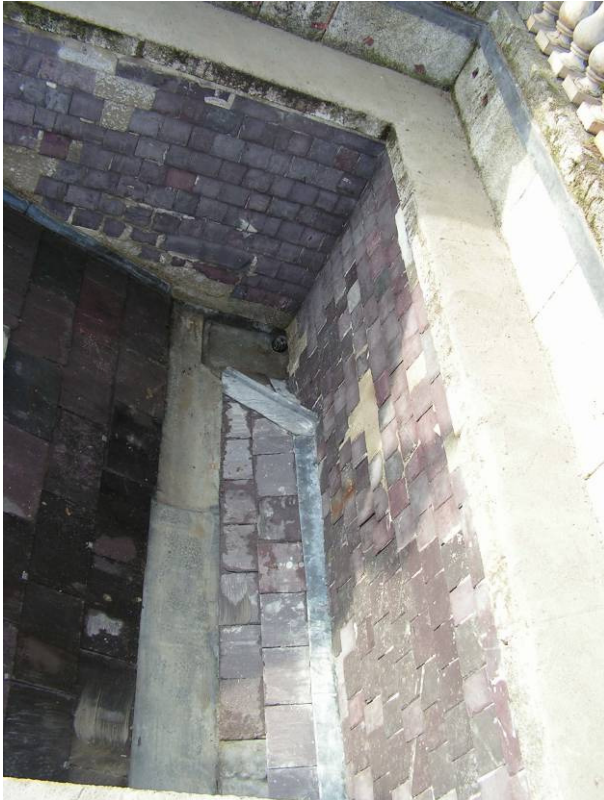
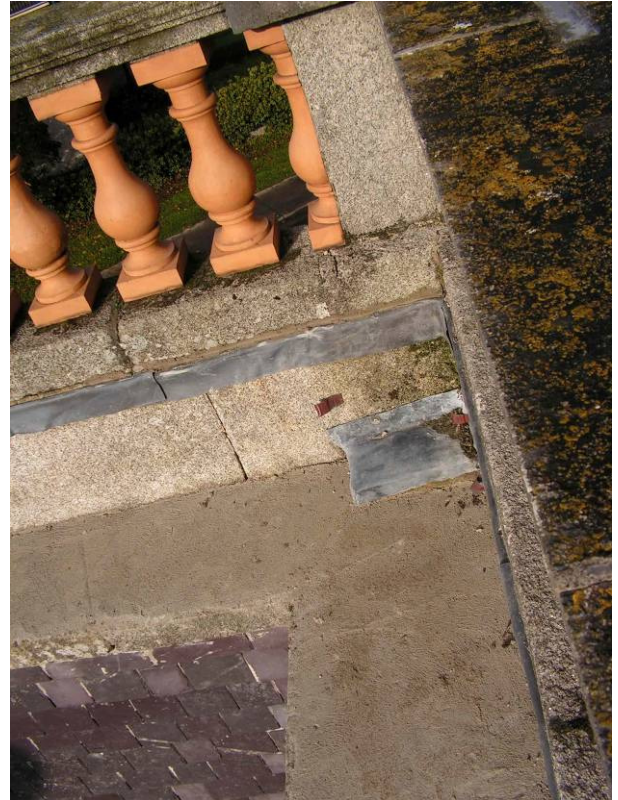
Left side: The new lead lined gutter and repaired hipped roof along the northern side of the building and new lime mortar fillet flaunching on the parapet wall above, November 2014. Right side: The new flaunching in the north-eastern corner.

10. A new flaunching fillet of lime mortar was made on the upper surface of the parapet wall, so that rain water will be directed off the wall and onto the slate roof covering below. The flaunching fillet was laid in two separate courses (with three days between to allow the lime adequate curing) to a fall and was made from a NHL 3.5 hydraulic lime mortar.

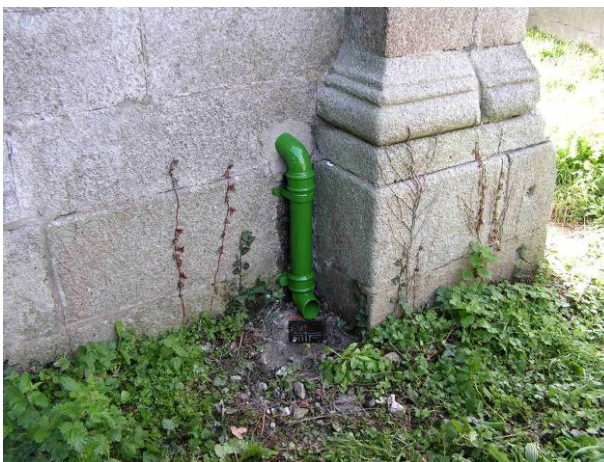
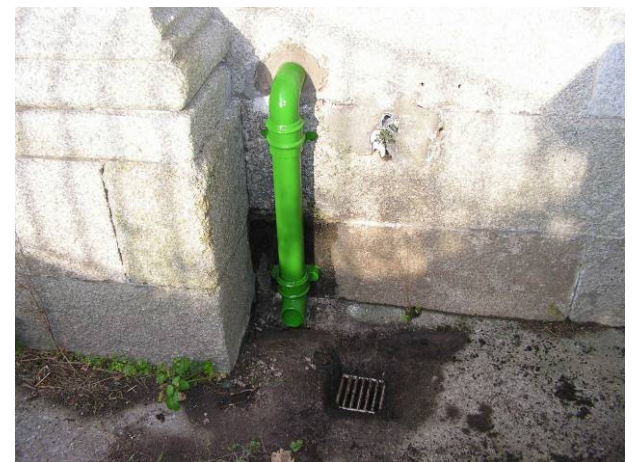
Left side: The new cast iron rainwater pipe and outlet on the north-western side of the building, November 2014. Right side: The new cast iron rainwater pipe and outlet on the south-eastern side of the building, November 2014

The two plastic rainwater pipes and outlets installed during the 2010 works were subsequently damaged by vandals, kicked and broken. These had been fitted to the bottom of the existing cast iron rainwater down pipe that remained in the corner inside each of the two former gate lodges. Therefore the rain water collected in the two gutters at roof level above was directed to the ground on either side of the Roman Arch via these two internal downpipes. As part of the 2014 works, new cast iron rainwater pipes and outlets were connected to the existing pipes in the gate lodges and secured to the outer walls with brackets.

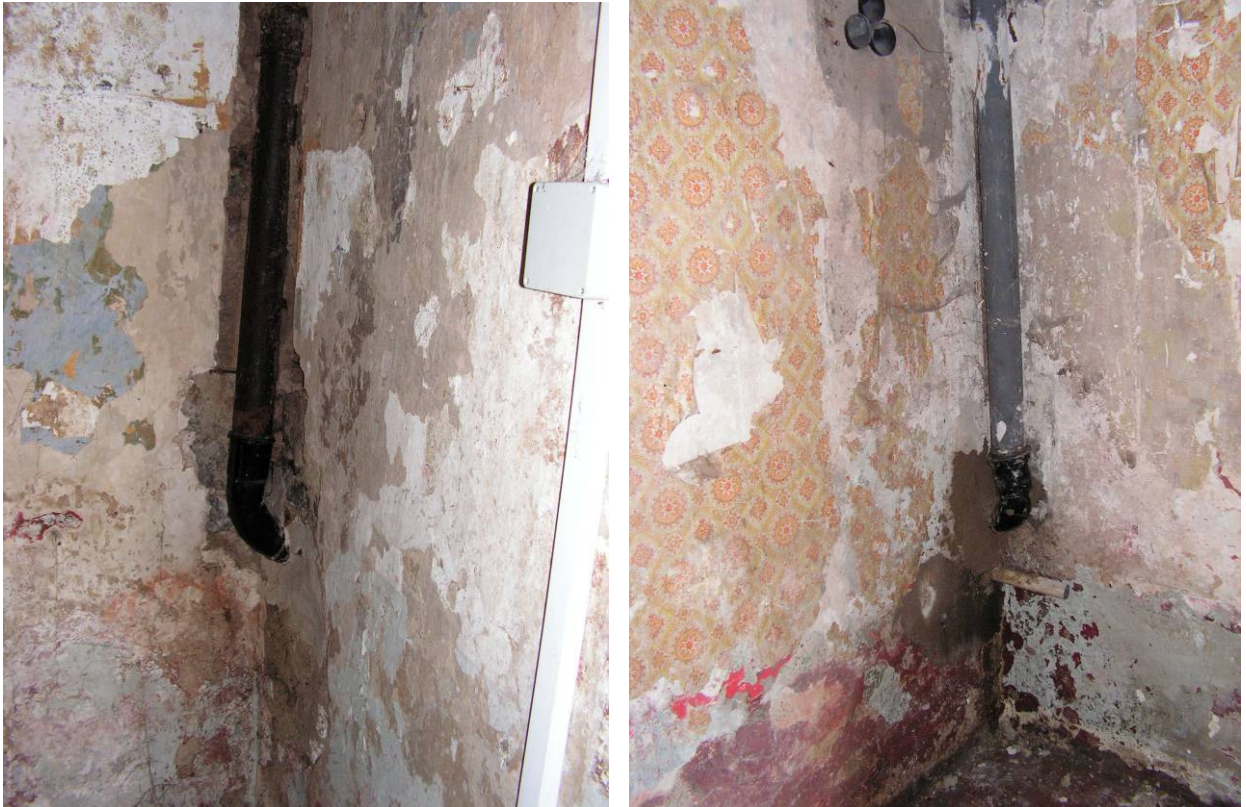
Left side: The existing cast iron rainwater pipe and outlet in the northern lodge, November 2014. Right side: The southern lodge
