PROJECT TITLE:
 ESSENTIAL REPAIRS & CONSERVATION OF THE
 ROMAN ARCH,
 DODDER PARK ROAD,
 RATHFARNHAM,
 DUBLIN
 PROJECT STAGE: POST SUBSTANTIAL COMPLETION

DRAWING TITLE:
 AS-BUILT DRAWINGS
 NORTH-WEST ELEVATION

DRAWING NUMBER: 2009-008-I-28 REV:

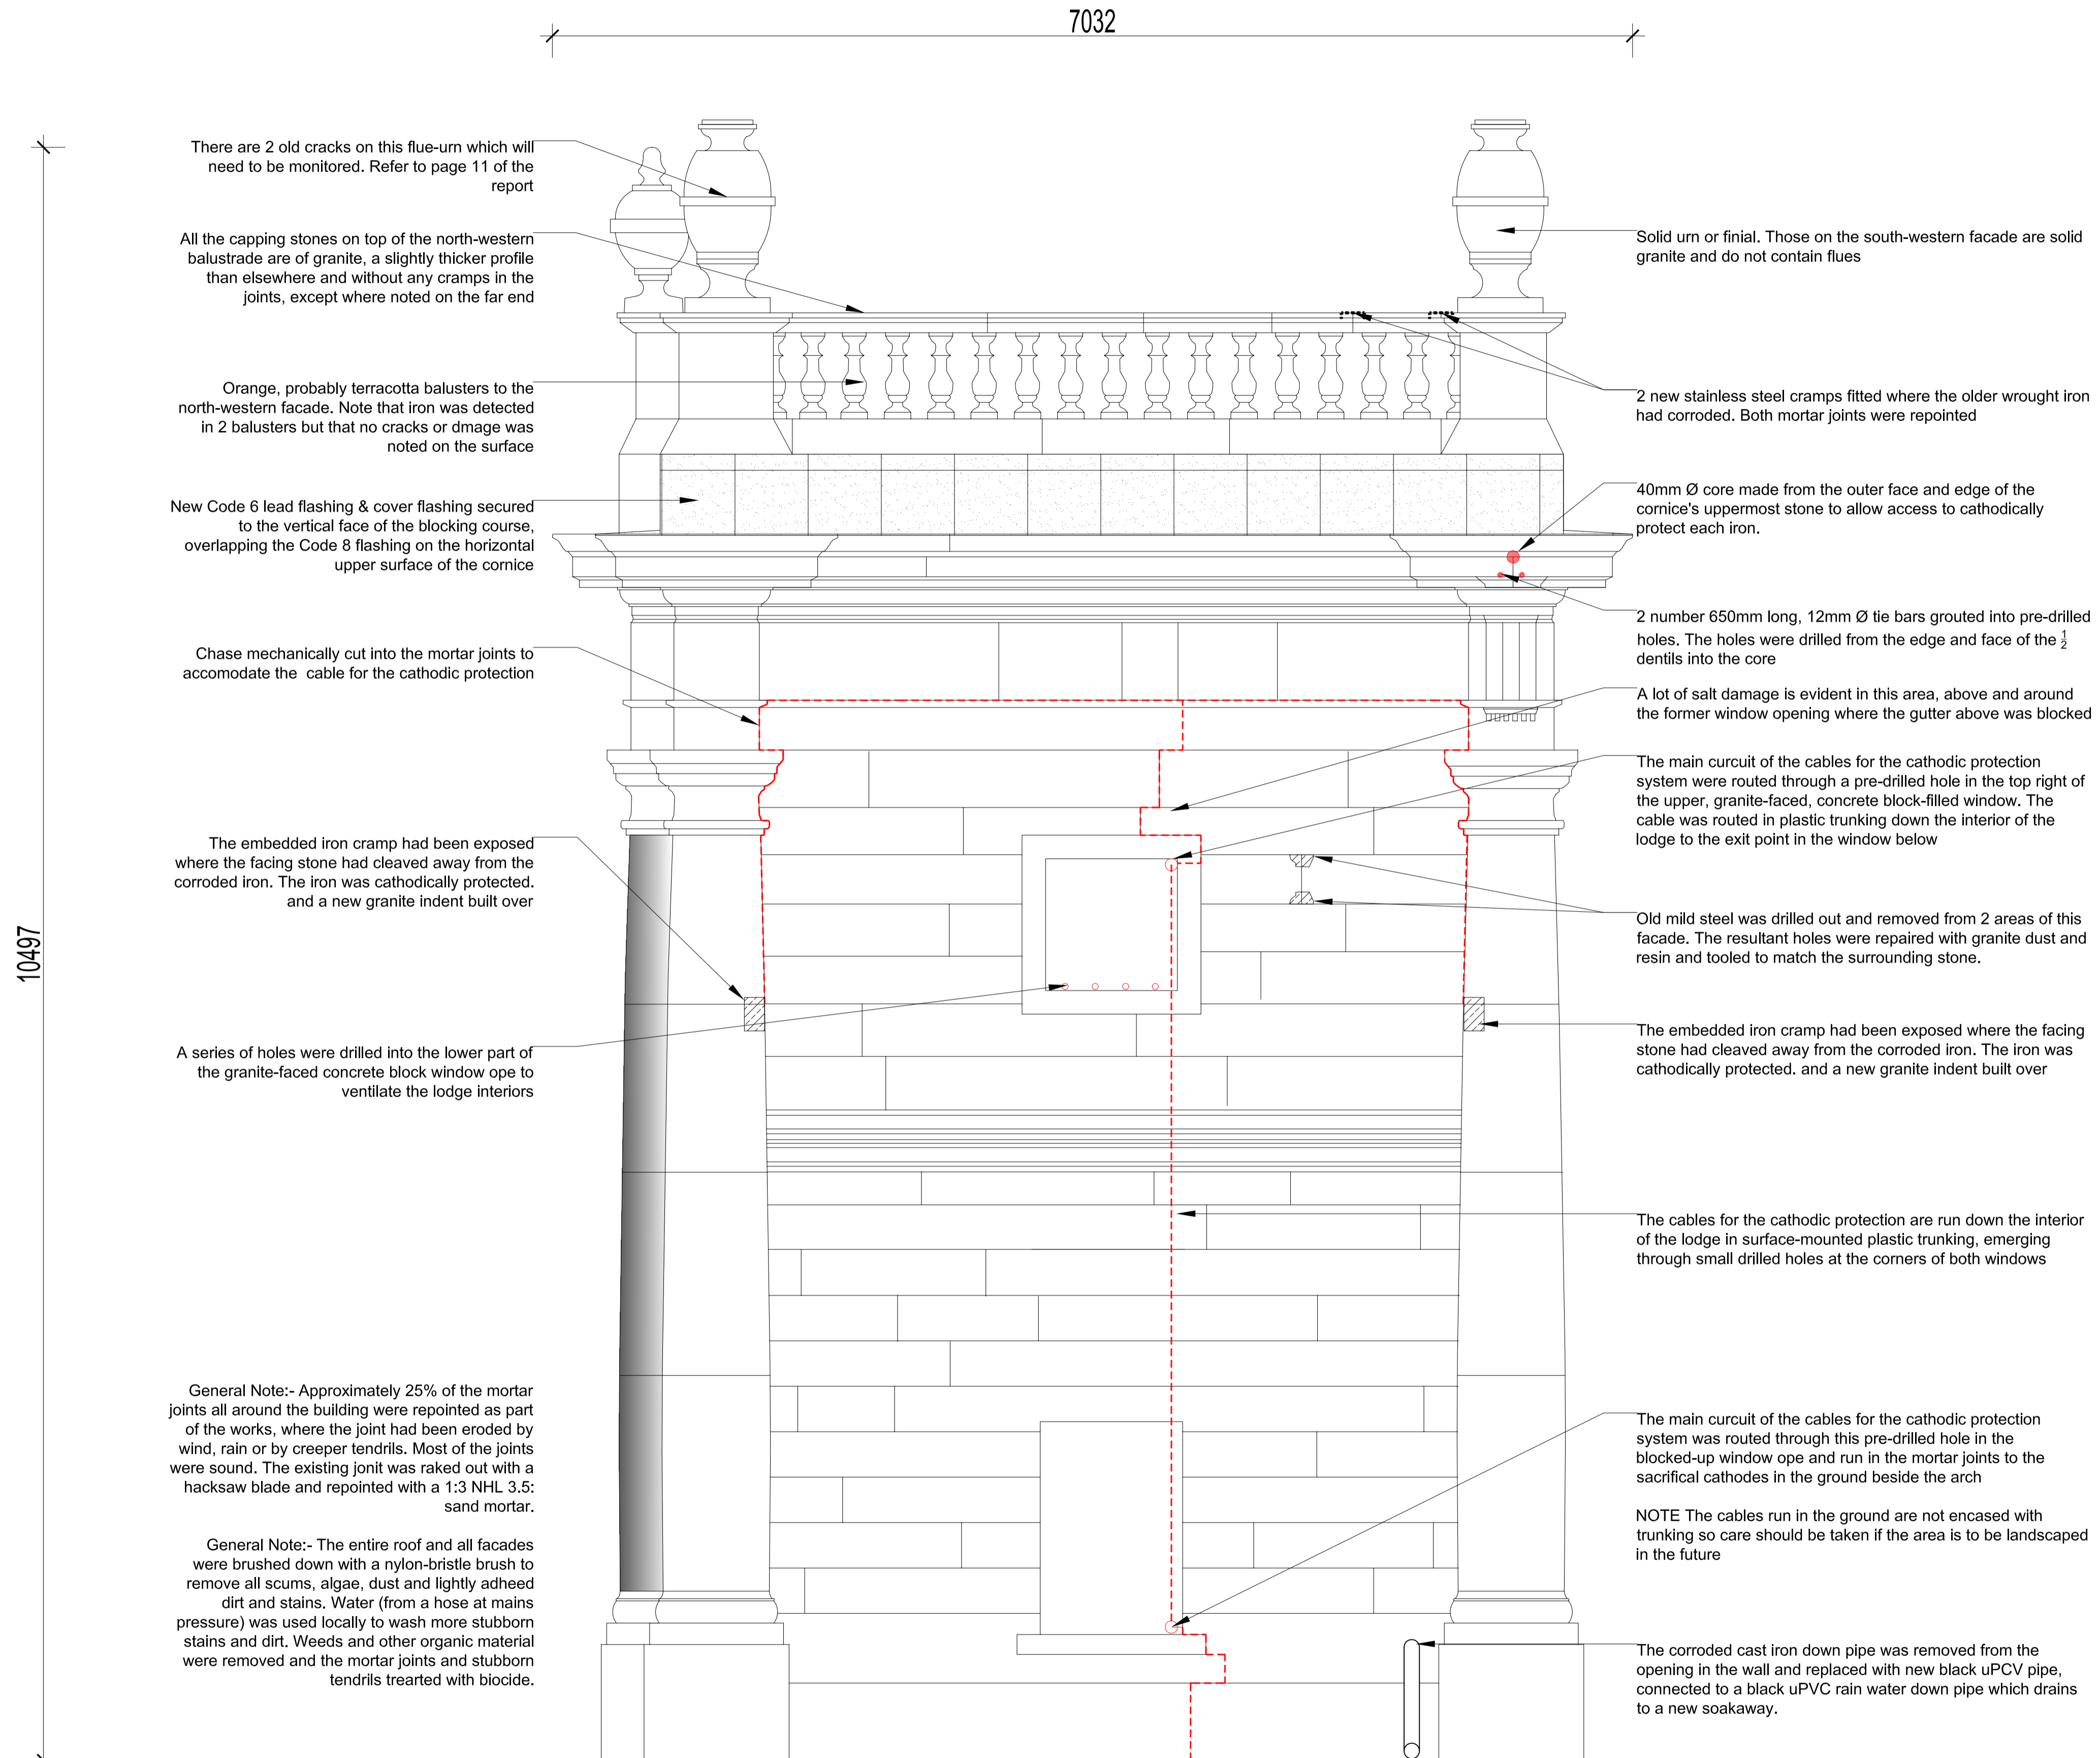
NORTH-WEST ELEVATION
SCALE: 1:25 (A1 page)

There are 2 old cracks on this flue-urn which will need to be monitored. Refer to page 11 of the report

All the capping stones on top of the north-western balustrade are of granite, a slightly thicker profile than elsewhere and without any cramps in the joints, except where noted on the far end

Orange, probably terracotta balusters to the north-western facade. Note that iron was detected in 2 balusters but that no cracks or damage was noted on the surface

The embedded iron cramp had been exposed where the facing stone had cleaved away from the corroded iron. The iron was cathodically protected, and a new granite indent built over

Solid urn or finial. Those on the south-western facade are solid granite and do not contain flues

A lot of salt damage is evident in this area, above and around the former window opening where the gutter above was blocked

New Code 6 lead flashing & cover flashing secured to the vertical face of the blocking course, overlapping the Code 8 flashing on the horizontal upper surface of the cornice

Chase mechanically cut into the mortar joints to accommodate the cable for the cathodic protection

A series of holes were drilled into the lower part of the granite-faced concrete block window opening to ventilate the lodge interiors

2 new stainless steel cramps fitted where the older wrought iron had corroded. Both mortar joints were repointed

40mm Ø core made from the outer face and edge of the cornice's uppermost stone to allow access to cathodically protect each iron.

2 number 650mm long, 12mm Ø tie bars grouted into pre-drilled holes. The holes were drilled from the edge and face of the 1/2 dentils into the core

The main circuit of the cables for the cathodic protection system were routed through a pre-drilled hole in the top right of the upper, granite-faced, concrete block-filled window. The cable was routed in plastic trunking down the interior of the lodge to the exit point in the window below

Old mild steel was drilled out and removed from 2 areas of this facade. The resultant holes were repaired with granite dust and resin and tooled to match the surrounding stone.

The cables for the cathodic protection are run down the interior of the lodge in surface-mounted plastic trunking, emerging through small drilled holes at the corners of both windows

The main circuit of the cables for the cathodic protection system was routed through this pre-drilled hole in the blocked-up window opening and run in the mortar joints to the sacrificial cathodes in the ground beside the arch

NOTE The cables run in the ground are not encased with trunking so care should be taken if the area is to be landscaped in the future

The corroded cast iron down pipe was removed from the opening in the wall and replaced with new black uPVC pipe, connected to a black uPVC rain water down pipe which drains to a new soakaway.
