PROJECT TITLE:  
 ESSENTIAL REPAIRS & CONSERVATION OF THE  
 ROMAN ARCH,  
 DODDER PARK ROAD,  
 RATHFARNHAM,  
 DUBLIN  
 PROJECT STAGE: POST SUBSTANTIAL COMPLETION

DRAWING TITLE:  
 AS-BUILT DRAWINGS  
 SOUTH-EAST ELEVATION

DRAWING NUMBER: 2009-008-I-27 REV:

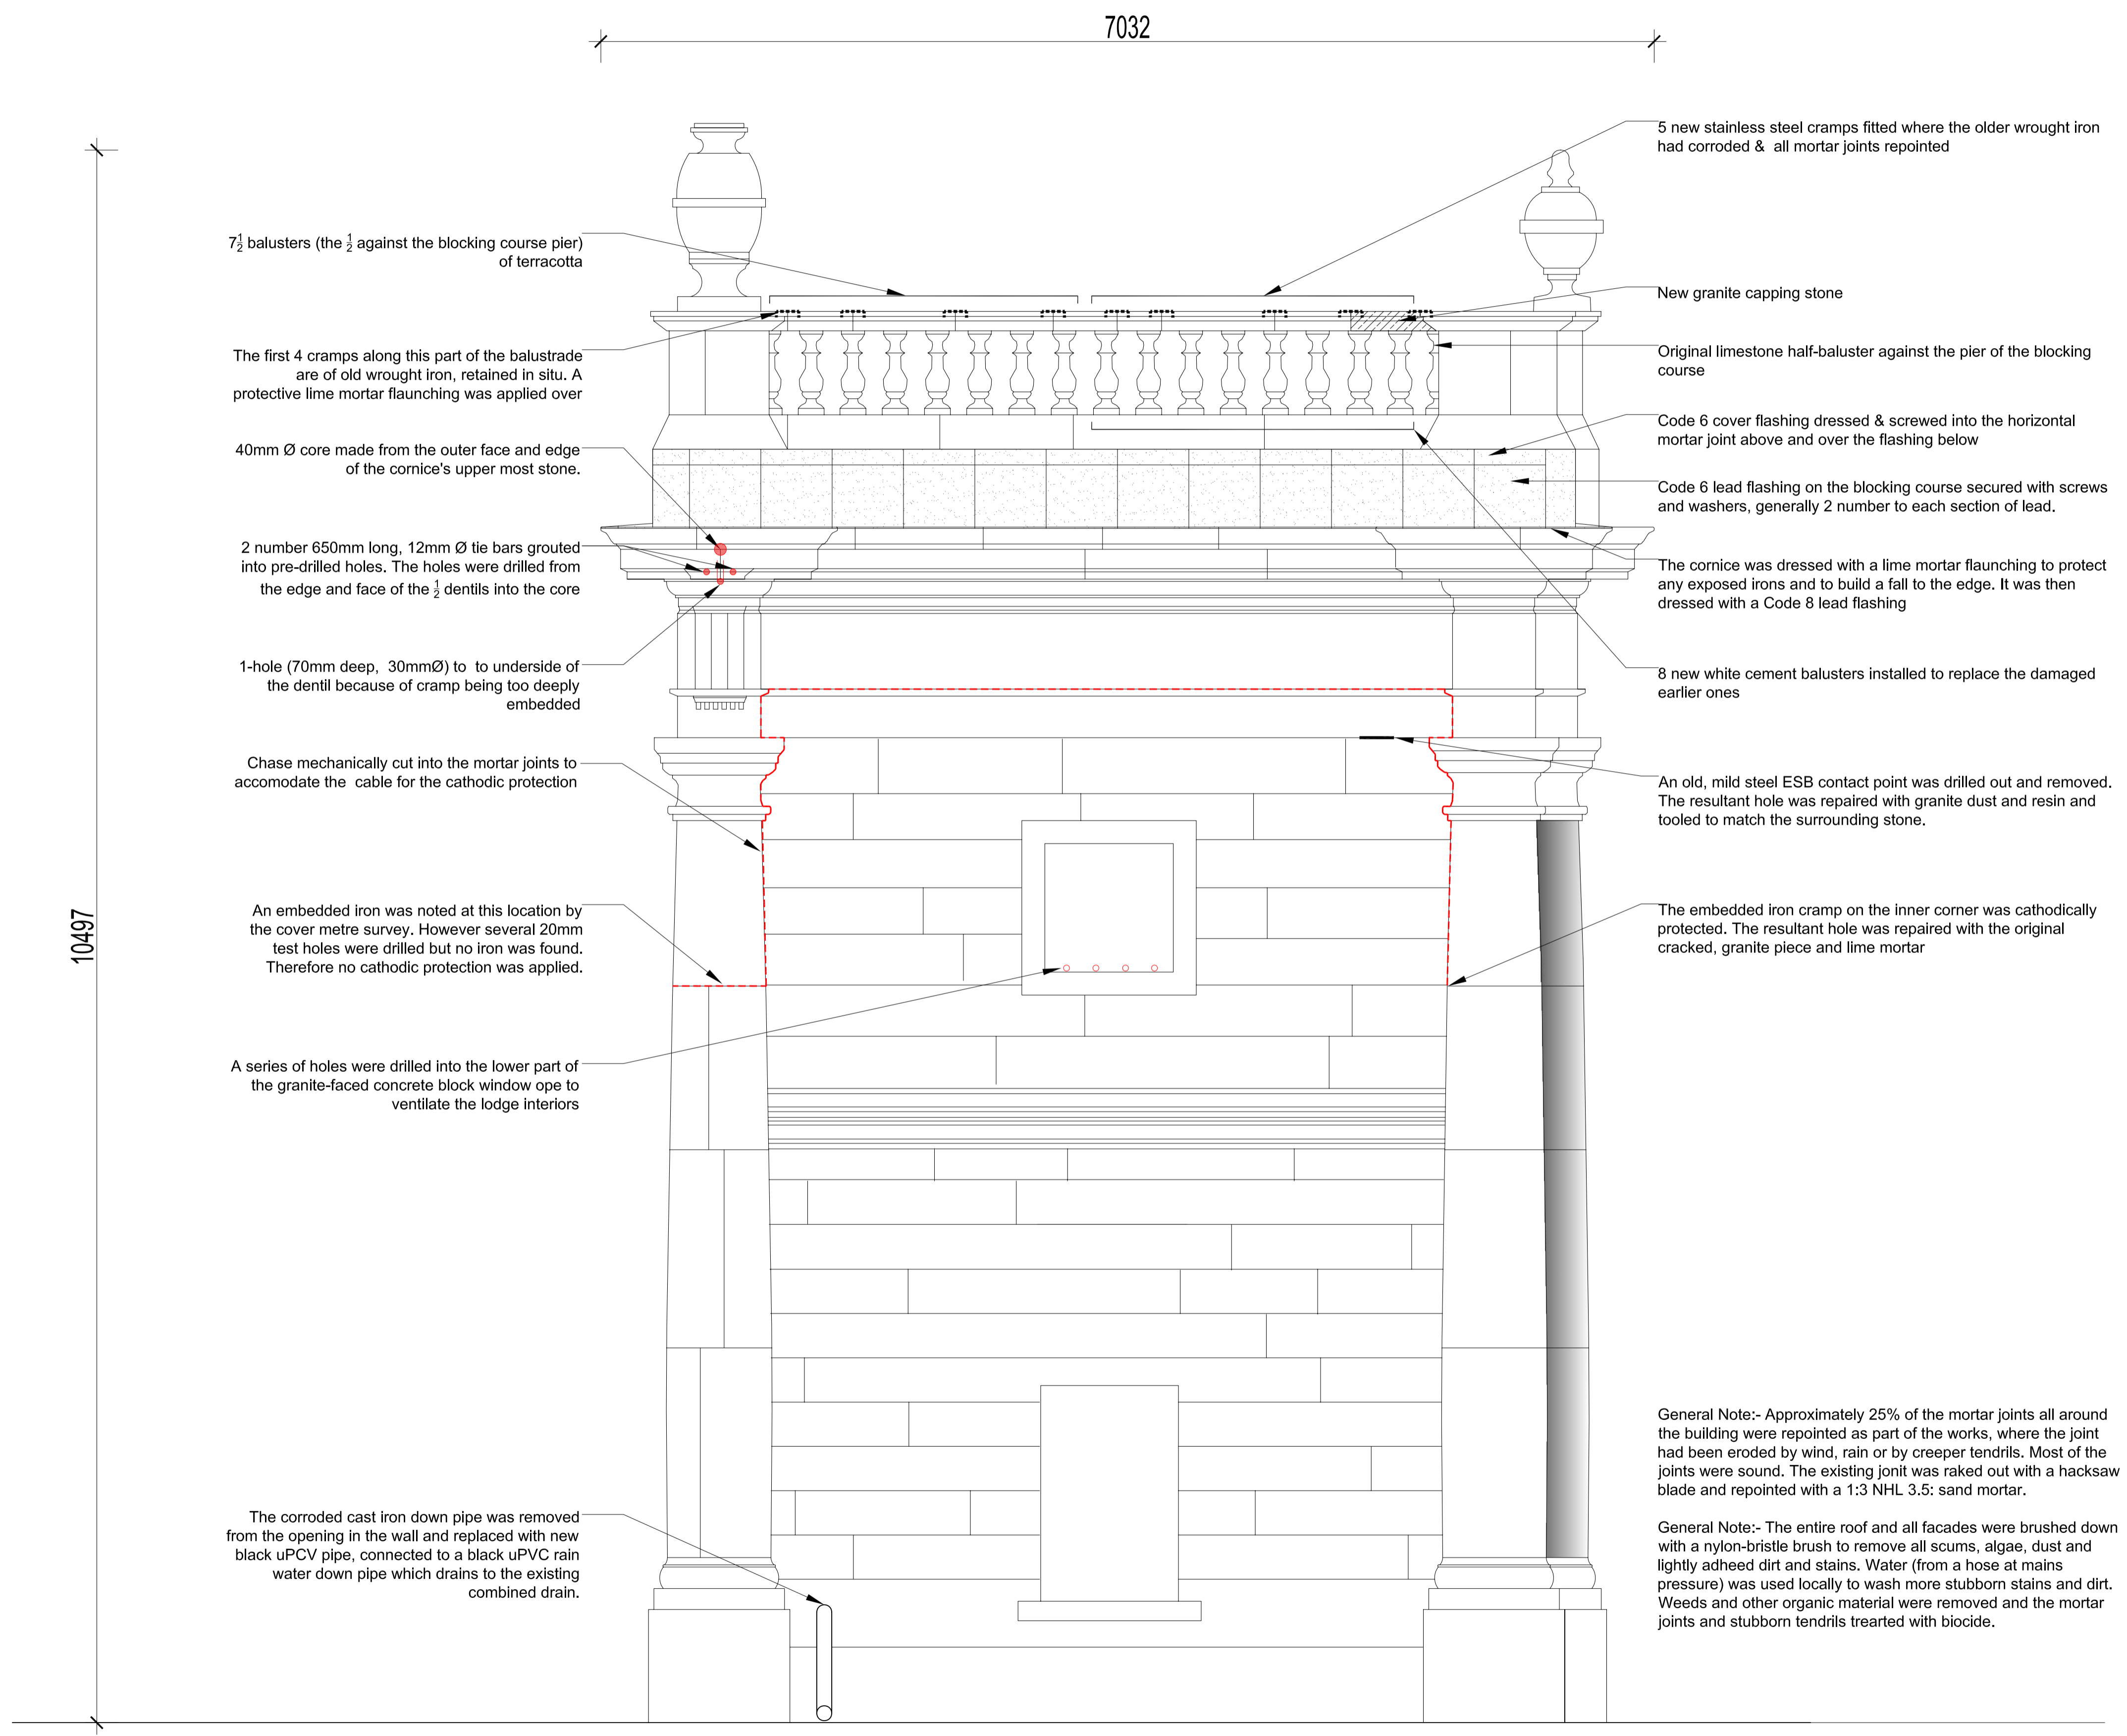
SOUTH-EAST ELEVATION  
SCALE: 1:25 (A1 page)

7½ balusters (the ½ against the blocking course pier) of terracotta

The first 4 cramps along this part of the balustrade are of old wrought iron, retained in situ. A protective lime mortar flaunching was applied over

40mm Ø core made from the outer face and edge of the cornice's upper most stone.

1-hole (70mm deep, 30mmØ) to underside of the dentil because of cramp being too deeply embedded

An embedded iron was noted at this location by the cover metre survey. However several 20mm test holes were drilled but no iron was found. Therefore no cathodic protection was applied.

Original limestone half-baluster against the pier of the blocking course

2 number 650mm long, 12mm Ø tie bars grouted into pre-drilled holes. The holes were drilled from the edge and face of the ½ dentils into the core

Chase mechanically cut into the mortar joints to accommodate the cable for the cathodic protection

A series of holes were drilled into the lower part of the granite-faced concrete block window ope to ventilate the lodge interiors

The corroded cast iron down pipe was removed from the opening in the wall and replaced with new black uPCV pipe, connected to a black uPVC rain water down pipe which drains to the existing combined drain.

5 new stainless steel cramps fitted where the older wrought iron had corroded & all mortar joints repointed

New granite capping stone

Code 6 cover flashing dressed & screwed into the horizontal mortar joint above and over the flashing below

Code 6 lead flashing on the blocking course secured with screws and washers, generally 2 number to each section of lead.

The cornice was dressed with a lime mortar flaunching to protect any exposed irons and to build a fall to the edge. It was then dressed with a Code 8 lead flashing

8 new white cement balusters installed to replace the damaged earlier ones

An old, mild steel ESB contact point was drilled out and removed. The resultant hole was repaired with granite dust and resin and tooled to match the surrounding stone.

The embedded iron cramp on the inner corner was cathodically protected. The resultant hole was repaired with the original cracked, granite piece and lime mortar
