PROJECT TITLE:
ESSENTIAL REPAIRS & CONSERVATION OF THE ROMAN ARCH,
DODDER PARK ROAD,
RATHFARNHAM,
DUBLIN
PROJECT STAGE: POST SUBSTANTIAL COMPLETION

DRAWING TITLE:
AS-BUILT DRAWINGS
SOUTH-WEST ELEVATION

DRAWING NUMBER: 2009-008-1-25 REV:

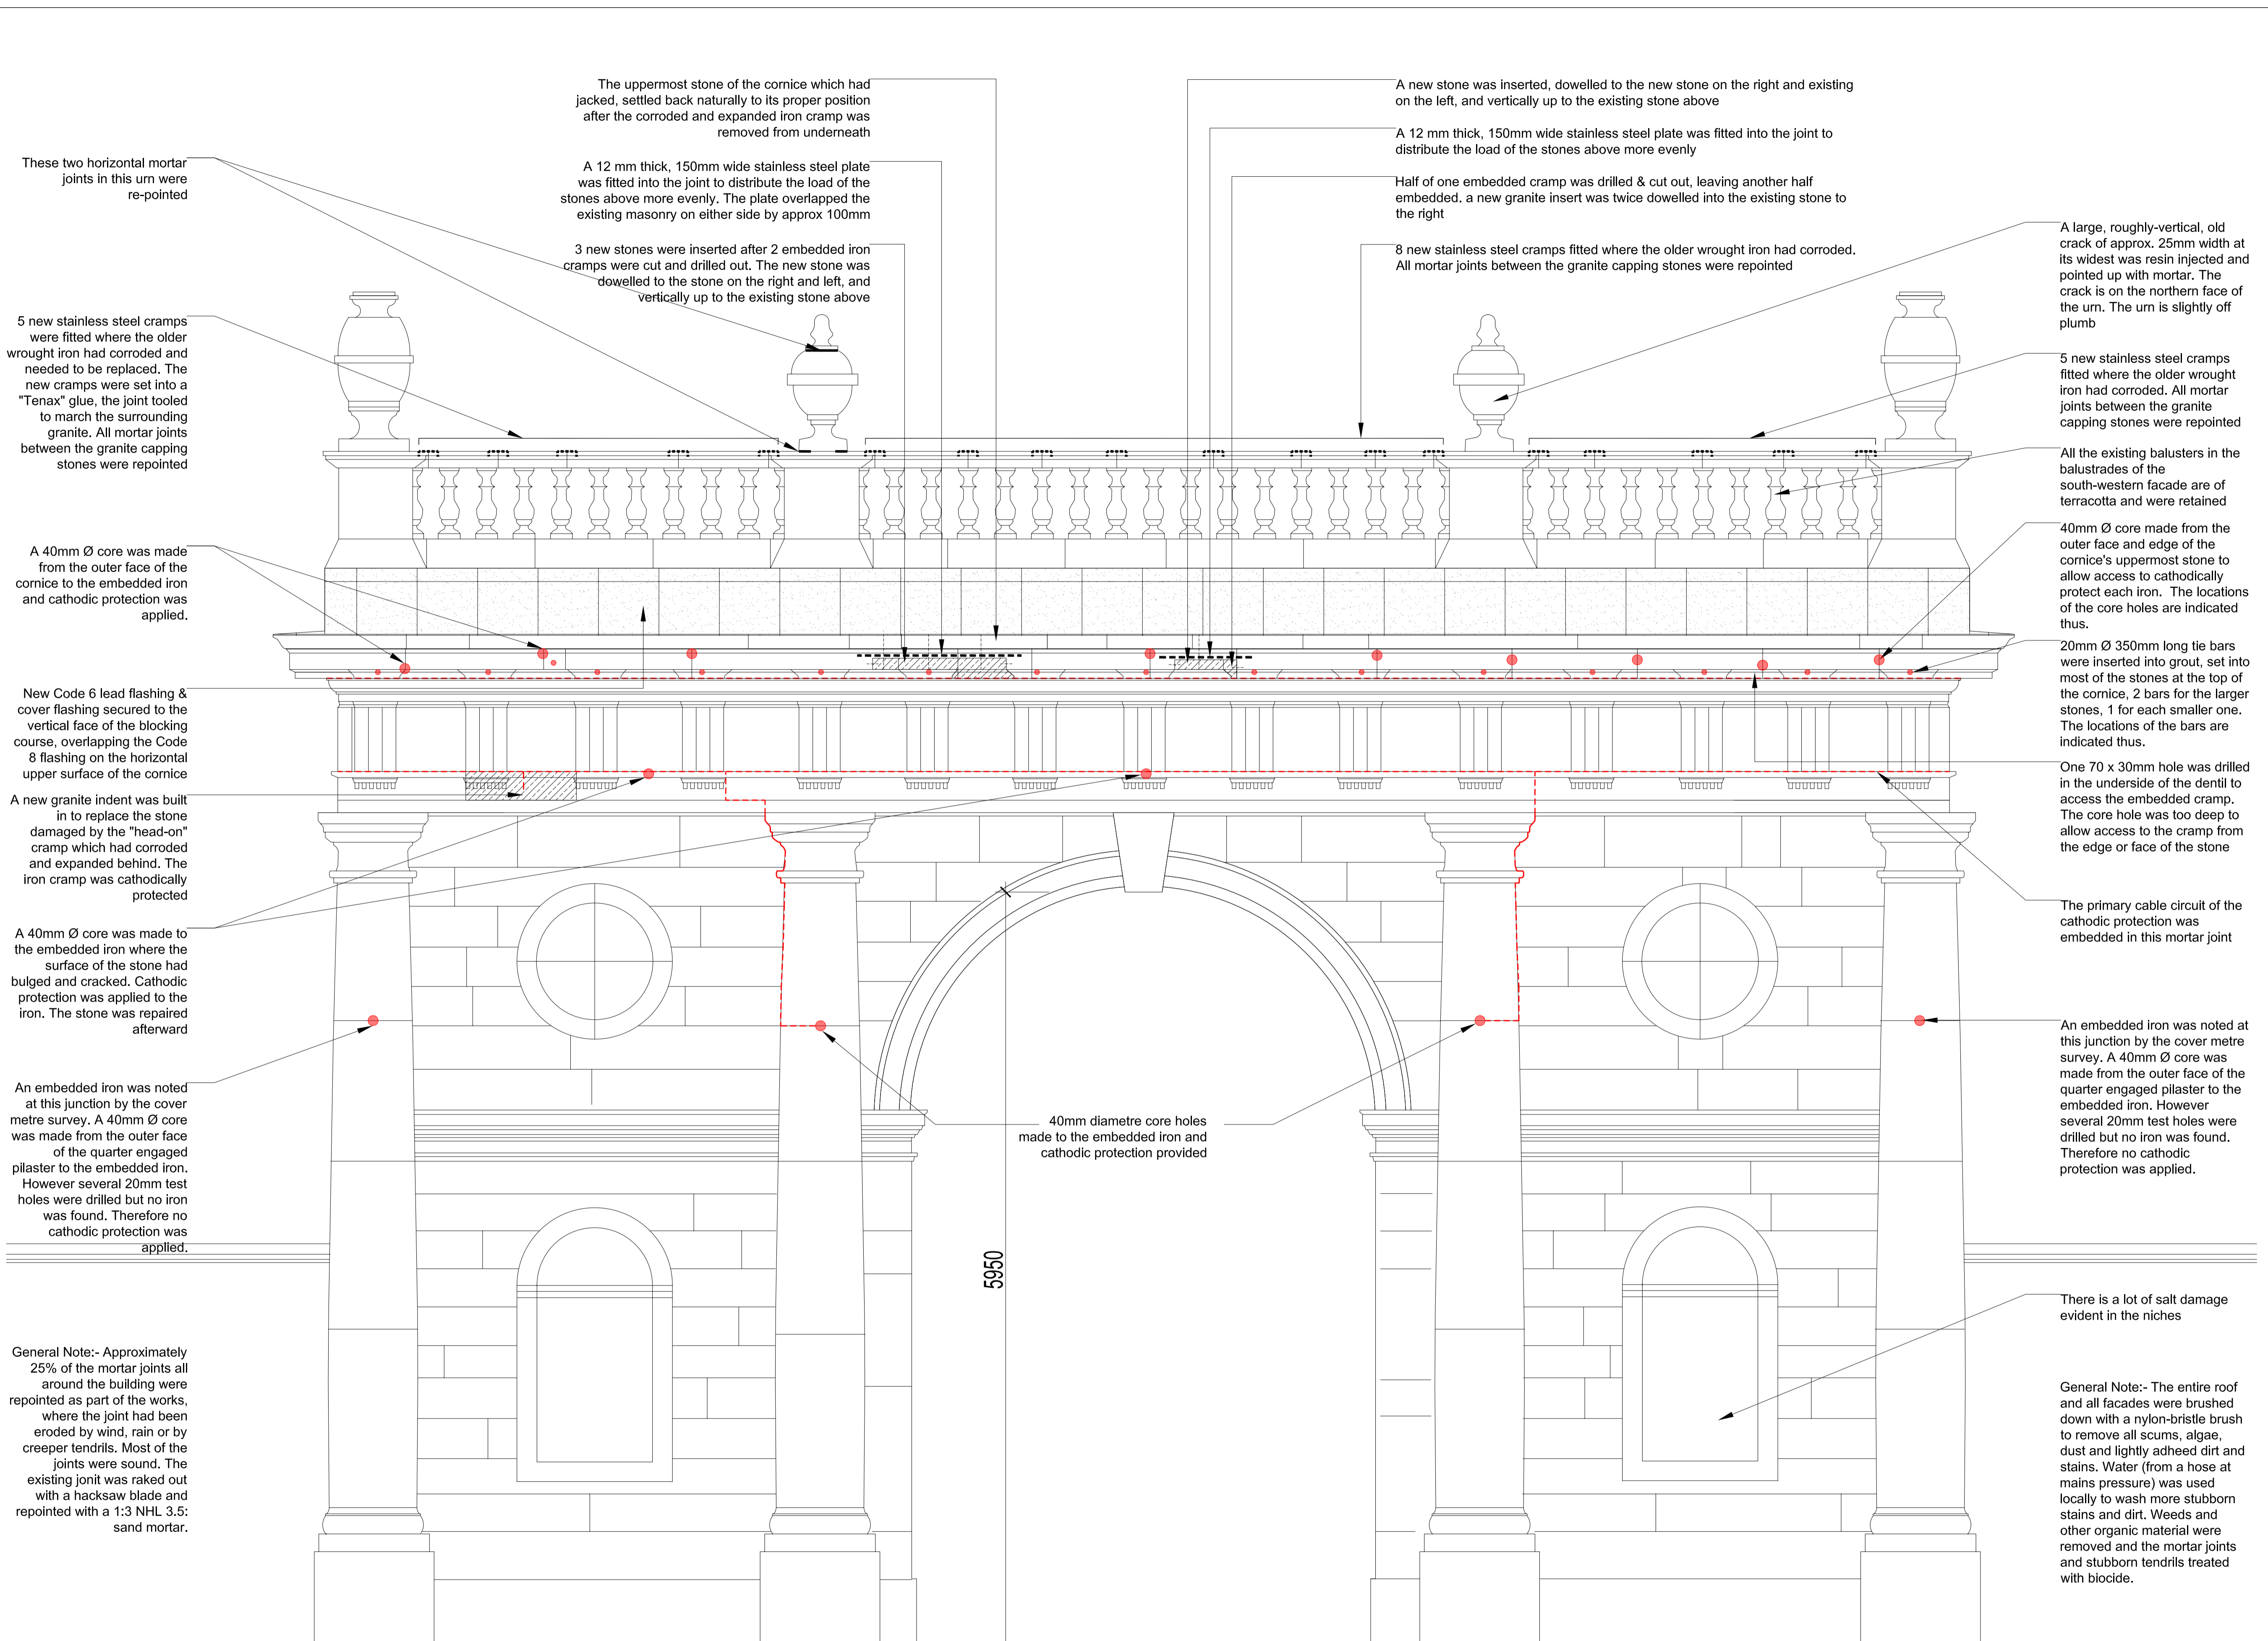
SOUTH-WEST ELEVATION
SCALE: 1:25

The uppermost stone of the cornice which had jacked, settled back naturally to its proper position after the corroded and expanded iron cramp was removed from underneath

A large, roughly-vertical, old crack of approx. 25mm width at its widest was resin injected and pointed up with mortar. The crack is on the northern face of the urn. The urn is slightly off plumb

All the existing balusters in the balustrades of the south-western facade are of terracotta and were retained

One 70 x 30mm hole was drilled in the underside of the dentil to access the embedded cramp. The core hole was too deep to allow access to the cramp from the edge or face of the stone

An embedded iron was noted at this junction by the cover metre survey. A 40mm Ø core was made from the outer face of the quarter engaged pilaster to the embedded iron. However several 20mm test holes were drilled but no iron was found. Therefore no cathodic protection was applied.

There is a lot of salt damage evident in the niches

A 12 mm thick, 150mm wide stainless steel plate was fitted into the joint to distribute the load of the stones above more evenly. The plate overlapped the existing masonry on either side by approx 100mm

3 new stones were inserted after 2 embedded iron cramps were cut and drilled out. The new stone was dowelled to the stone on the right and left, and vertically up to the existing stone above

A new stone was inserted, dowelled to the new stone on the right and existing on the left, and vertically up to the existing stone above
A 12 mm thick, 150mm wide stainless steel plate was fitted into the joint to distribute the load of the stones above more evenly

Half of one embedded cramp was drilled & cut out, leaving another half embedded. a new granite insert was twice dowelled into the existing stone to the right

8 new stainless steel cramps fitted where the older wrought iron had corroded. All mortar joints between the granite capping stones were repointed

5 new stainless steel cramps fitted where the older wrought iron had corroded. All mortar joints between the granite capping stones were repointed

40mm Ø core made from the outer face and edge of the cornice's uppermost stone to allow access to cathodically protect each iron. The locations of the core holes are indicated thus.

20mm Ø 350mm long tie bars were inserted into grout, set into most of the stones at the top of the cornice, 2 bars for the larger stones, 1 for each smaller one. The locations of the bars are indicated thus.

The primary cable circuit of the cathodic protection was embedded in this mortar joint

These two horizontal mortar joints in this urn were re-pointed

5 new stainless steel cramps were fitted where the older wrought iron had corroded and needed to be replaced. The new cramps were set into a "Tenax" glue, the joint tooled to match the surrounding granite. All mortar joints between the granite capping stones were repointed

A 40mm Ø core was made from the outer face of the cornice to the embedded iron and cathodic protection was applied.

New Code 6 lead flashing & cover flashing secured to the vertical face of the blocking course, overlapping the Code 8 flashing on the horizontal upper surface of the cornice

A new granite indent was built in to replace the stone damaged by the "head-on" cramp which had corroded and expanded behind. The iron cramp was cathodically protected

A 40mm Ø core was made to the embedded iron where the surface of the stone had bulged and cracked. Cathodic protection was applied to the iron. The stone was repaired afterward

40mm diameter core holes made to the embedded iron and cathodic protection provided
