The conservation and essential repair of the Roman Arch

Building Dossier

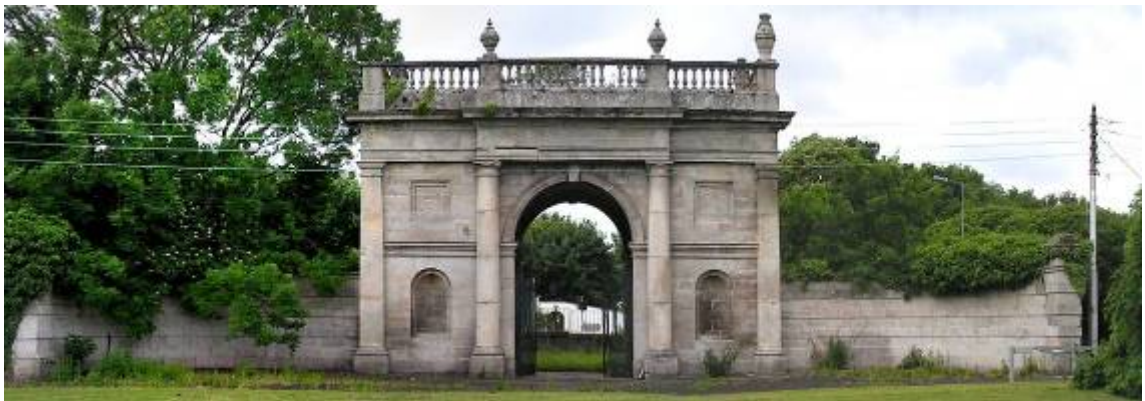
A view of the north-eastern façade. The north-eastern façade to the public park, formerly the public side of the Arch which addressed the natural open space made by the valley around the Dodder river and the junction of the three roads shown in the map on pg. 8. Note the missing urn on the left side. (Photographed September 2009)

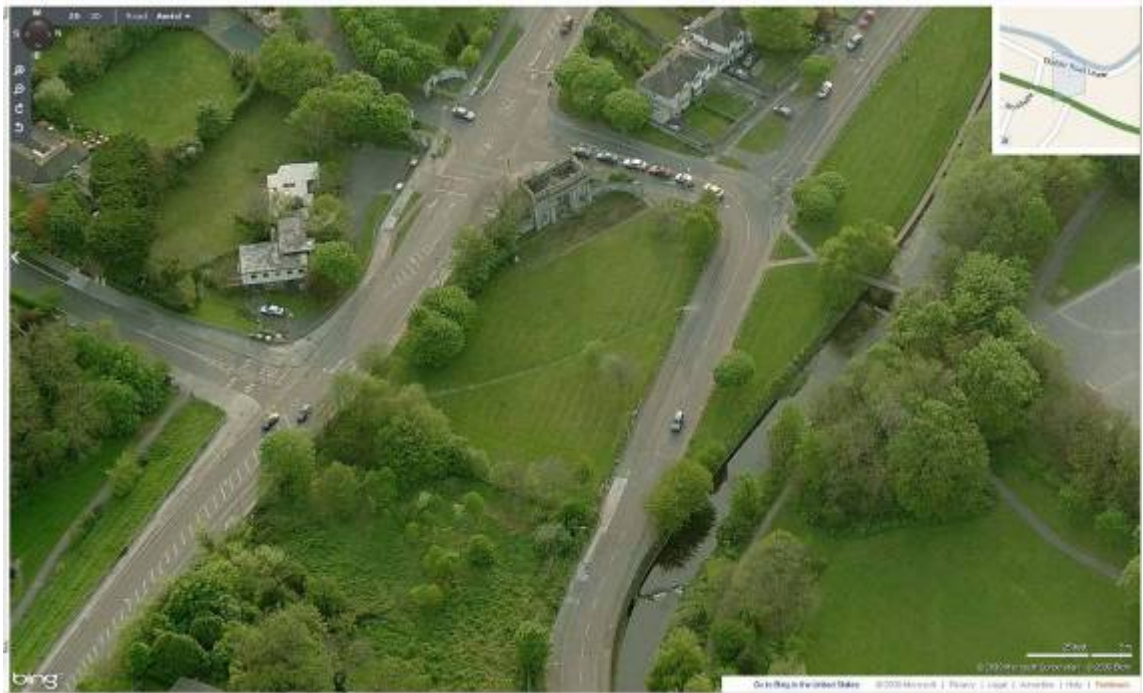
An aerial photograph of the Roman Arch from the north-east. The river Dodder is on the right side of the photo
(The photograph was sourced from the website <http://www.bingmaps.com>)

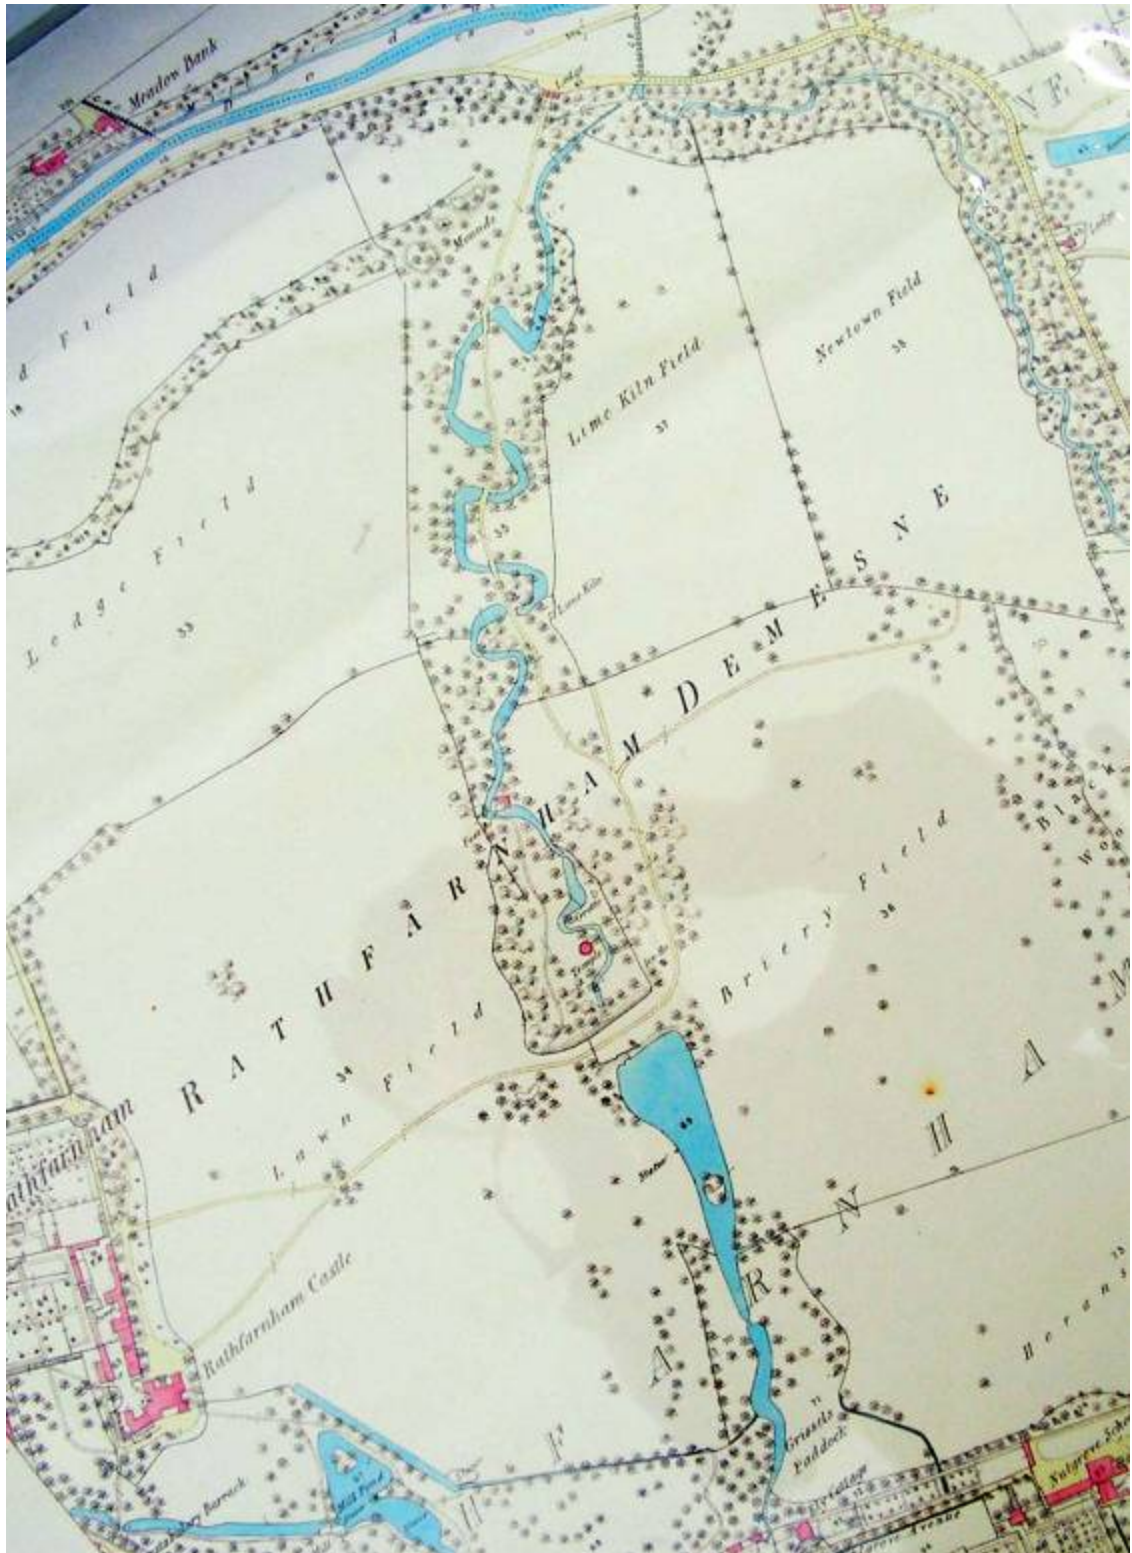
An extract from the second edition Ordnance Survey. "Ordnance Survey. Parish of Rathfarnham Co. Dublin" (surveyed in 1864 by Captain Martin R.E. and zincographed in 1865 under the direction of Captain Wilkinson R.E. at the Ordnance Survey office). The Roman Arch is at the top of the map. The map has been rotated so that North is no longer up the page.

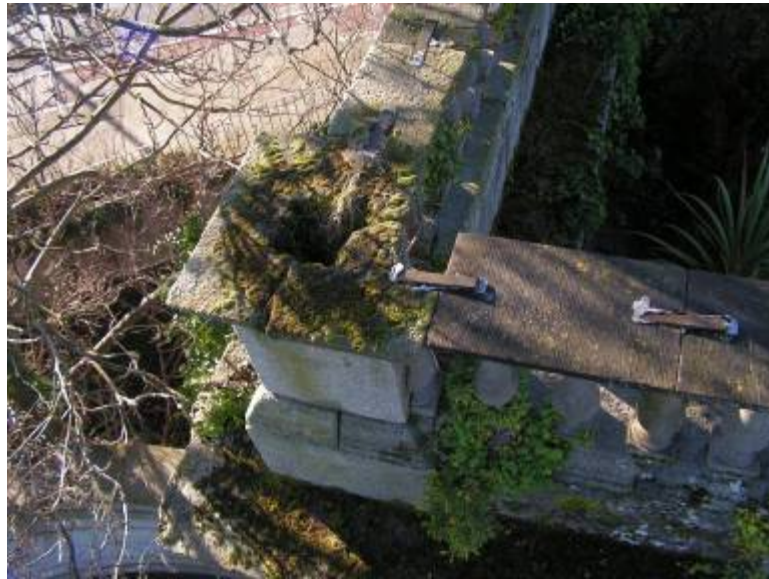
The south-eastern corner. Note the damage around the flue and the popped iron cramps with the lead still visible on either side. Note also the granite cap stones of the south-eastern façade above and the limestone of the north-eastern façade to the right.

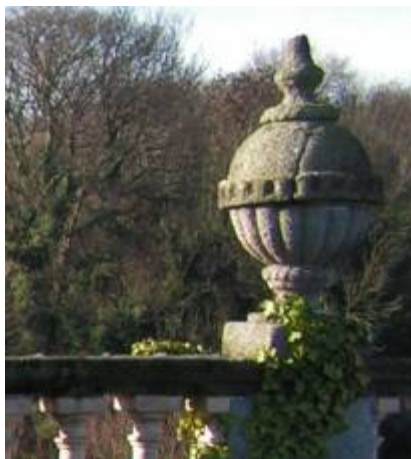
Crack in the southernmost smaller urn on the south-western façade

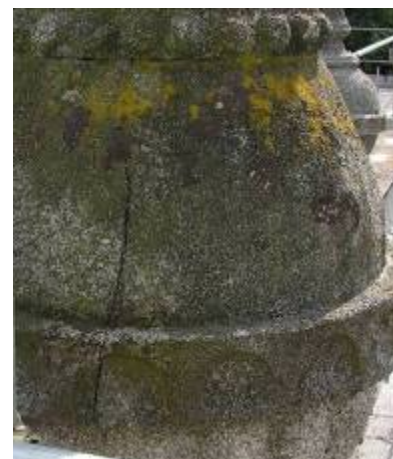
Crack in the large flue-urn at the north-eastern corner

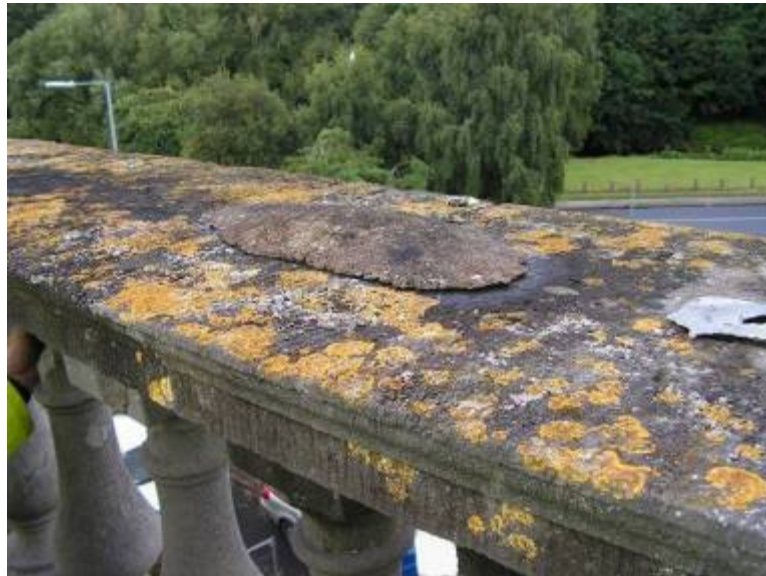
Some of the limestone cap stones on the north-east façade. Note the mortar covering or protection over the iron cramps which reinforced the most of the joints between the cap stones. Note also the tooled lines on the cap stones

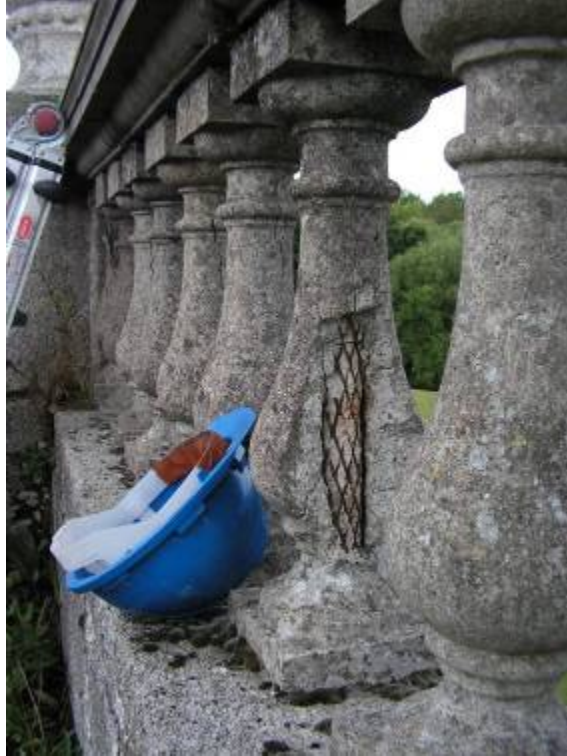
A baluster in the north-eastern façade, near the north-east corner. Note the corroded wire mesh reinforcement wrapped around a central iron or mild steel core and spalled, cast masonry.

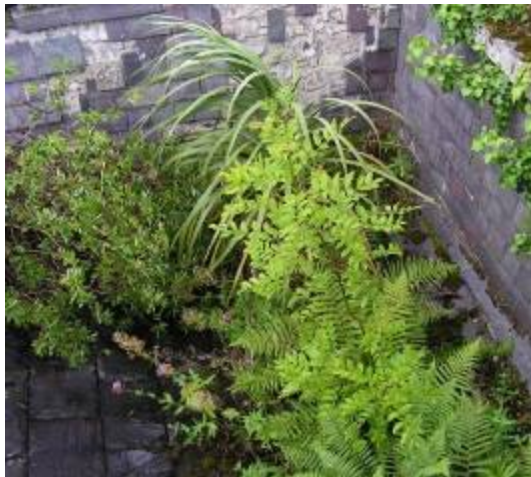
Biological colonisation of the northern gutter

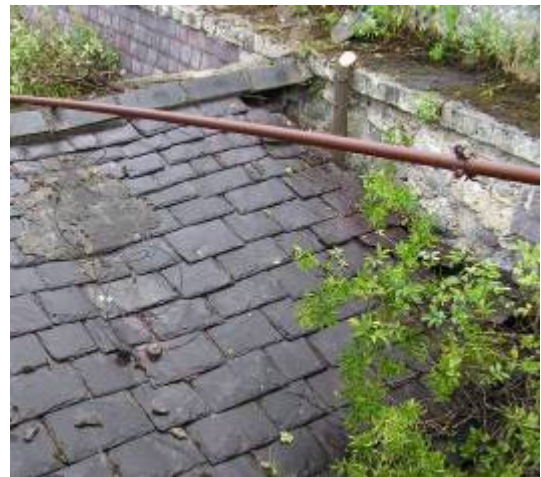
The hole in the roof and shrubs growing from it

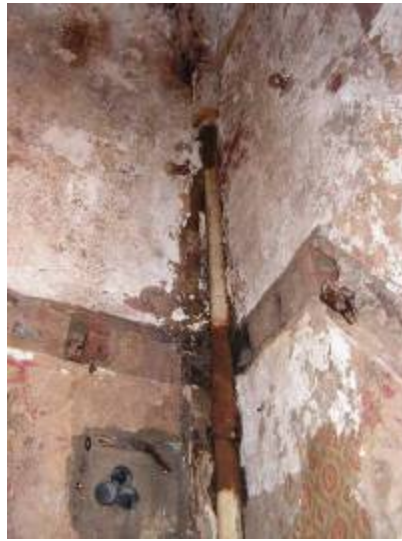
The corroded rainwater down-pipe in the southern lodge. Note the hole at the top of the pipe. Note also the joist holes in the brickwork which one supported the floor. Note the springing of the vault above.

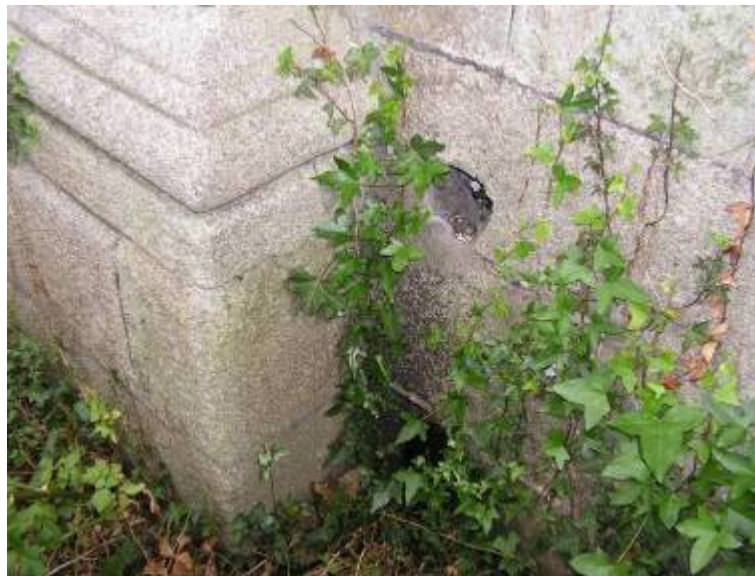
The rain-water outlet from the southern lodge, at the base of the south-eastern facade. Both outlet pipes had badly corroded within the stone opening causing localised damage in the area.

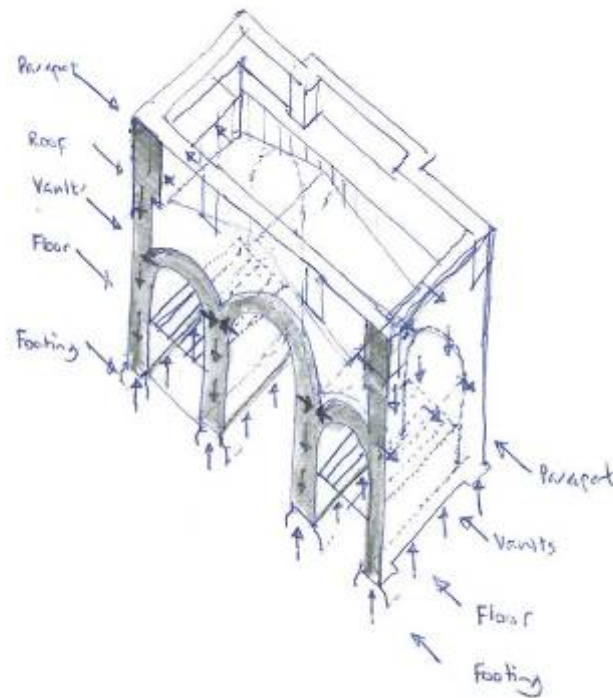
A sketch of the main structural forces acting on the Arch (sketch by the author)

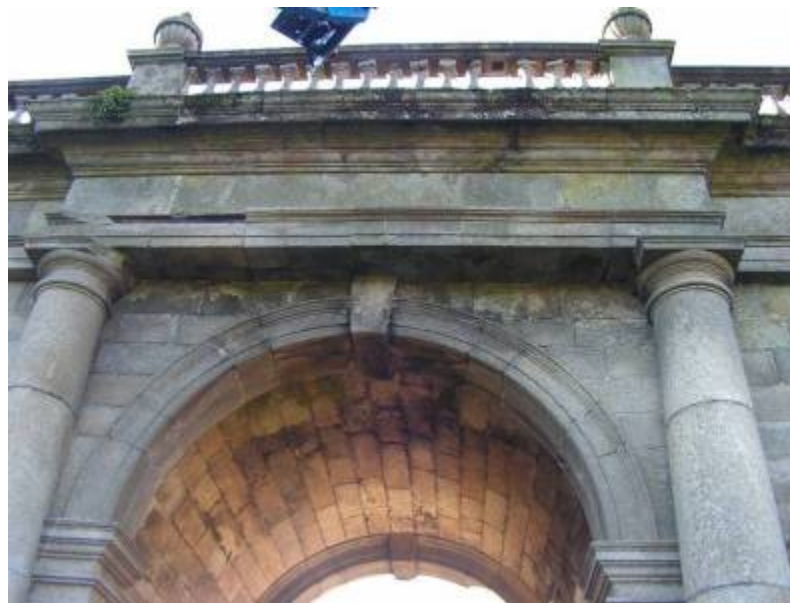
A closer view of the front of the central part of the north-eastern façade before works began. Note the missing piece of stone and the damaged and missing balusters (photographed January 2009)

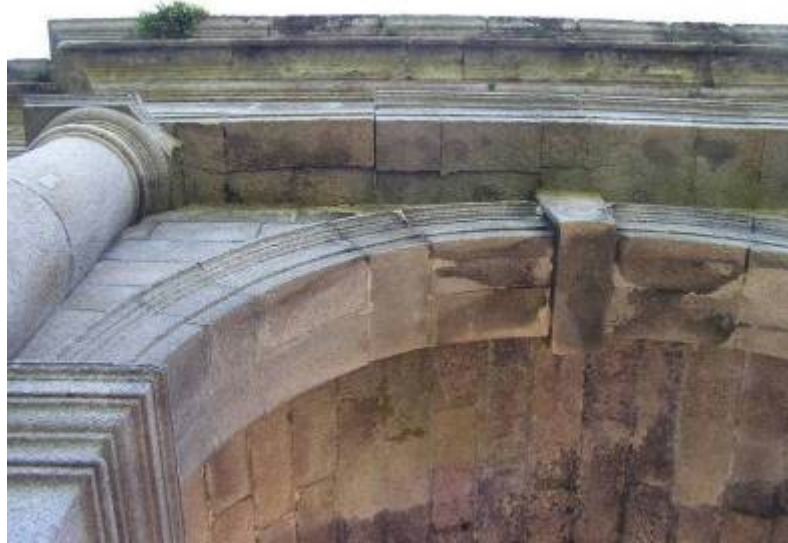
The damaged projecting entablature on the north-eastern façade viewed from below. Note the crack on the underside of the architrave of the entablature, the damaged capital & plant growth on the cornice on the left in the image. Note also the green lichens and black stains left by water run-off and residual dirt and salt staining.

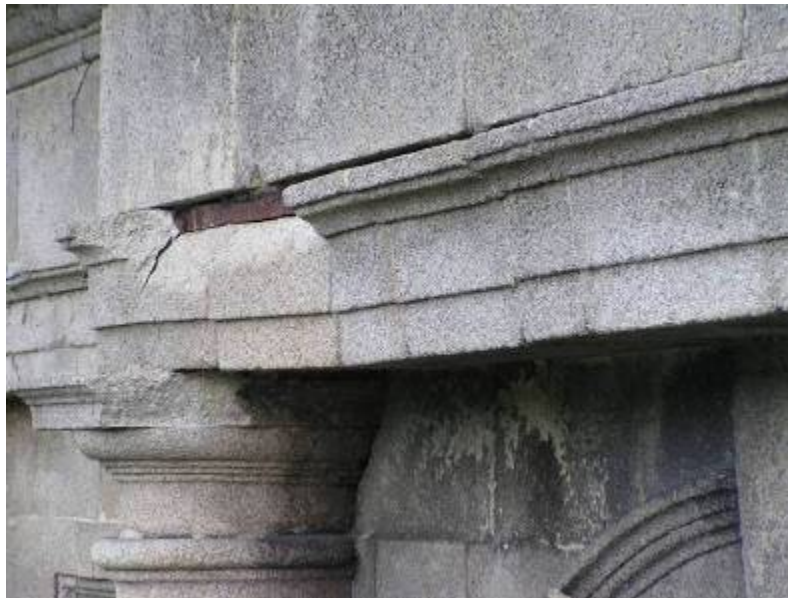
The same architrave of the north-eastern entablature viewed from the north-east. Note the exposed iron tie bar.

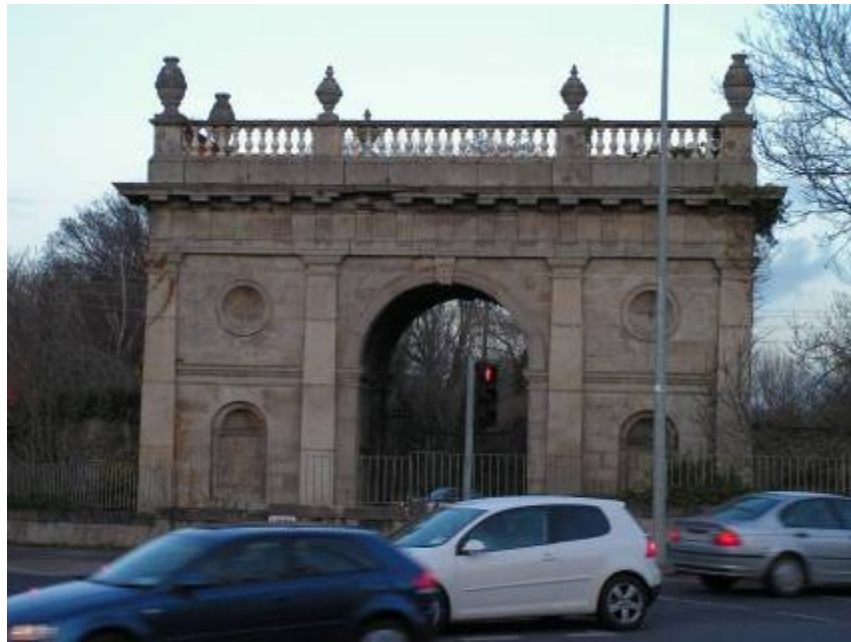
The south-western façade viewed from Dodder Valley Road (photographed January 2009)

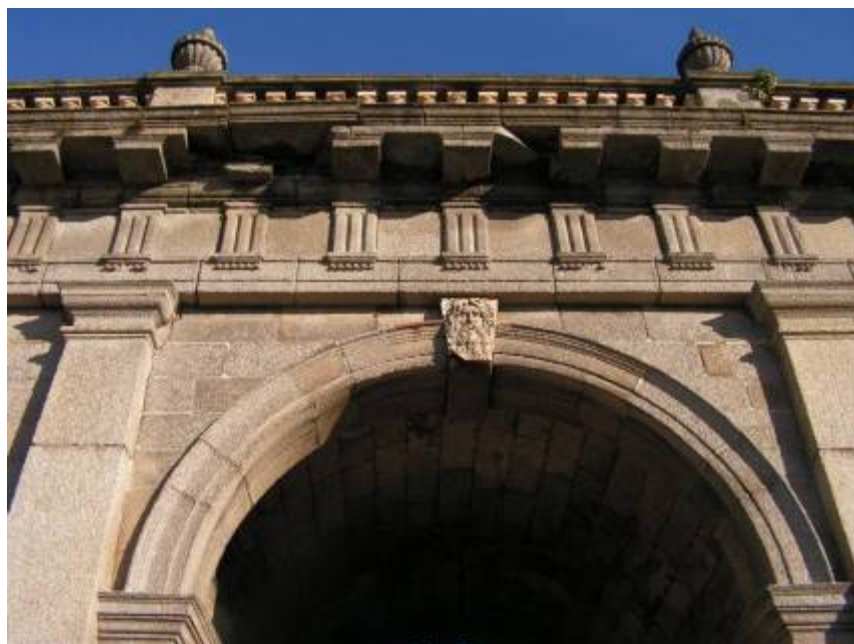
A view of the central part of the south-western façade viewed from Dodder Valley Road – Braemor Road junction (photographed January 2009). Note the missing piece from the Coade stone mask and the two missing pieces of dentil course.

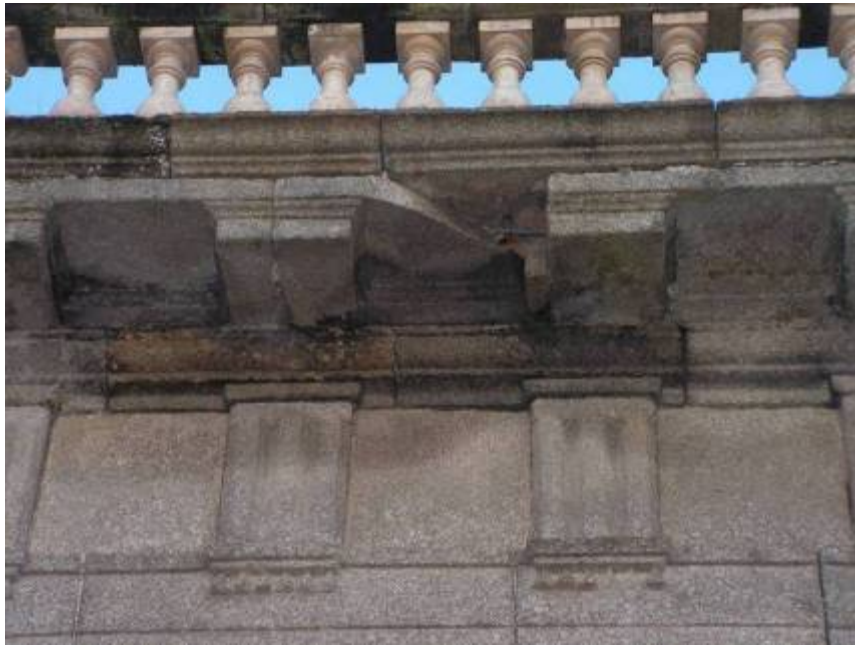
A closer view of one part of the damaged dentil course of the south-western façade. Note the small piece of cramp visible

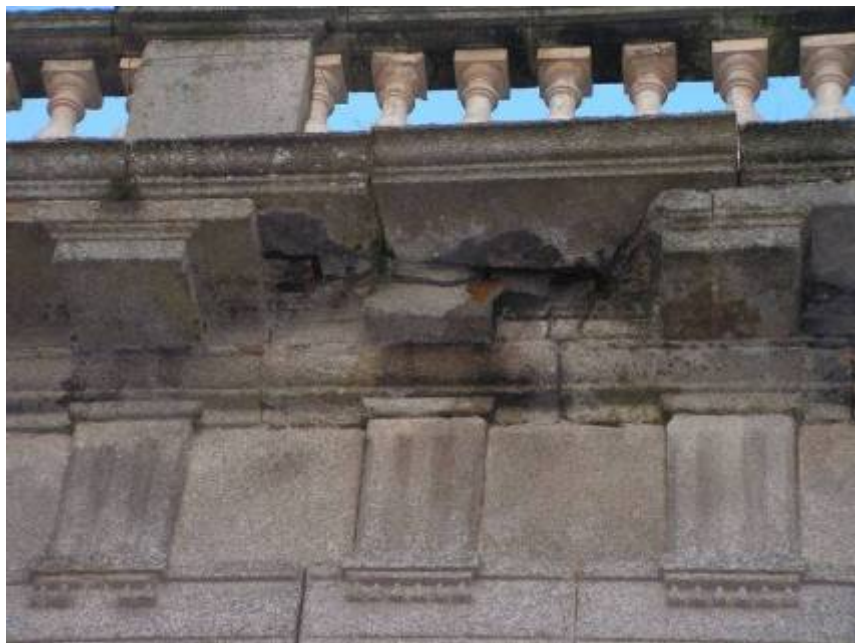
Another part of the damaged dentil course of the south-western façade. Note the slightly jacked stone at the top of the cornice and the edge of an iron cramp at the back underneath. Half of another cramp is visible on the left. Note the iron oxide stains.

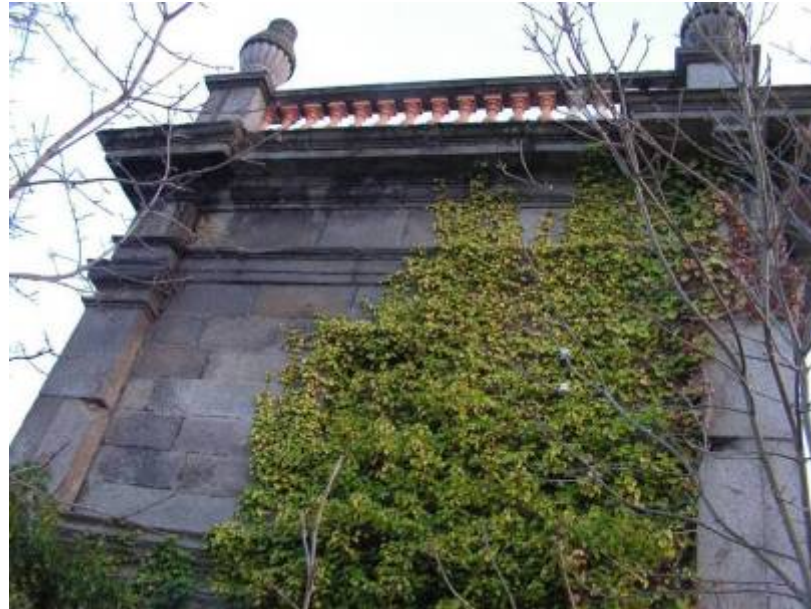
The upper part of the north-west façade photographed January 2009. The ivy has reached the very top of the structure. Note also the missing pieces of stone in the corners of both engaged pilasters, more damage caused by corrosion of embedded iron.

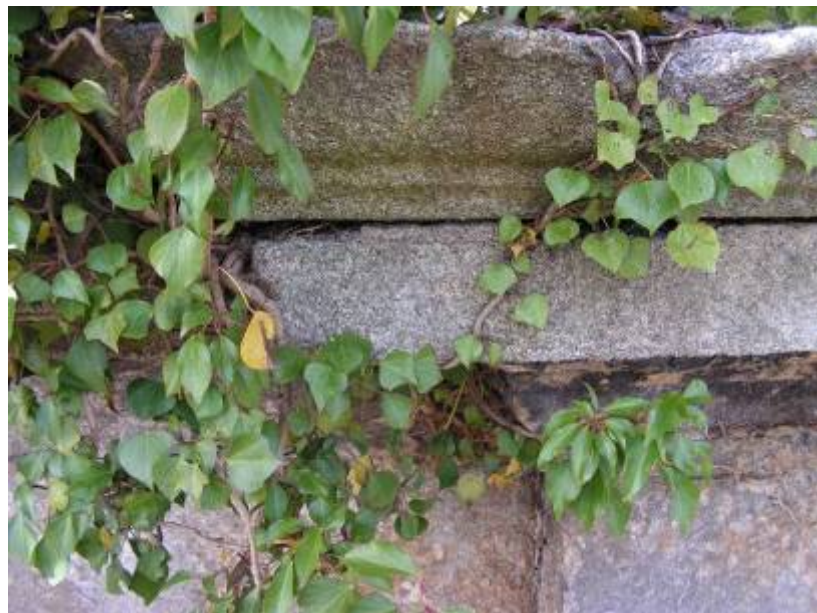
The corona stone of the cornice at the top of the corner pilaster at the south-eastern corner of the south-eastern façade. Note that the creepers had colonised the full height of the building in this area and had matured to such an extent that the strong, woody tendrils had penetrated the mortar joints and over time had lifted and dislodged one of the large corona stones.

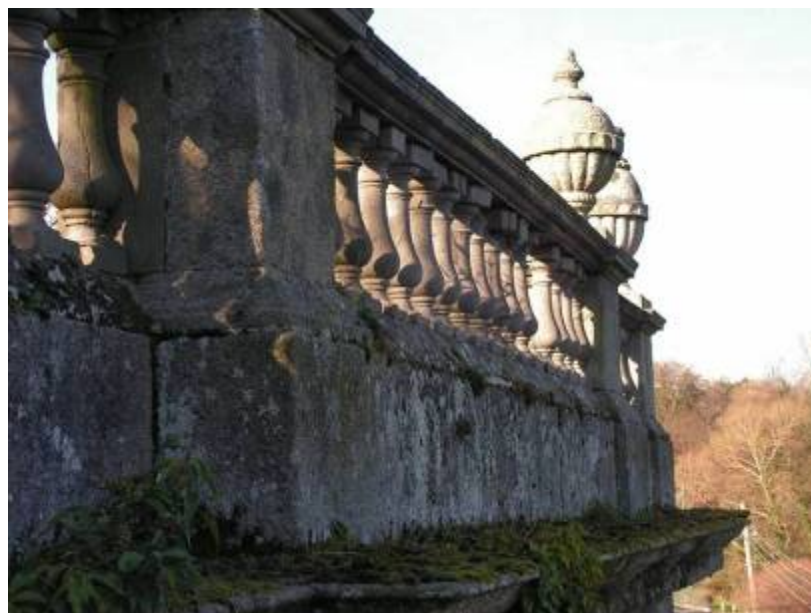
The upper surface of the cornice above the north-eastern façade. Note the extensive growth of mosses and weeds on the flat surface. (photographed January 2009)

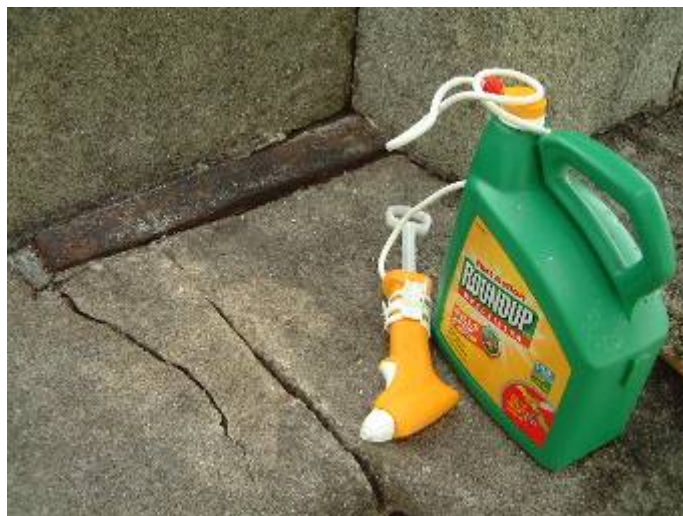
The crack at the south-eastern corner of the cornice, at the right side of the south-eastern façade. Note the large iron cramp. The crack could have been caused or assisted by the falling or removal of the flue-urn above at some time in the past as well as the expansive action of the corroding iron. Note that the iron was exposed to the elements and was not embedded or protected by stone. It is possible that the top of the cornice was originally dressed with a sacrificial lime mortar flaunching fillet.

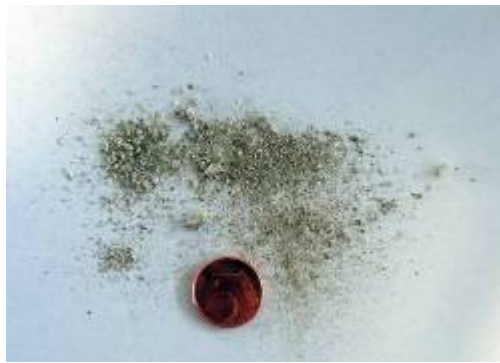
Mortar sample raked out from a joint in the south-eastern façade

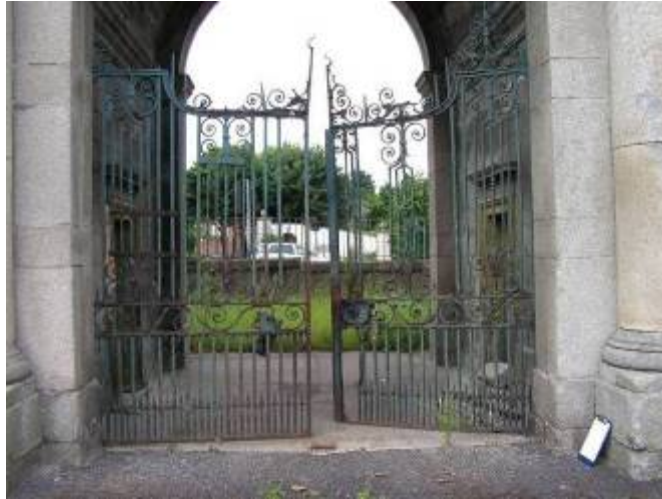
A general view of the gates from the north-east. No conservation works have been carried out.

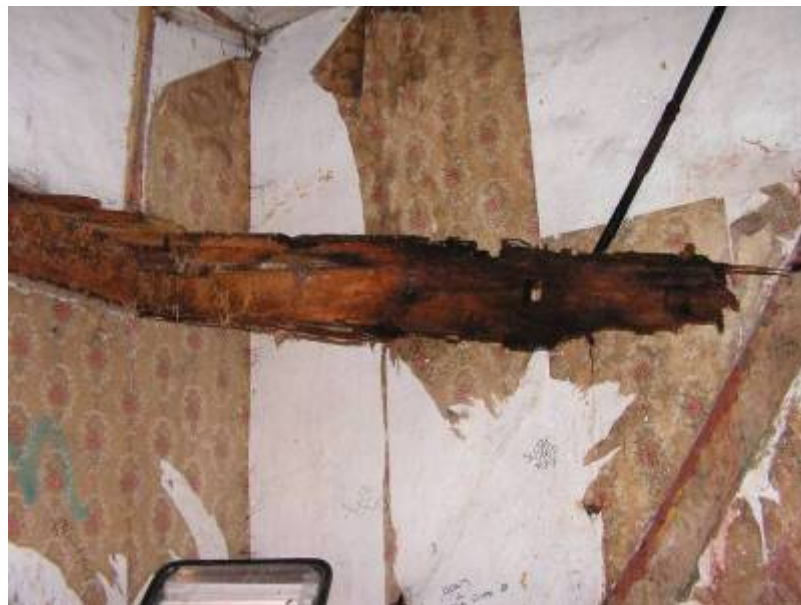
The northern lodge. A fragment of the first floor structure, a trimmer joist at the edge of the ladder- stairs

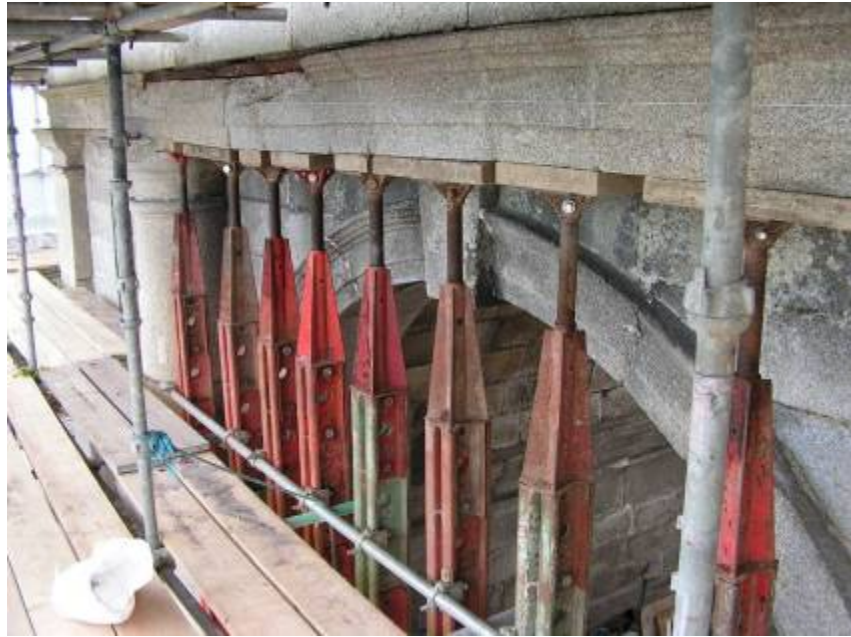
Shoring of the structurally unsound but historic and significant north-eastern entablature

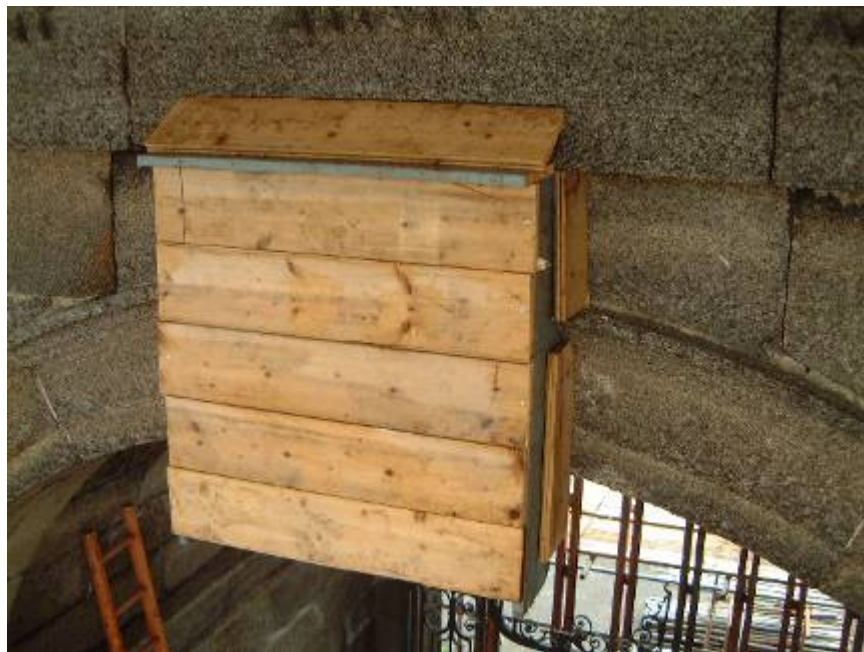
Protection of the Coade stone mask from damage during the works. A silicone cast was also taken of the mask to help reconstruct it should it be damaged during the course of the works

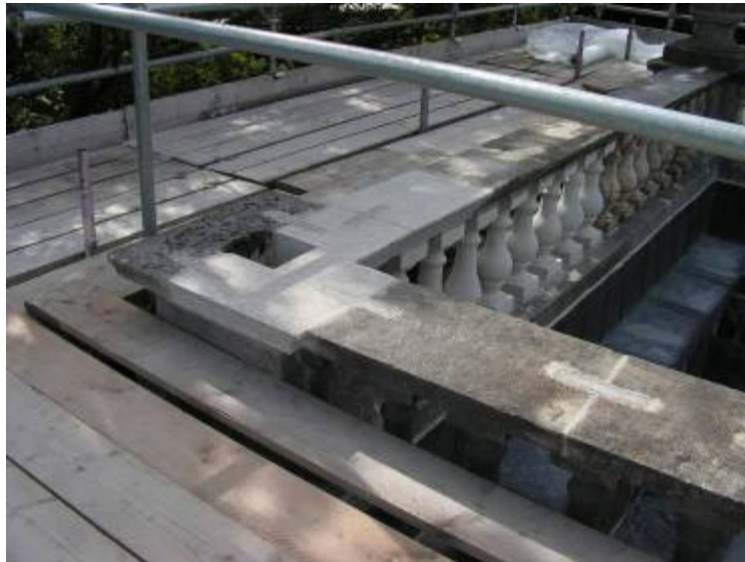
The south-eastern corner. New granite jointed with new stainless steel cramps.

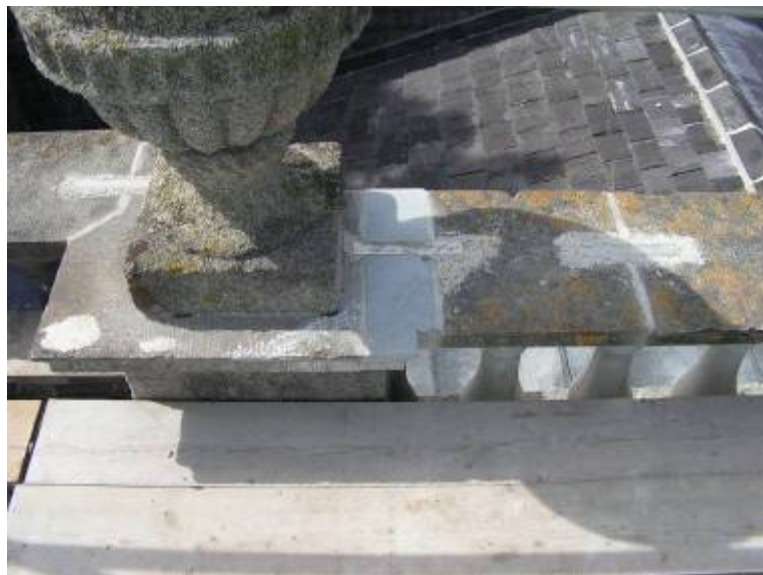
New limestone indented above the balustrade on the north-eastern façade. Note also the new stainless steel cramps

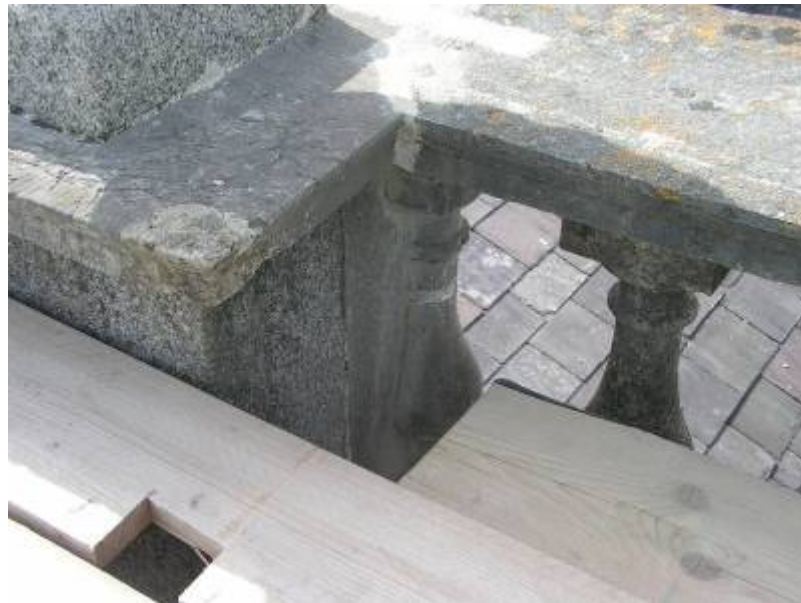
Existing limestone half-baluster on the south-eastern façade which was repaired

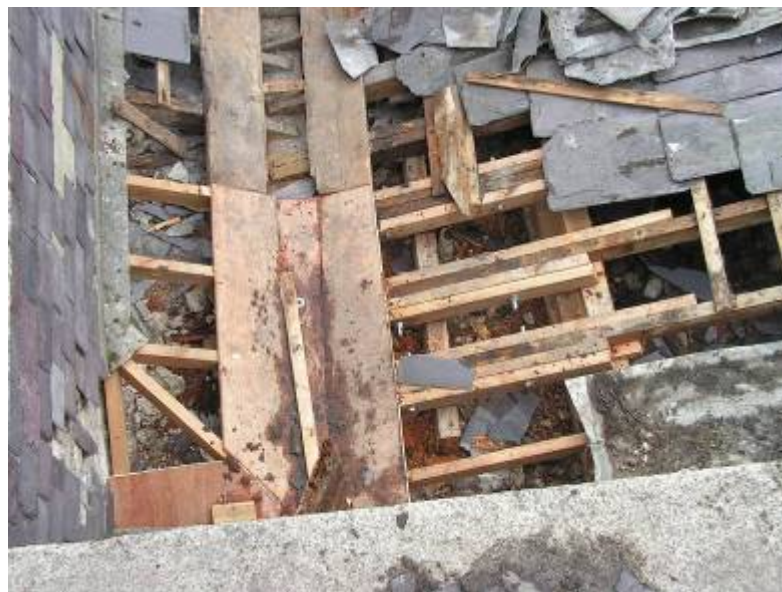
The new plywood gutter and valley boards. Note the reinforcement of existing timbers where they had rotted at the lower ends

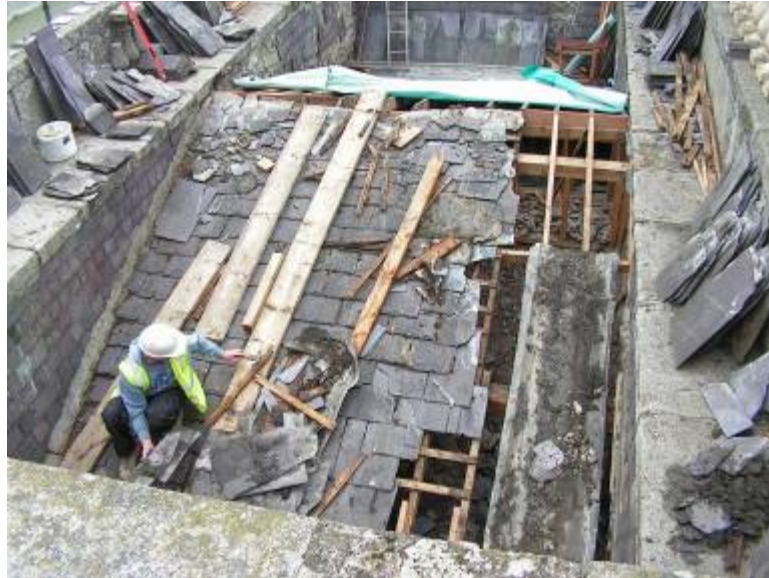
The roof repairs underway, viewed from the north-west. Note the balustrade on the north-eastern façade had been mostly taken down

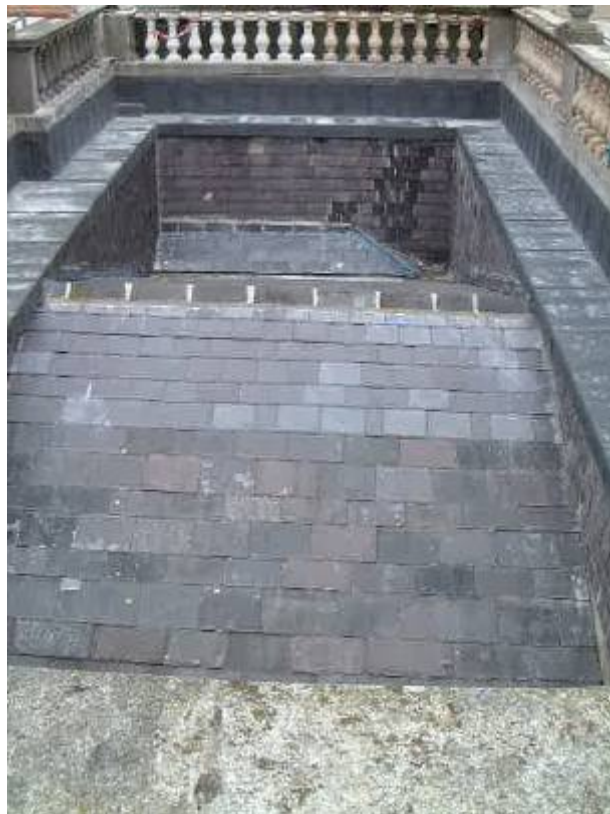
The repaired roof, viewed from the north-west. Note the darker, new vertical slate cladding. Note the lighter coloured slate on the 6 top courses of the roof slope and on the "small roofs" beside the valley.

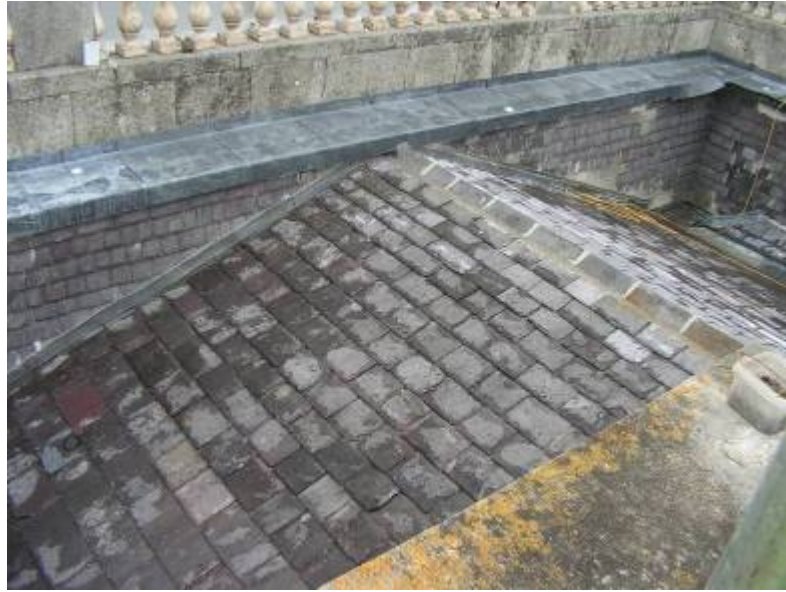
The repaired roof viewed from the east. Note that some of the previous mortar patch repairs of the vertical slate cladding that were in good condition were left as they were. Note the new lead soaker dressed into the chase above the roof line and the new lead dressed over the top of the parapet wall. The inner side of the blocking course had yet to be dressed with a cover flashing

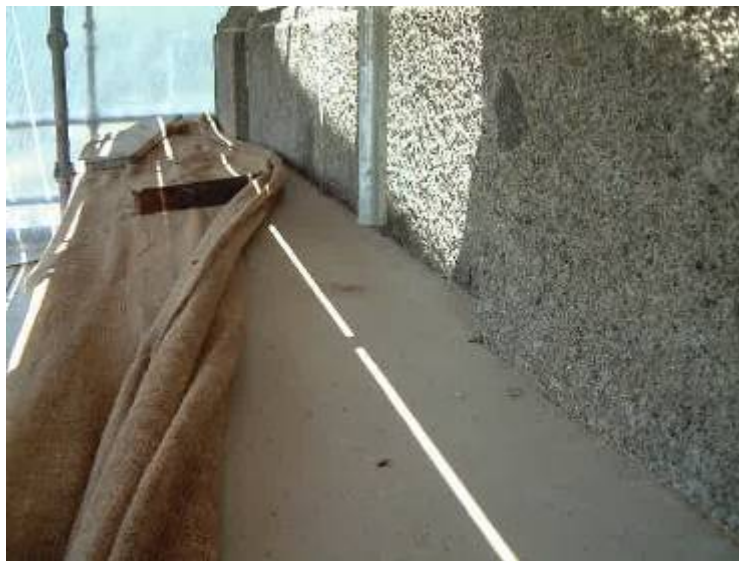
The lime mortar flaunching fillet on the cornice, protected with dampened hessian after its application.

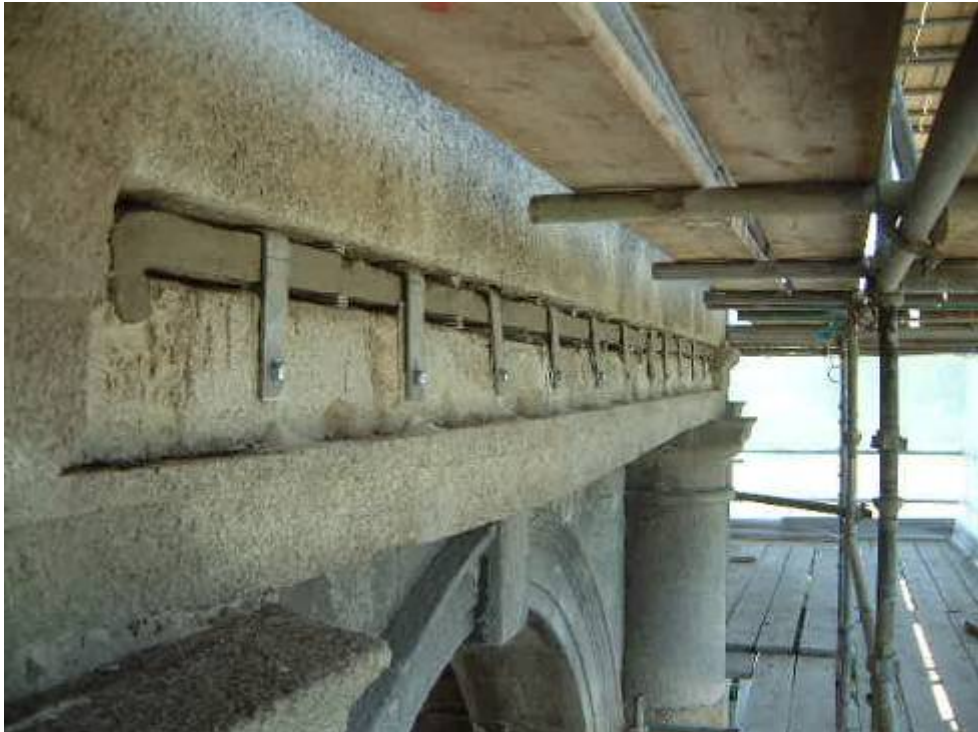
The north-eastern entablature: the exposed iron beam with the stainless steel L-sections bolted to the stone blocks below and hooked over the iron bar above. Note also the stainless steel shims or packers above and below the iron bar.

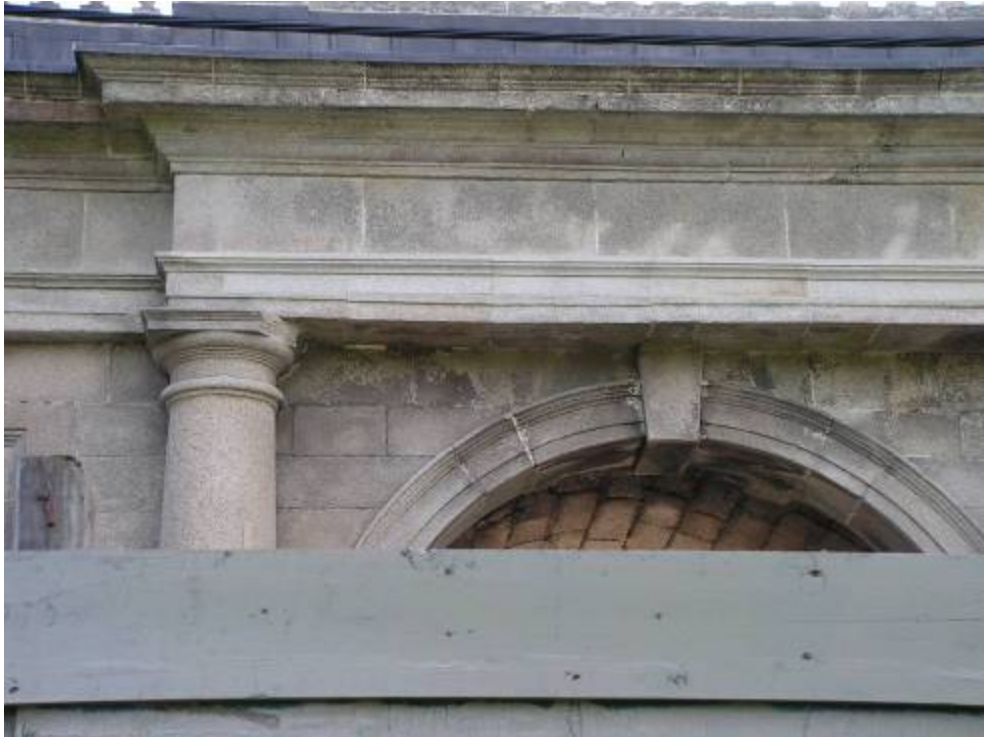
The north-eastern entablature: the completed repair. Note the new stone in front of the iron beam. The corner of the capital was not repaired because of budgetary constraints and because it was not an essential (photographed September 2010)

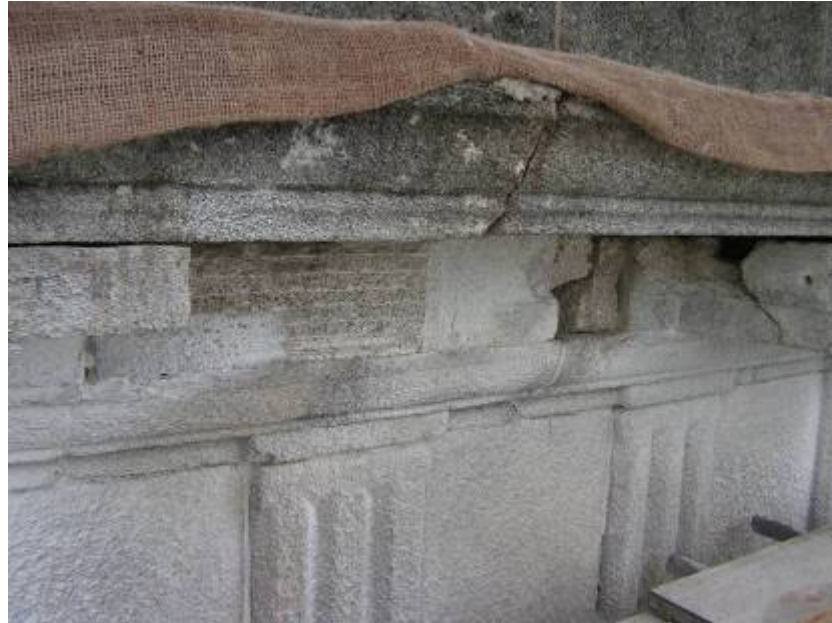
The larger of two repairs in the mutule course of the south-western entablature. One cramp has been entirely removed and two halves remain on either side; one is just visible on the right side. Note the diagonal crack in the existing stone to the right. Note also the dowel hole drilled into the existing stone. The dowel joint was made as follows: The hole was drilled into the existing stone to a depth of 400mm. Grout was pumped into the hole. The 400mm long dowel bar was secured with a rope half way along its length and fully inserted into the hole. The new stone section was predrilled to match and erected. When in place, the rope was pulled until the dowel was 200mm in both the new and existing stone. This technology has remained the same for centuries.

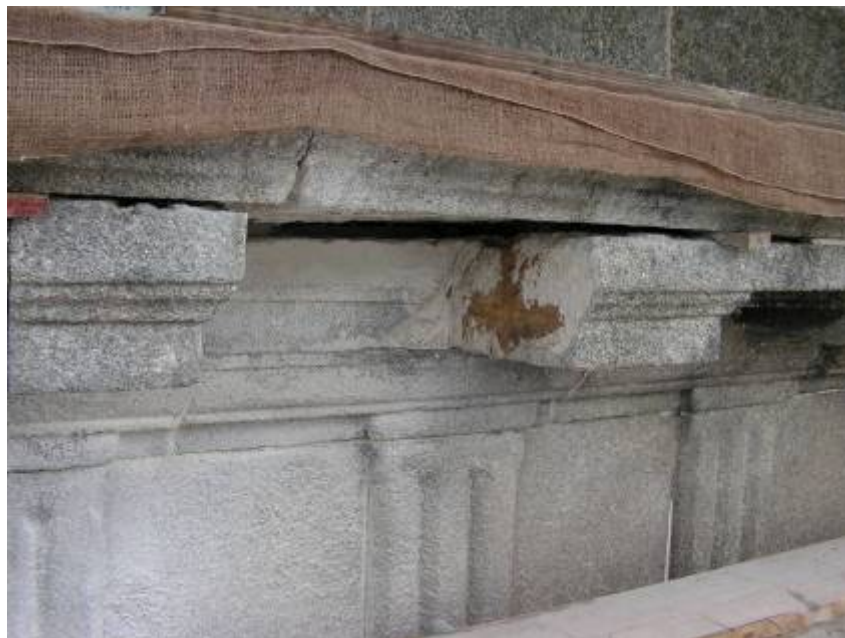
The smaller repair in the mutule course of the south-western entablature. The crack in the adjacent block has been repaired. Note that the jacked corona stone above settled back naturally into its correct position after the rusted cramp had been removed.

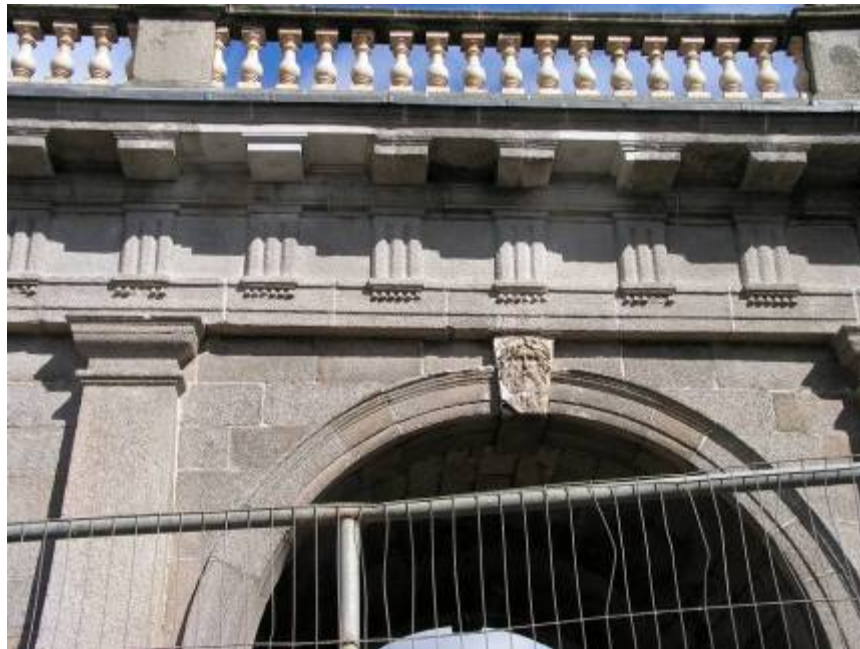
The south-western entablature: the completed repairs (photographed September 2010)
