The conservation and essential repair of the Roman Arch

Building Dossier

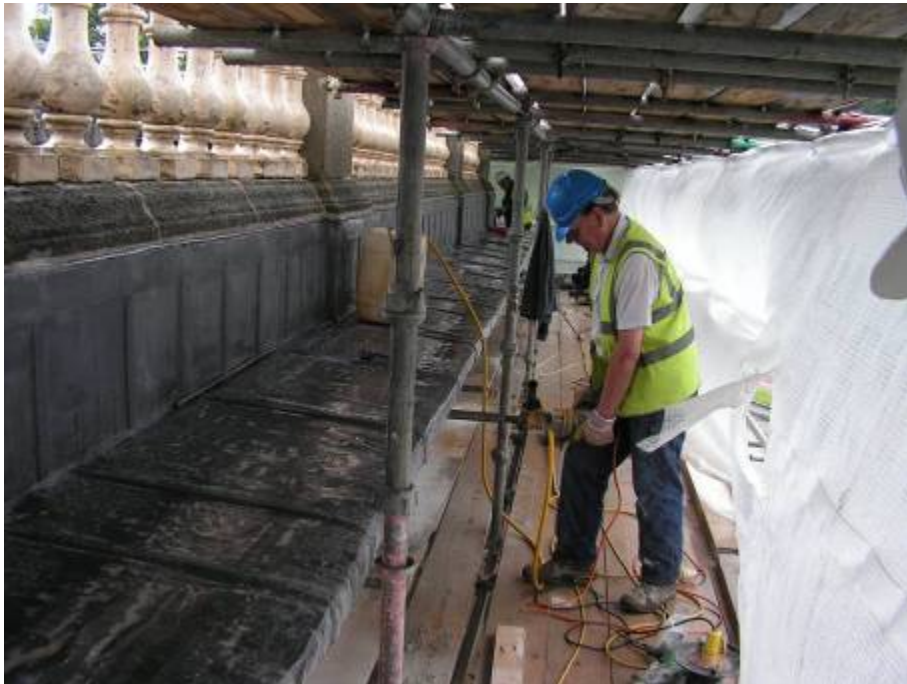
Drilling the cores at each joint in the corona course of the south-western cornice to each cramp behind to allow the cables to be attached to each cramp.

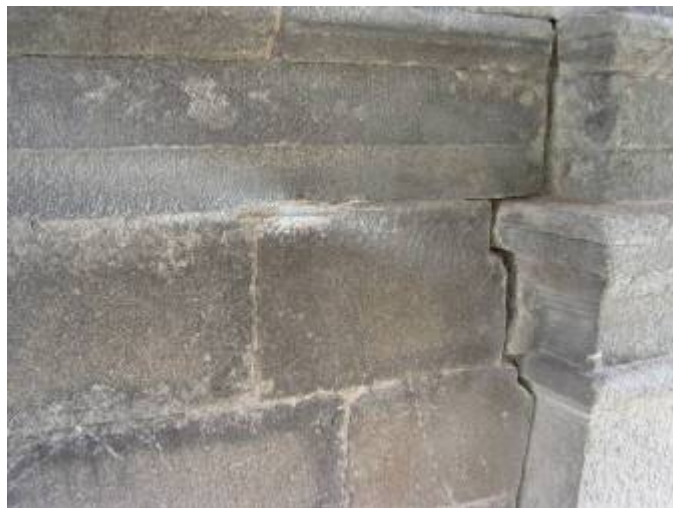
The south-eastern façade: the repaired stone and re-pointed mortar joint after the steel plate had been drilled out.

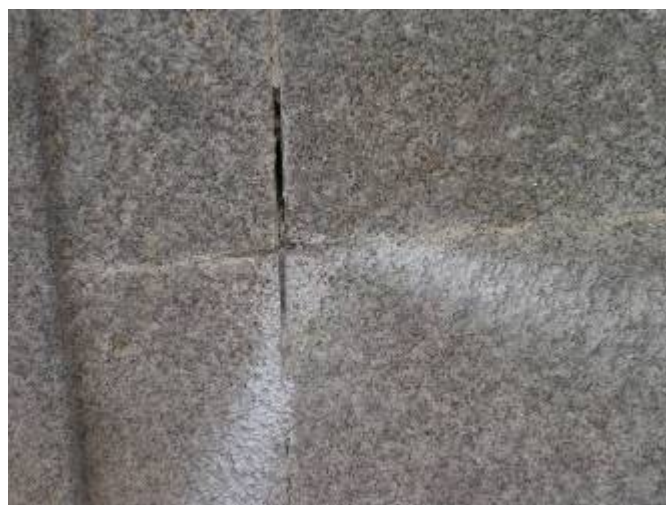
The north-eastern façade: a close up view of the left-side, square recessed panel where a pin, approximately 200mm long, was drilled out of the stone. Note where the stone had been drilled out around the pin. The resultant cavity was filled with a mixture of granite dust and resin, into which a chase was made while still fresh aligning with the mortar joints. The resin-dust repair was then tooled to match the appearance of the surrounding stone during dry weather conditions.

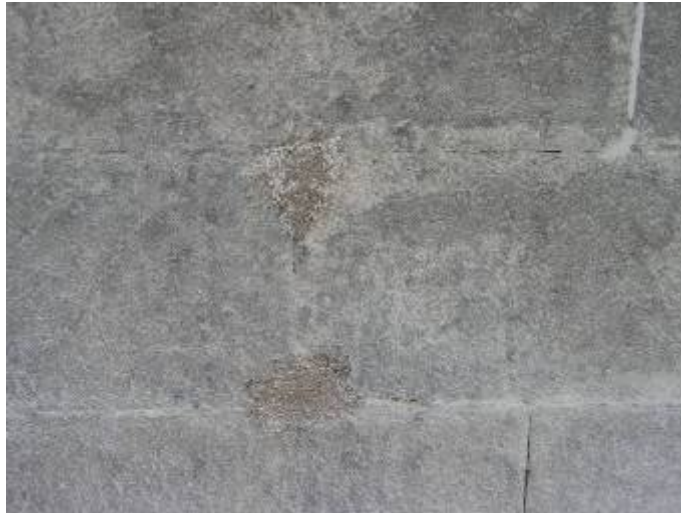
The north-western façade: 2 repairs similar to that above, involving the removal of embedded irons which were close to the surface and relatively easy to remove

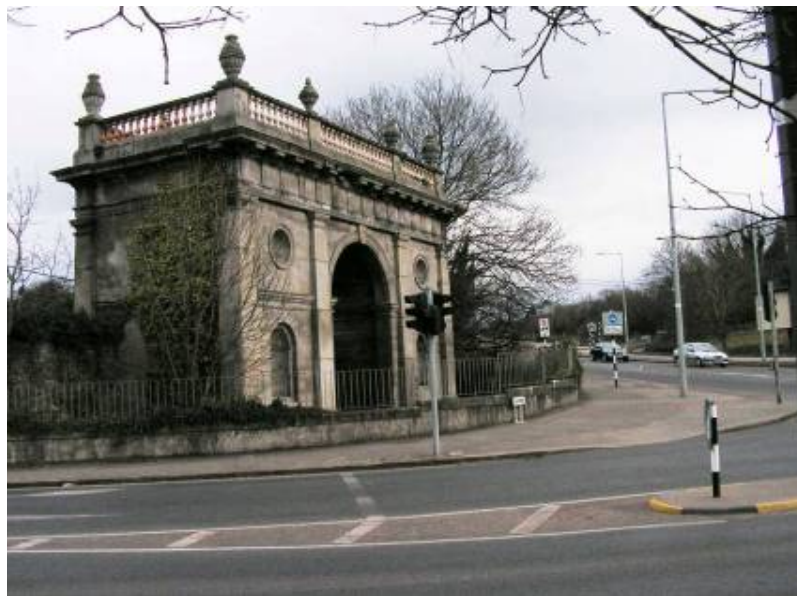
The Roman Arch viewed from the west, looking toward Braemor Road

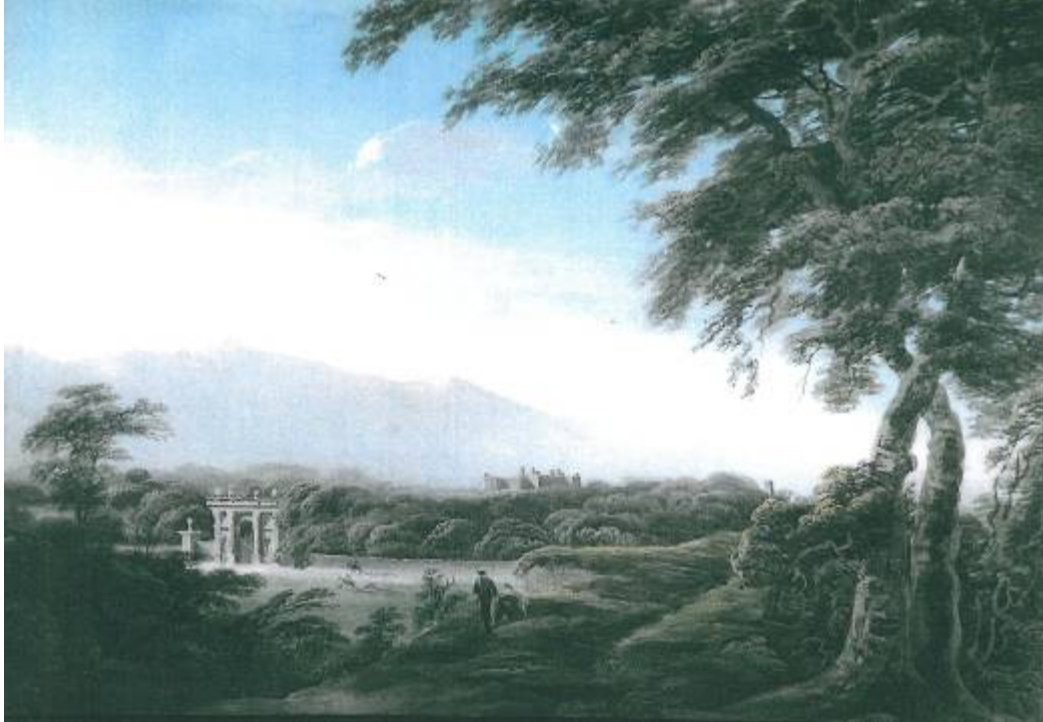
"A view of Rathfarnham Castle" by Thomas Walmsley (reproduced courtesy of the Castletown Foundation)

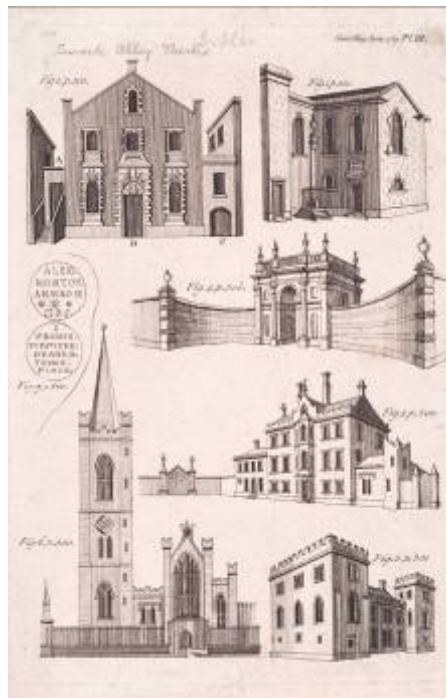
"Park Gate at Rathfarnham", Fig.4, pg. 500, Gent Magazine, June 1789 (approx. 50% of the original size, reproduced courtesy of the National Library of Ireland)

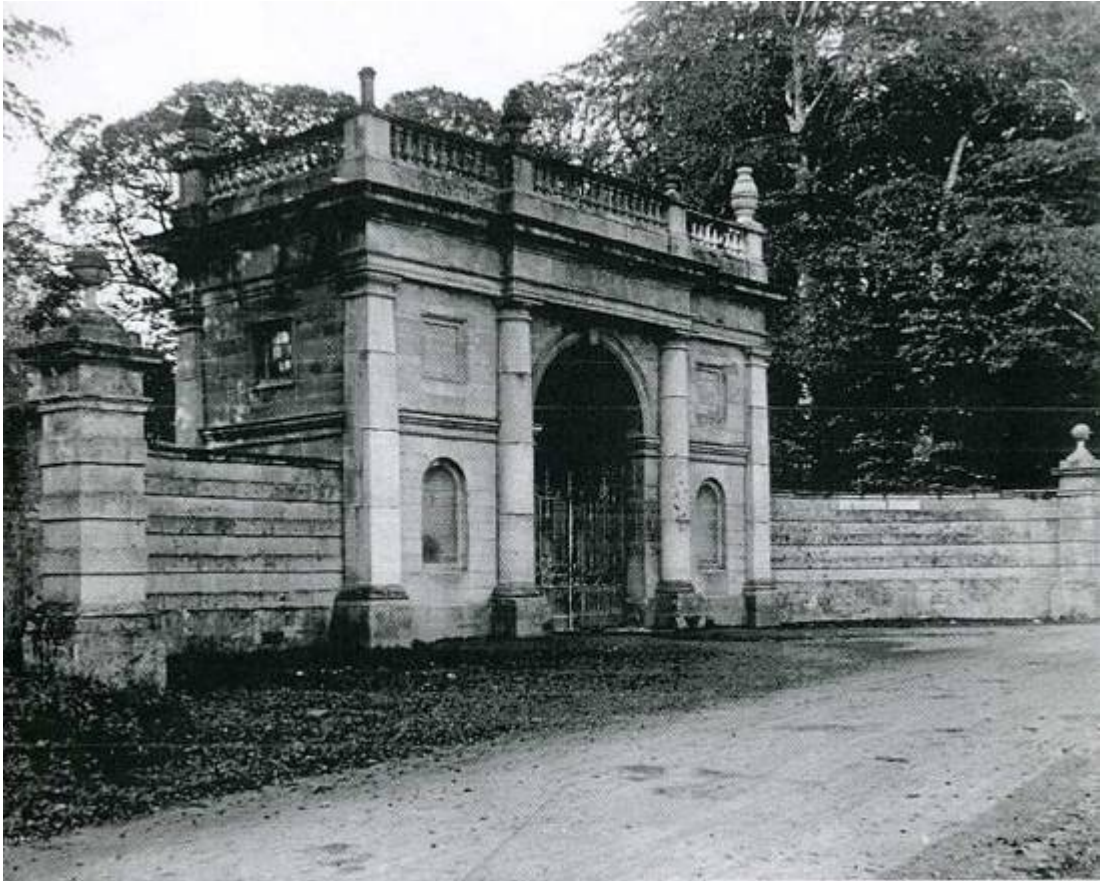
The Roman Arch circa 1940 (reproduced courtesy of the Irish Architectural Archive)
