Conservation of the ruins at Killininny, Oldcourt, Tallaght, Dublin 24

Building Dossier for works done during March and July - September 2016

Date of this report, 31st January 2017

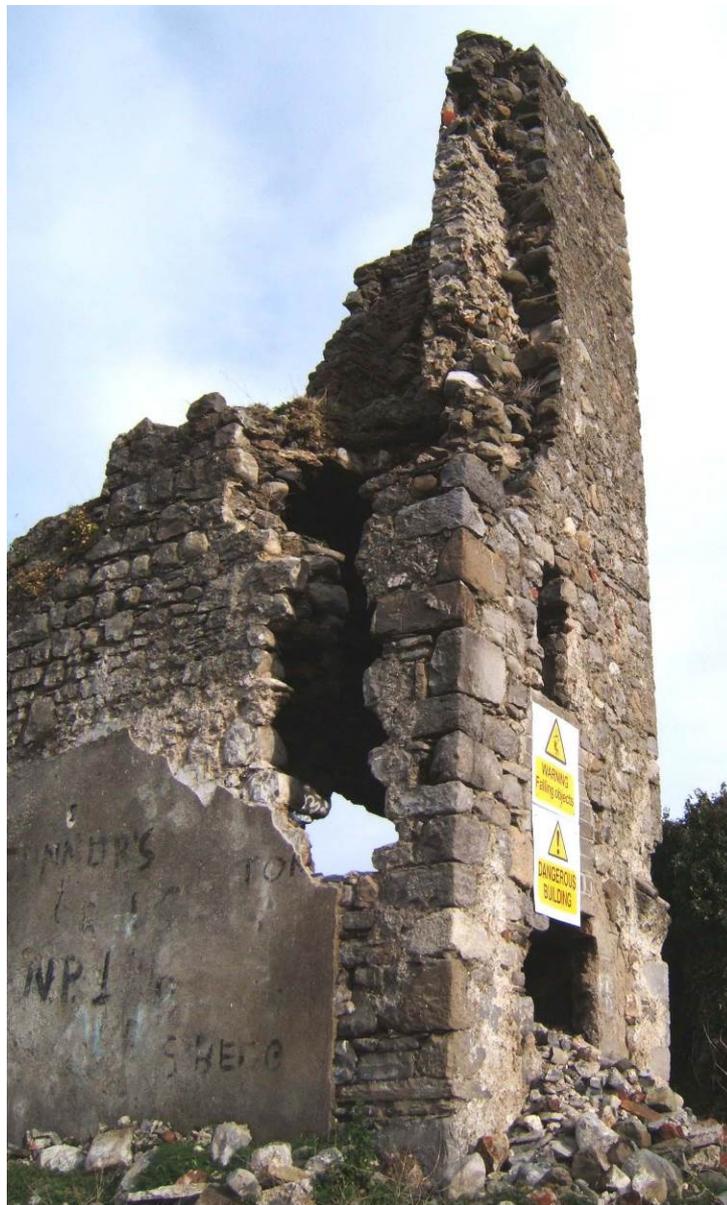
The remains of the tower, viewed from the south-west. This is the only photograph discovered that shows the former appearance of the south elevation of the tower before it collapsed in 2009, and as such it is an important record. The photograph was taken by South Dublin County Council staff in March 2007

In 2015 the ruins were roofless with the remains of a tower at its extreme southern end. The tower had collapsed about 2009 leaving a large heap of rubble around its base. Part of the boundary wall of Allenton house remains, separating the open space around the ruins from Allenton road. The ruins were heavily overgrown and mostly concealed by trees, shrubs, ivy and weeds. It was surrounded by two palisade fences with signs which read "Dangerous Building, Keep Out". Works had been done before; rubble from the collapsed buildings had been separated and stored in two or three heaps nearby in 2006, and possibly also during the archaeological excavation of 1990 by Leo Swan, referred to above. There were also signs of previous repairs, mostly impromptu, sometimes poorly-considered interventions. No document was found that records or explains the purpose of these works.

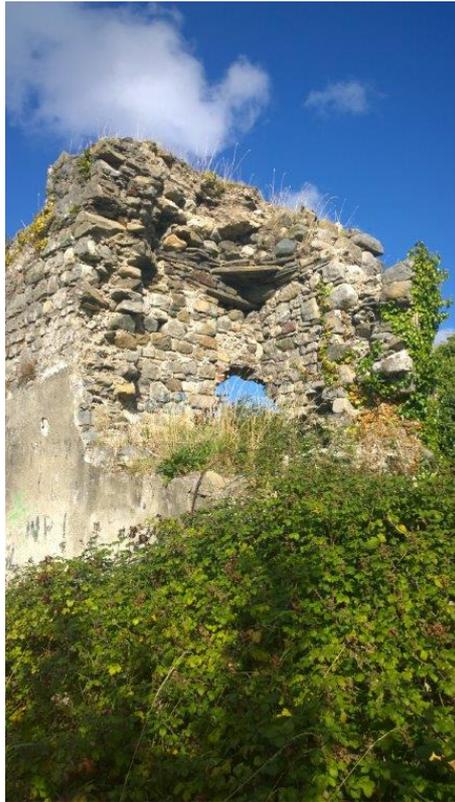
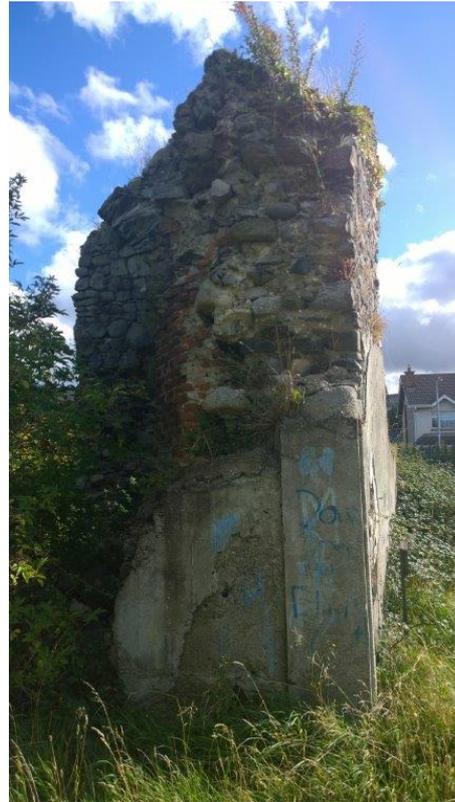
Left: The remains of the tower, from the south, October 2015. Right: The remains of the tower, from the north, October 2015.

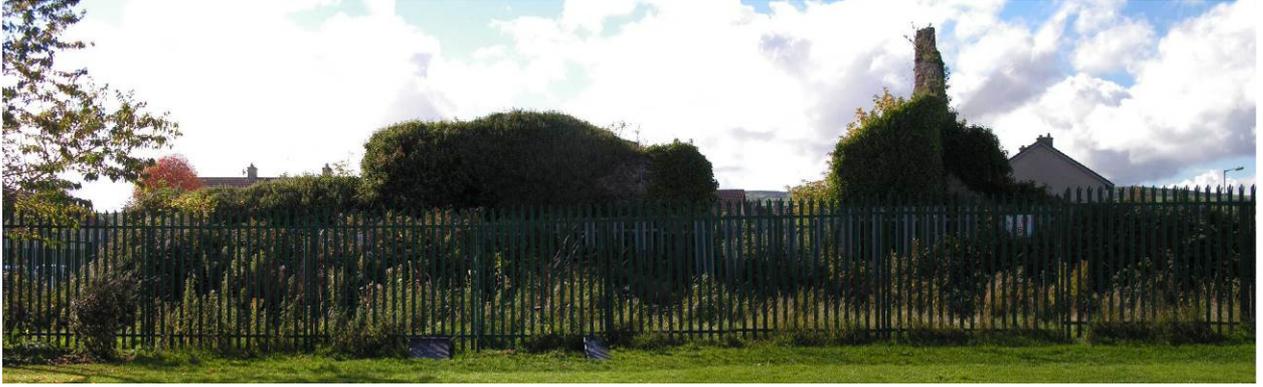
The monument viewed from the east north-east, October 2015

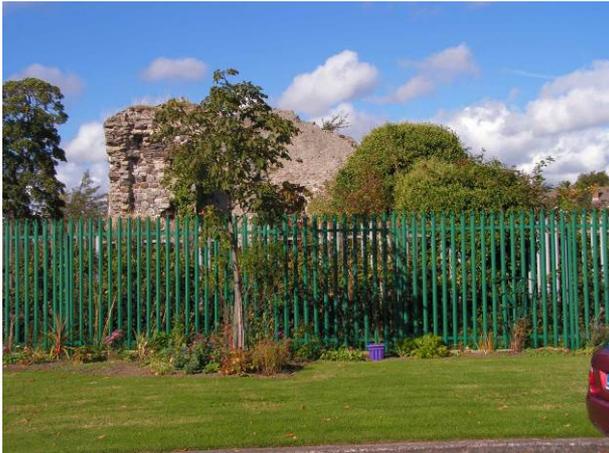
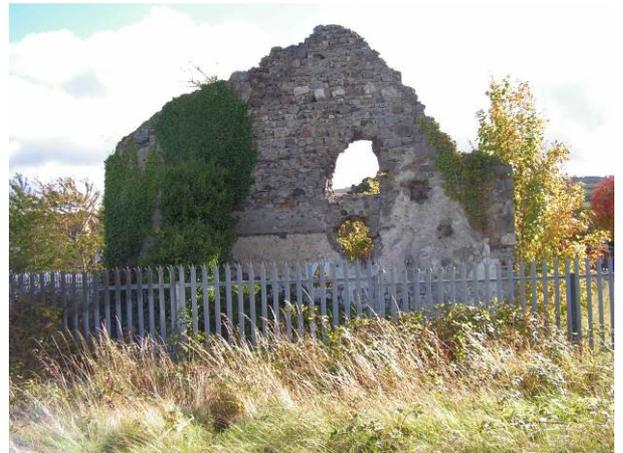
Left: The stump of the tower and adjacent wall, from the south-west, October 2015. Right: The external face of the north-facing gable wall, from the north, October 2016.

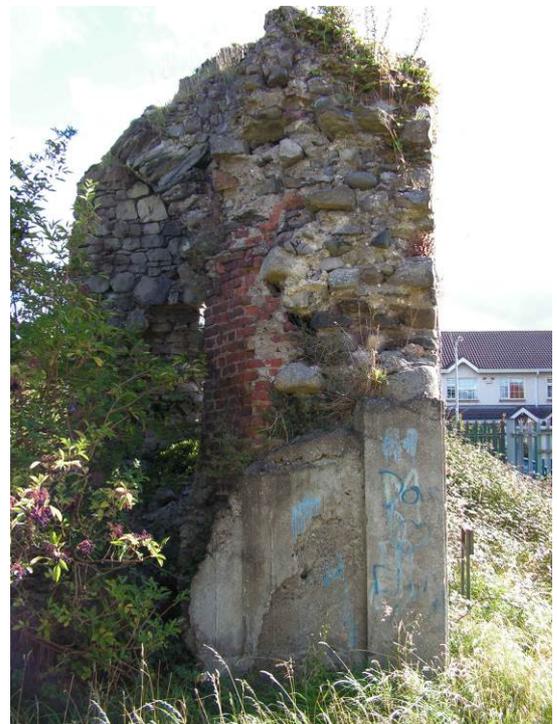
Left: The doorway in the external face of the north-facing gable wall, October 2015. Right: The brick lining to the internal face of the tower, viewed from the north, October 2016.

10. Grouting of wall cores: Unlike the thinner eighteenth and nineteenth the century walls, the construction of the remains of the tower was much thicker, about 1.5 – 1.8 metres thick and also massive. During the eighteenth century a lining or facing of brick and small stones had been applied to the north, internal face of the former tower. This had fallen away, exposing the wall core. Because of the massive structural failure of the tower above and the damage to the remaining stump, a decision was taken to grout the wall cores and cavities in this part of the monument. A liquid grout, the consistency of yogurt was mixed from a 1:2 mix of NHL 5.0 hydrated hydraulic lime powder, sharp, gritty wall-graded, clean sand and water, and was hand pumped with a proprietary mixer by three operatives: one to drill small holes and insert the nozzle end of the black flexible hope pipe into the pre-drilled holes, another to operate the hand pump periodically and the rotating paddle which prevented settlement and separation of the liquid grout in the drum, and the third person to clean off any spillages of grout onto the wall surfaces and to block any leaks with daubs of quickly applied mortar. In this way, starting at the bottom and gradually working up

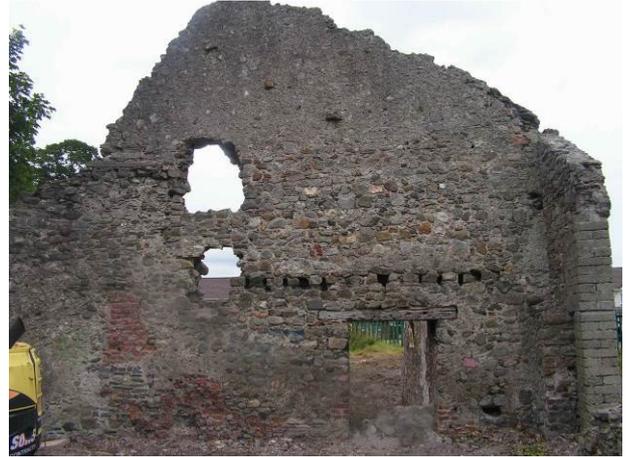
1) **Collapsed masonry and unstable walls:** In 2015 and for many years before the ruins were in a dangerous condition and it was necessary to prevent access to them by members of the public. From examination of the photographs taken during recent decades and comparison with the ruins in 2015 it was apparent that the buildings had been unused and ruinous for approximately 40 years, possibly more. Parts of the ruins had already collapsed by the 1970s. The tower collapsed as recently as 2009. In the still standing walls, there were several lacunae or holes had formed high in the north gable wall where stone had fallen out.

Left: The SE corner of the ruin after removal of all vegetation, viewed from the west, from inside, July 2016. Right: The internal face of the north-facing gable wall after removal of all vegetation, July 2016.

7. The lacunae or holes in the north-facing gable wall: Originally it was agreed that the edges of these holes would be lined with salvaged stone to prevent loose masonry from falling out of the wall cores. However during the works it was decided to completely fill these holes. We could not ascertain if the holes were former window openings that had gradually enlarged or were holes that had formed gradually in the wall.

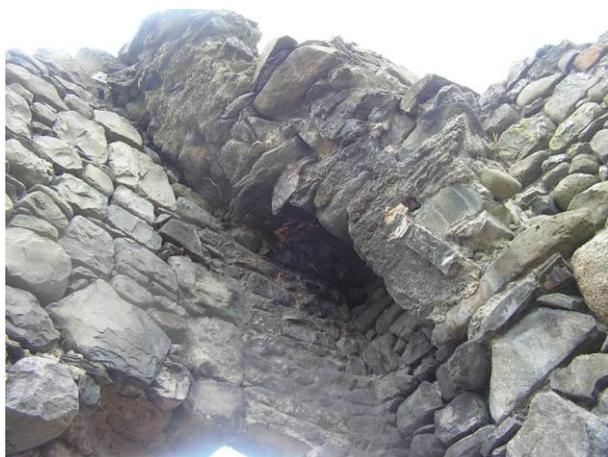
Left: The fragment vault after removal of all vegetation, July 2016. Right: The cobbles in the ground to the west of the ruin, July 2016.

11. Repairs to the remains of the tower and the fragment of masonry vault: Jason Bolton's report highlighted the importance of the fragment of the vault springing and its fragments of mortar. This fragment appeared to be supported in tension by the mortar between the joints and by friction and was unsatisfactory. Therefore, the engineer designed a simple sheet of stainless steel which was pre-curved in a workshop to match the profile of the vault reinforcement and to support it from underneath. Although this is a modern intervention it is discrete and functional, and was designed in consideration of Article 10 of the Venice Charter.

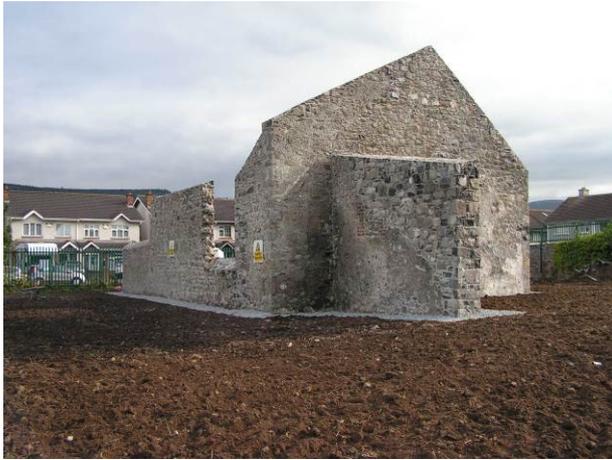
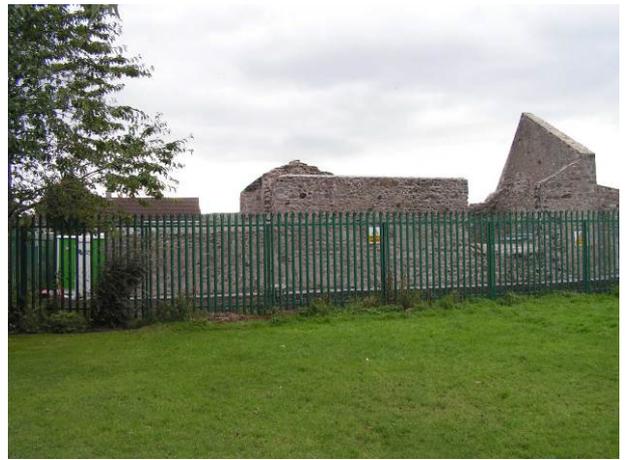
The completed works, September 2016. The fence was retained until the grass seed had germinated.

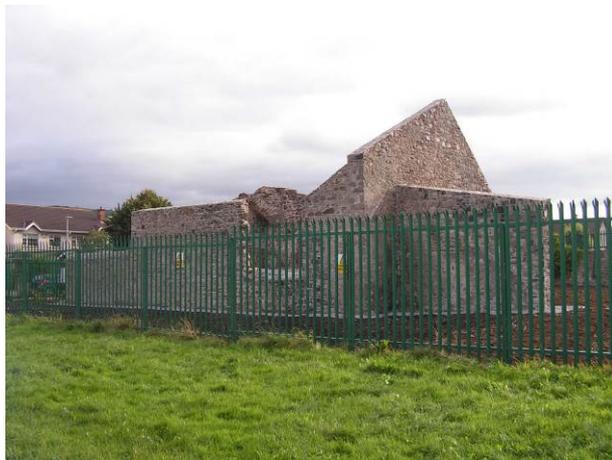
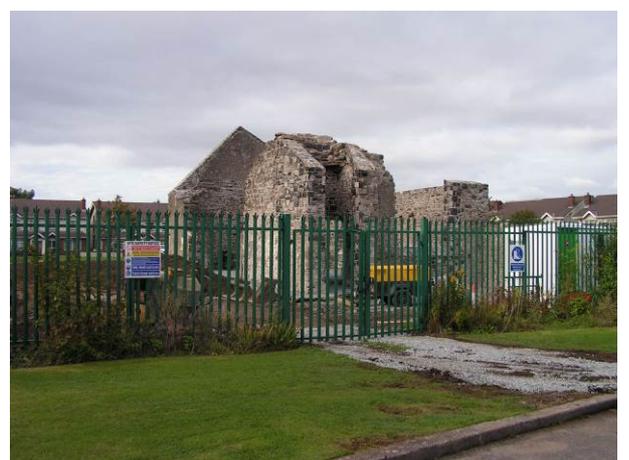
The completed works, September 2016.
