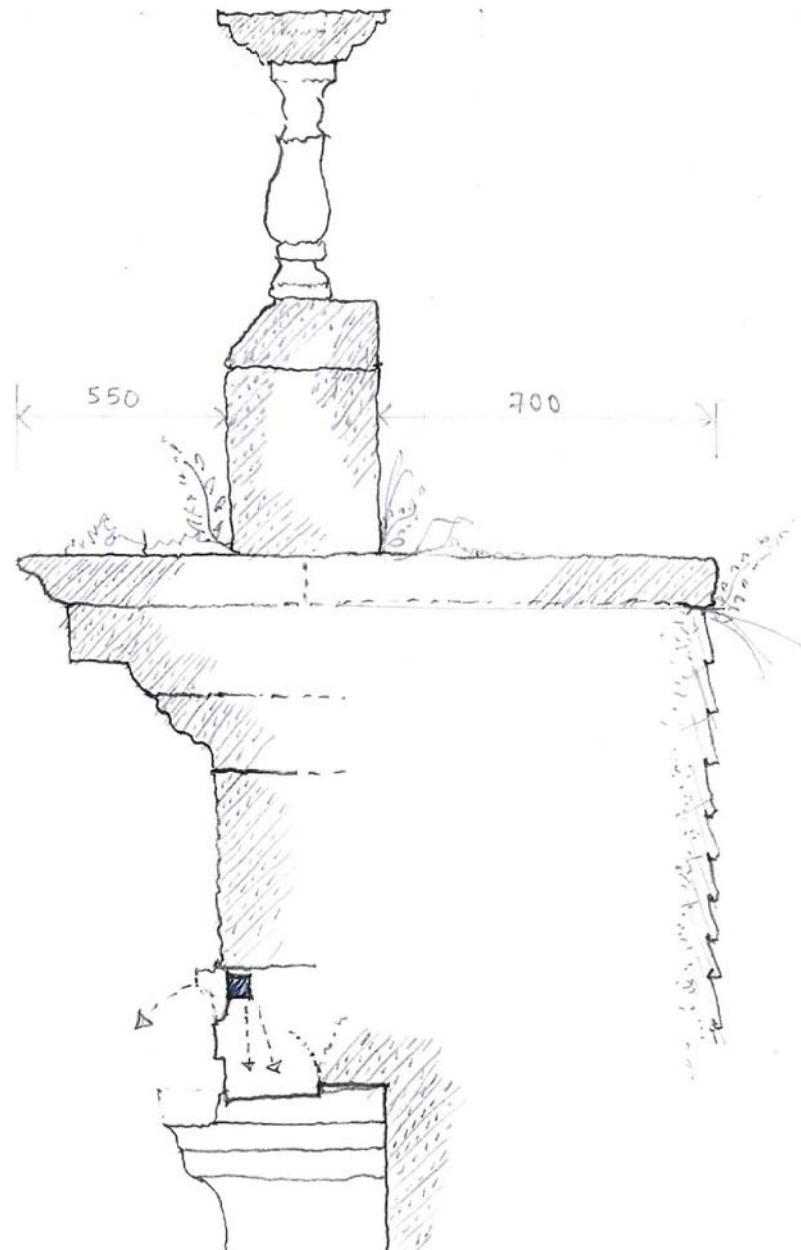
MOSSES, SCUMS AND ALGAE HAD GROWN ON THE WET, FLAT, UPPER SURFACES OF THE CORNICE

50mm X 50mm CORRODED W.I. BAR EXPANDED, SPALLED STONE FROM THE FACADE AND PUSHED THE SOFFIT DOWN

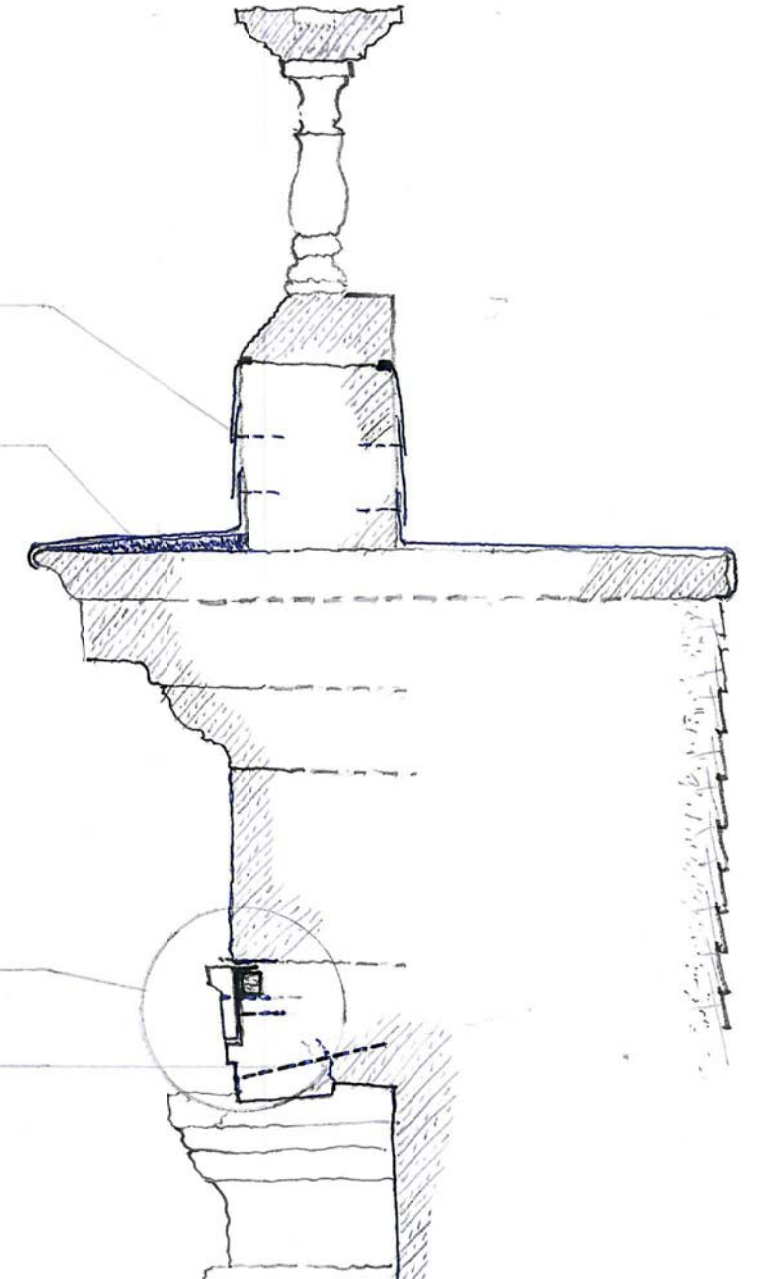
MANY VERTICAL S MISSING OR LOO

CODE 6 LEAD TO VERTICAL FACE OF BLOCKING COURSE

LIME MORTAR FILLET FLAUNCHING ON CORONA COURSE COVERED WITH CODE 8 LEAD

COLLAPSING STONE HUNG FROM THE W.I. BAR AS PER DETAIL A

COLLAPSING STONE PINNED TO RUBBLE CORE WITH 400mm LONG, 12mm  $\phi$  S.S. BAR
